Boise State University

Transgranular Stress Corrosion Cracking of 304L Stainless Steel Pipe Clamps in Direct Use Geothermal Water Heating Applications

Kent A. Johnson
City of Boise Geothermal Department

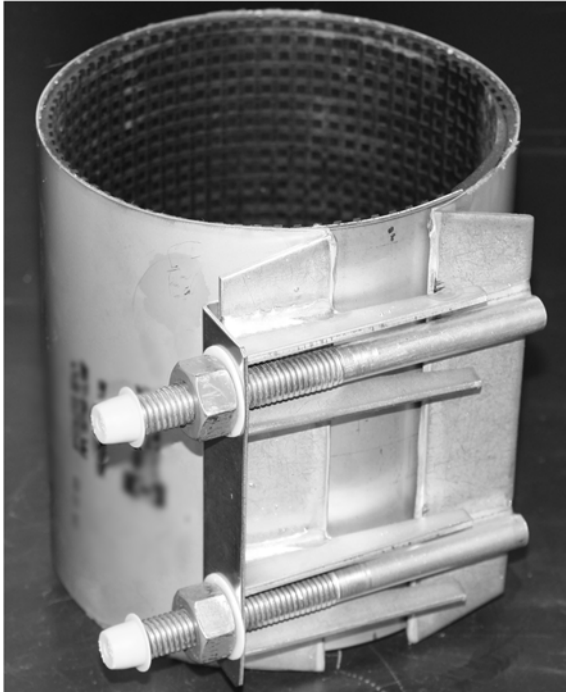
In addition to tensile testing, an investigation to determine the expected stress state of the clamp while in service was performed. A new clamp and pipe section, identical to those implemented in the Boise geothermal system, was procured (Figure 1). To determine the stress level, a 5 mm grid length, 120 Ω foil strain gauge was affixed to the clamp, orientated parallel to the direction of applied stress. The clamp was then placed around the pipe and tightened to the manufacturer's torque specifications, 80 ft/lbs. Resistance change measurements from the strain gauge were acquired during tightening and converted to amount of strain. The applied stress was determined to be 115 +/- 5 MPa, using the measured strain values and Young's Modulus for 304 stainless steel [9]. Provided the clamps were installed according to specifications, the applied stress level of 115 MPa is approximately 53% of the minimum yield stress (215 MPa), for 304 stainless steel. This stress level provides adequate seal pressure around the pipe while safely below the yield stress of the clamp.

Figure 1. Image of a new 304 stainless steel pipe repair clamp identical to those studied in this investigation. Once a leak in the geothermal system has been excavated and repaired the pipe clamp is placed and sealing pressure is applied via bolt tightening.

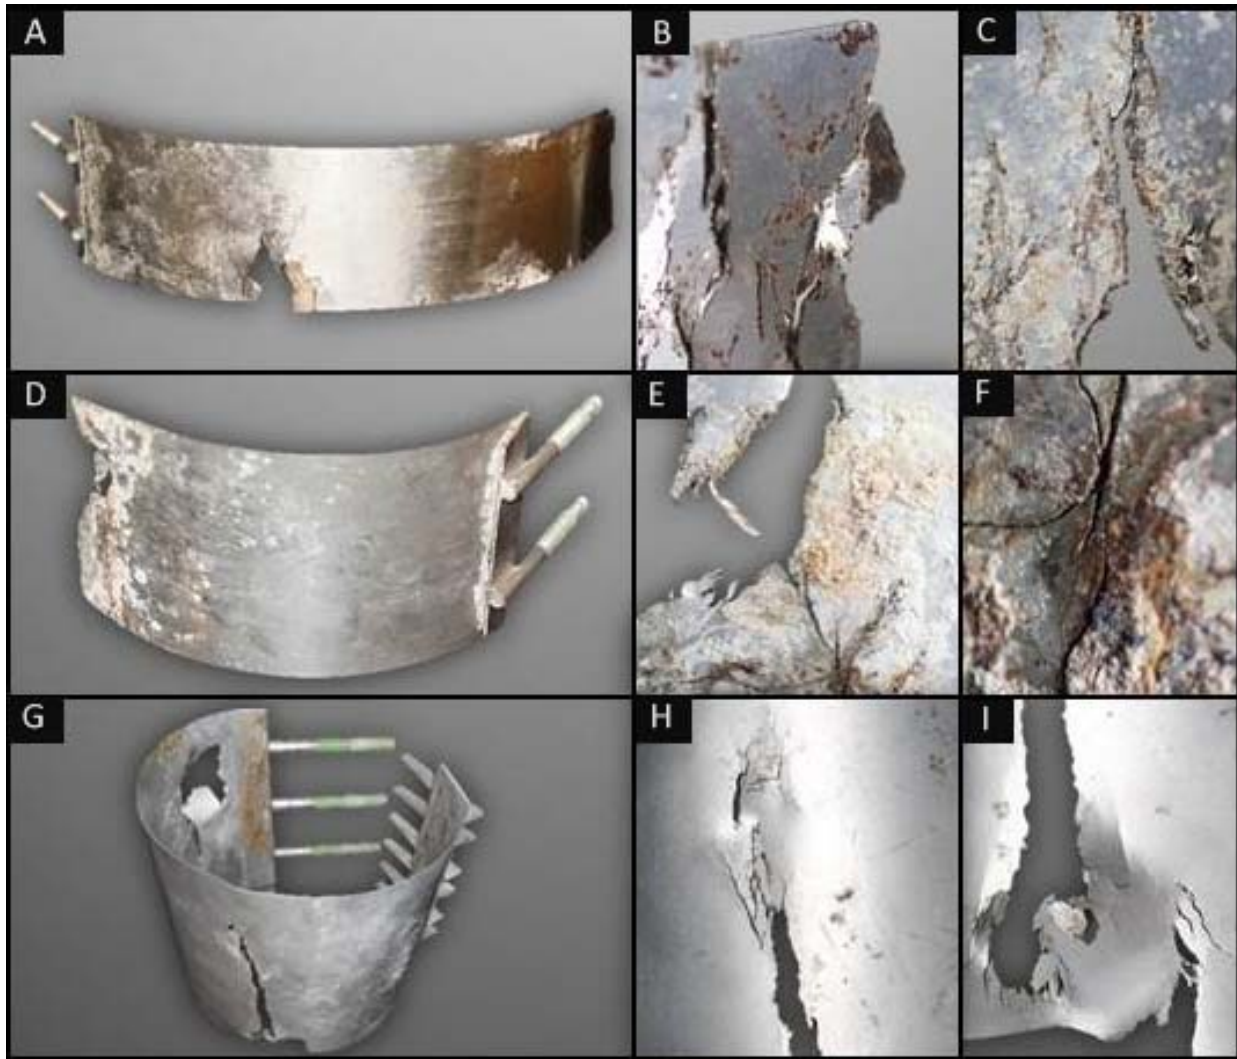
Figure 2, shows failed regions observed on stainless steel clamps collected after excavation. General, post-mortem examination of the failed stainless steel clamps show little indication of degradation aside from the failed region the component, Figure 2A,D,G. Failures typically occur far from welds or tensioning bolts, near the bottom (underside), and in most cases have shown small amounts of red or less frequently black corrosion products and/or mineral scale at the region of failure (Figure 2B,C,E,F). In a few cases, the bolts or region near the clamp closure have also failed or showed signs of degradation, but always in addition to the aforementioned strap failure.

In some instances at regions on the clamp where cracking was observed, was typically also slight red or black staining (Figure 2) and/or flaky, white deposits. Since these deposits were limited to the cracked area and no evidence of corrosion damage was observed elsewhere on the sample, it can be concluded that the general environment which the clamps were exposed was not aggressive enough to sustain widespread active corrosion, though some localized corrosion likely occurred associated with cracking. The flaky white deposits near a crack site are likely the cause and/or result of the local environment which enabled the failure to occur at that region on the clamp. One plausible explanation is that at some areas an aggressive local solution chemistry evolved to bring the corrosion potential of the metal in that region into a window of stress corrosion cracking susceptibility [10]. Localized corrosion was likely coupled crack propagation and continued on newly created surfaces at the crack faces following crack advancement (see section 3.1).

Figure 2. Pictures of three cracked geothermal pipe clamps (A, D, G), as observed following excavation of the geothermal line to obtain failed parts. Corresponding close-up images of typical failed regions are shown in images B,C,E,F,H, and I.

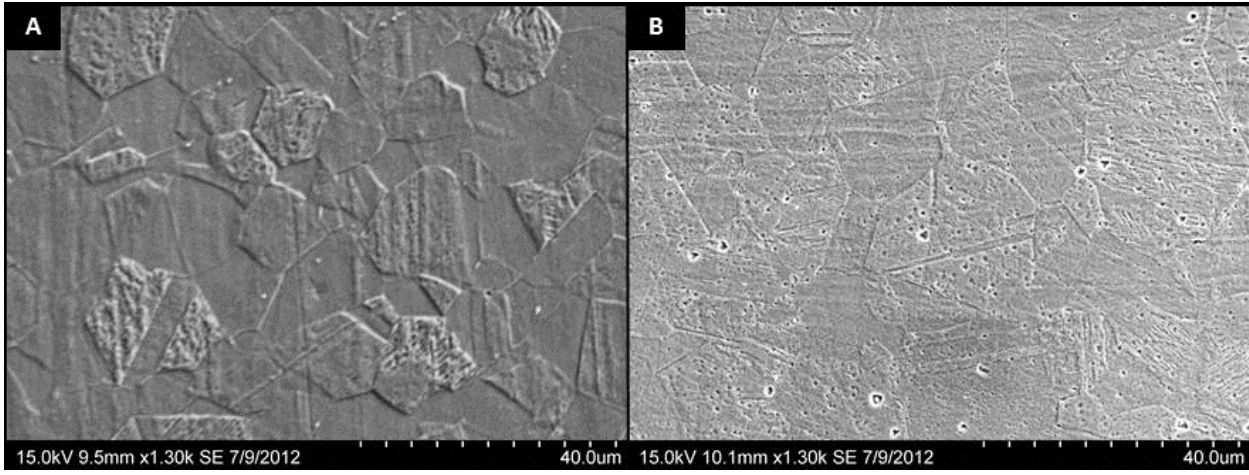
A preliminary effort was made to confirm the expected clamp material specifications. The stainless steel straps were specified from the manufacturer as grade 304 and the composition was confirmed through independent chemical analysis. Representative pieces of the clamp from unaffected areas were sectioned, polished and etched to observe the microstructure, Figure 3. A general purpose metallographic etch (1:1:1, Water:Nitric acid:Hydrochloric acid) was used in all images where an etched surface is presented. The longitudinal and transverse grain structure indicated that the microstructure was consistent with annealed 304 stainless steel [8]. There was no indication of unwanted secondary phases or the presence of preferential or excessive inclusion particles observed in the sections characterized. The composition and microstructure verified the component specifications and therefore failure could not be linked to faulty materials or processing.

Figure 3. SEM microstructure images of the longitudinal (A) and transverse (B) polished and etched sections of a failed 304 stainless steel geothermal pipe clamp.

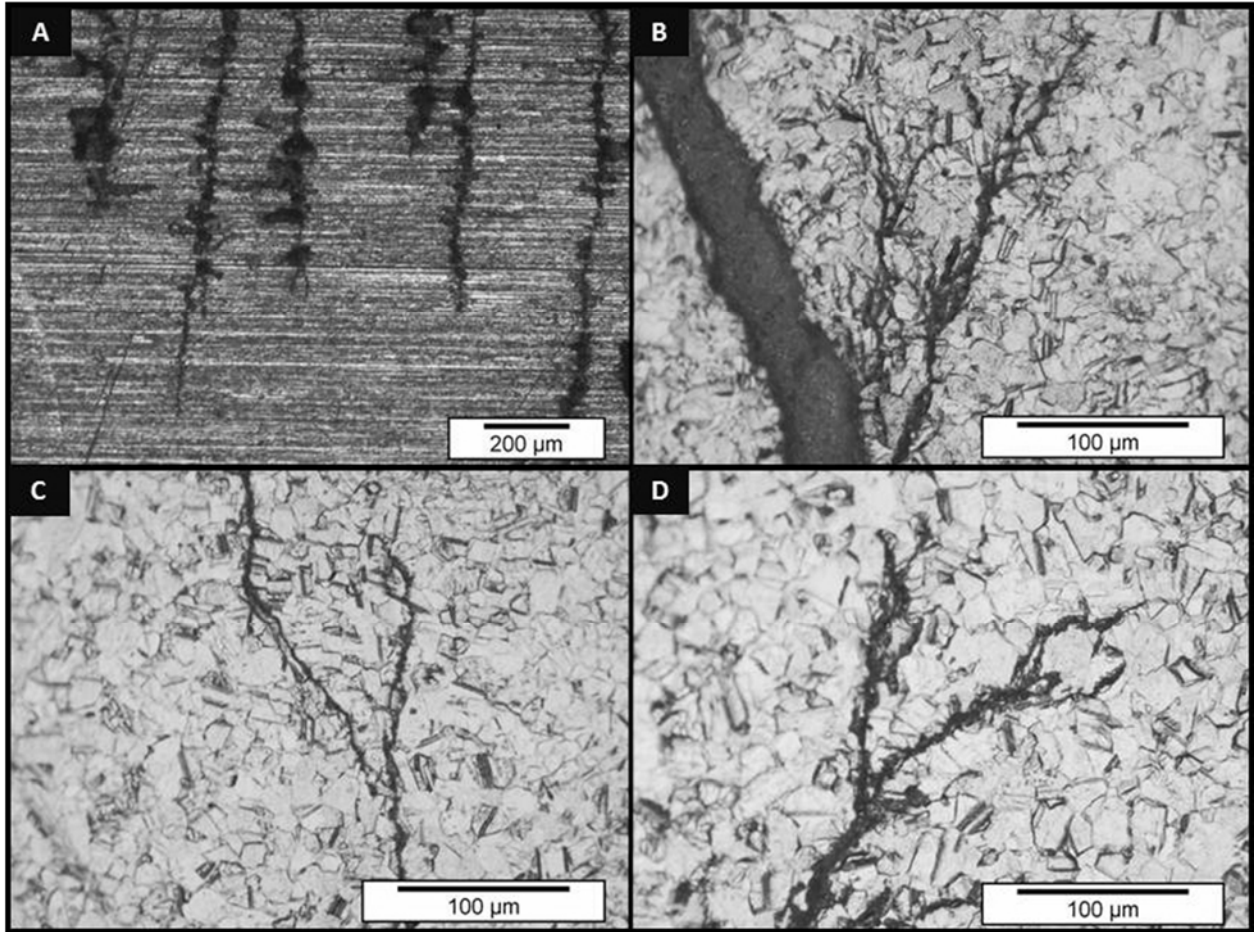
Visual characterization of the failed strap region showed that cracks propagated normal to the direction of applied stress, were brittle in appearance, and were accompanied by numerous smaller branched cracks (Figure 4). In addition, the observed cracks were limited to localized regions of the strap and the remaining area of the strap appeared unaffected. To better characterize the nature of cracking, samples were sectioned from cracked areas of the clamp and mounted in epoxy. Optical microscopy on the as-received surface revealed numerous branched cracks (Figure 4A) and polished, etched sections showed that cracking predominately propagated through grains, typically with numerous branches, Figure 4B-D. Moreover SEM characterization of polished and etched crack cross-sections showed populations of small, transgranular, branched cracks, Figure 5A-C. Some crack edges and tips also showed numerous, approximately 10 μ m rounded features, likely anodic dissolution sites associated with an advancing crack. A representative crack face, shown in Figure 5D, had brittle, cleavage type appearance with no indication of ductile

Figure 4. Optical (A) and scanning electron (B-D) micrographs of crack sites on a 304 stainless steel pipe clamp that failed in service.

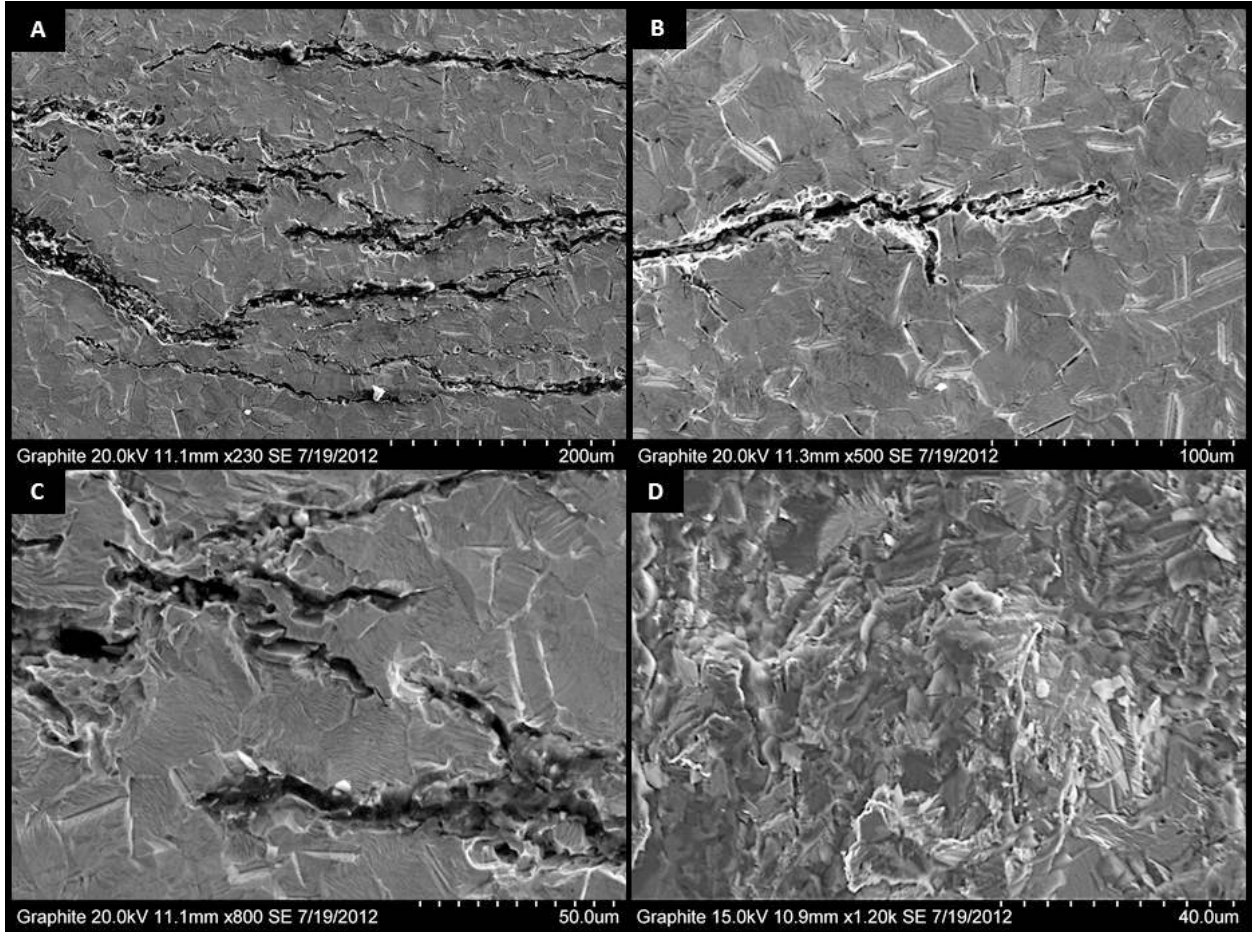
fracture. X-ray energy dispersive spectroscopy (EDS) performed on the crack face (Figure 5D) also indicated small volumes of Fe- and Cr-rich oxides were present (Table 2a-b.), consistent with the occurrence of localized corrosion. The presence of oxides or corrosion products was only observed on or adjacent to crack faces and no significant evidence of corrosion was seen elsewhere on the clamps.

Figure 5. SEM images of cracks sites (A-C) on geothermal pipe clamps. Samples in images A-C were polished and etched prior to imaging. D is an image of the typical crack face appearance.

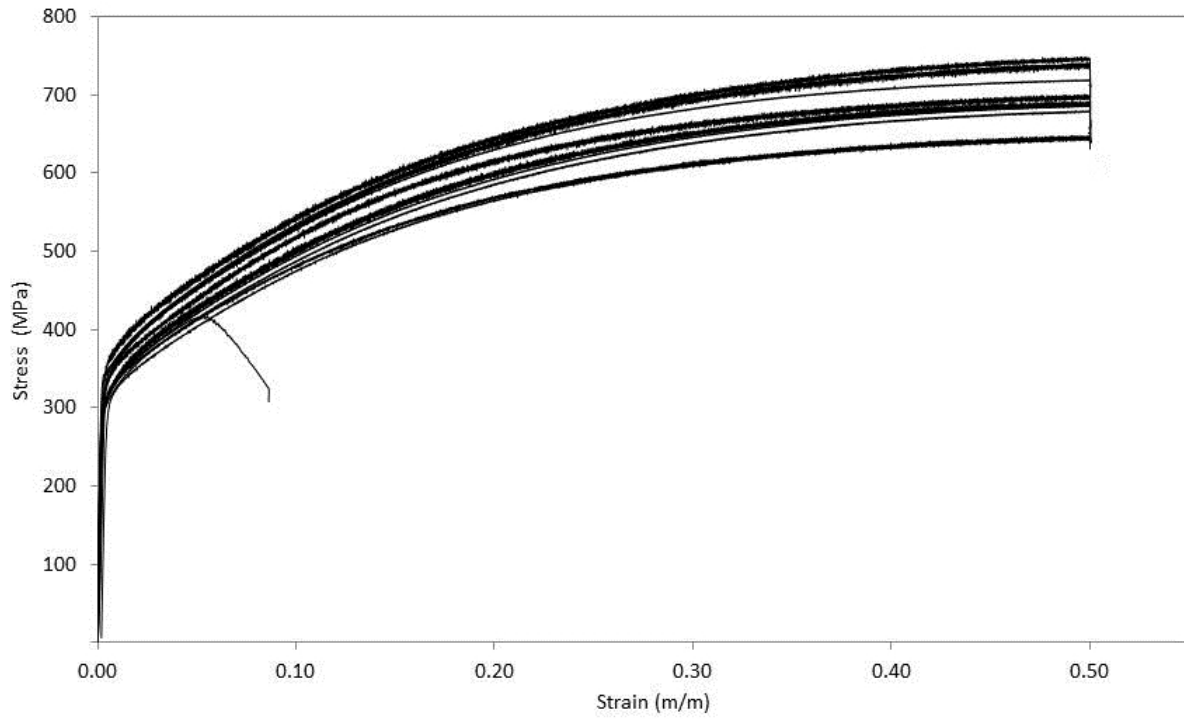
To assess the degree of which the clamp was compromised, tensile testing was performed on samples machined from regions of the clamp that showed no evidence of cracking or degradation. The goal of this testing was to determine if the entire clamp was affected or if the cracked sections were the result of a specific local phenomena occurring at discreet areas of the clamp. Tensile testing was performed according to ASTM standard E8, and the resulting stress vs. strain behavior is presented in Figure 6. Mechanical testing results generally showed no evidence of degraded mechanical properties as the ductility and strength behavior agreed with that expected for 304 stainless steel [9]. Figure 6 shows results from 13 separate tests, of which 9 samples were prepared from failed clamps taken out of service and 4 samples were prepared from a new, unused clamp identical to those used in service. Although some test to test variability was observed, all samples regardless of service history, showed similar properties and were in agreement with expected 304 stainless steel mechanical properties. However, in one of the tensile tests premature failure occurred near the yield point (Figure 6). The anomaly sample failed near the grip area and SEM imaging of the fracture surface showed two different regions of fracture behavior (Figure 7). In this instance it is likely that a region of the sample contained a pre-existing flaw, too small to detect visually, at which brittle type fracture initially occurred and ductile fracture then proceeded across the remaining cross-section. The brittle portion of the fracture surface (Figure 7B) was similar in appearance to that in Figure 5D (which failed while in service) and had a dark, dull appearance due to oxides present on the surface with no evidence of plastic deformation preceding fracture. In contrast, the ductile fracture region (Figure 7C) was shiny, displayed a cup-and-cone morphology indicative of microvoid coalescence, and experienced significant necking prior to fracture. In summary, observations from mechanical testing showed that most of the in service clamp material was un-degraded, though areas on the samples near to failed regions may contain small cracks or colonies of cracks that are too small to detect visually.

Figure 6. Results from mechanical testing from tensile test samples machined from both new (un-used, seen in Figure 1) and failed 304 stainless steel (as seen in Figure 2) pipe repair clamps. One sample failed prematurely at a total strain of approximately 0.09.

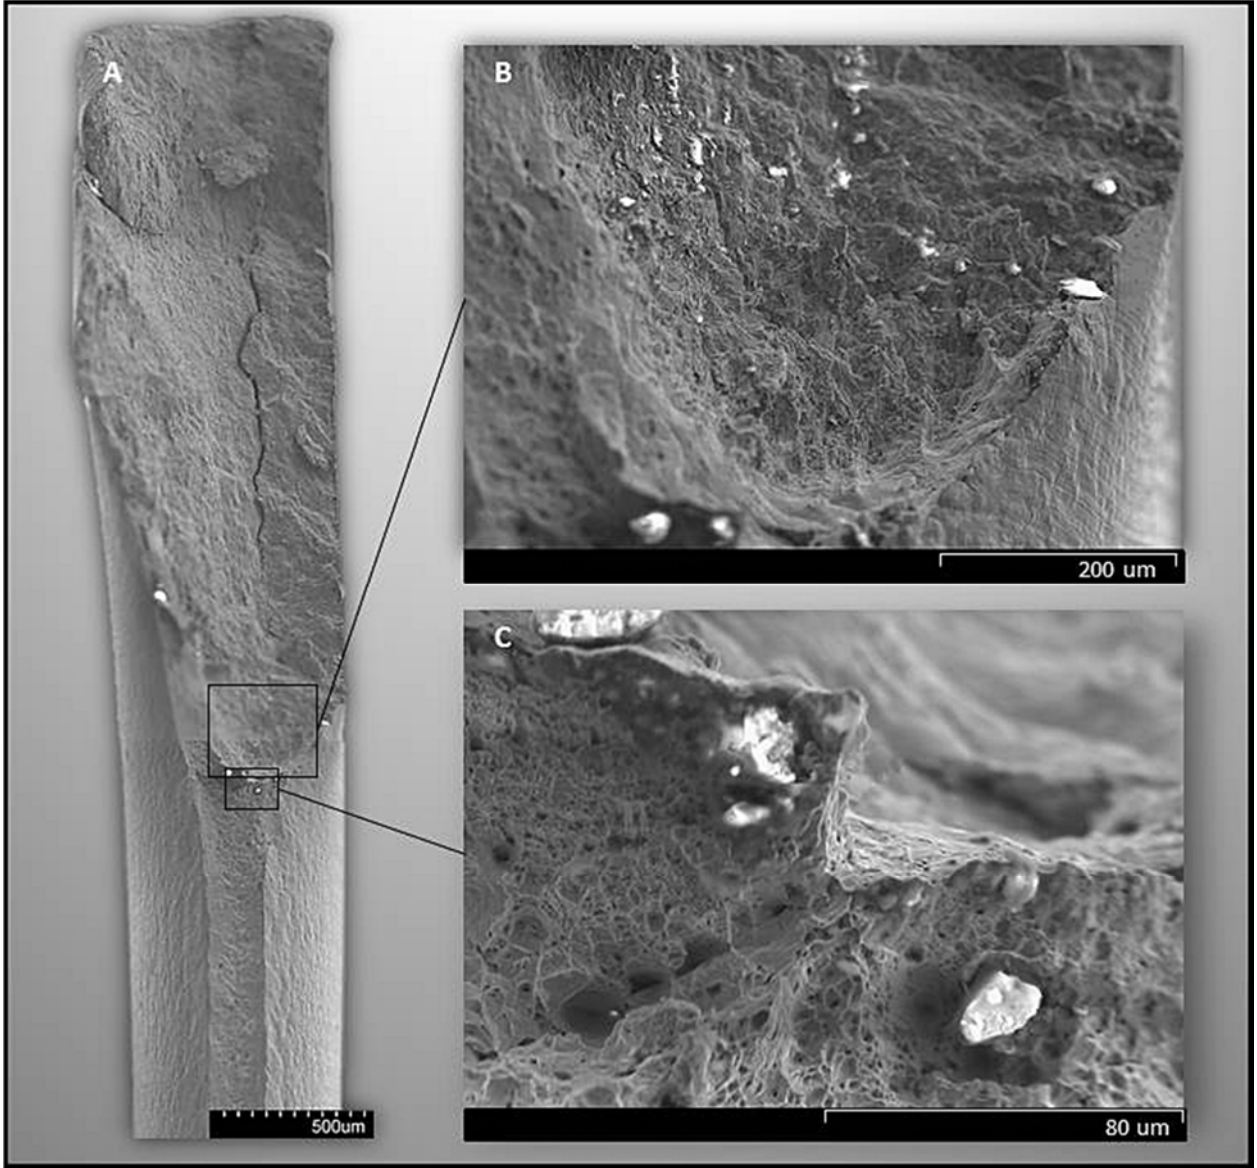
Figure 7. SEM images of the fracture surface following tensile testing to failure. The stress vs. strain data from this sample (which failed prematurely) can be seen in Figure 6. The sample fracture surface (A) showed two distinct regions of fracture behavior; brittle with no evidence of plastic deformation (top of A and B) and ductile with significant necking (bottom of A and C).

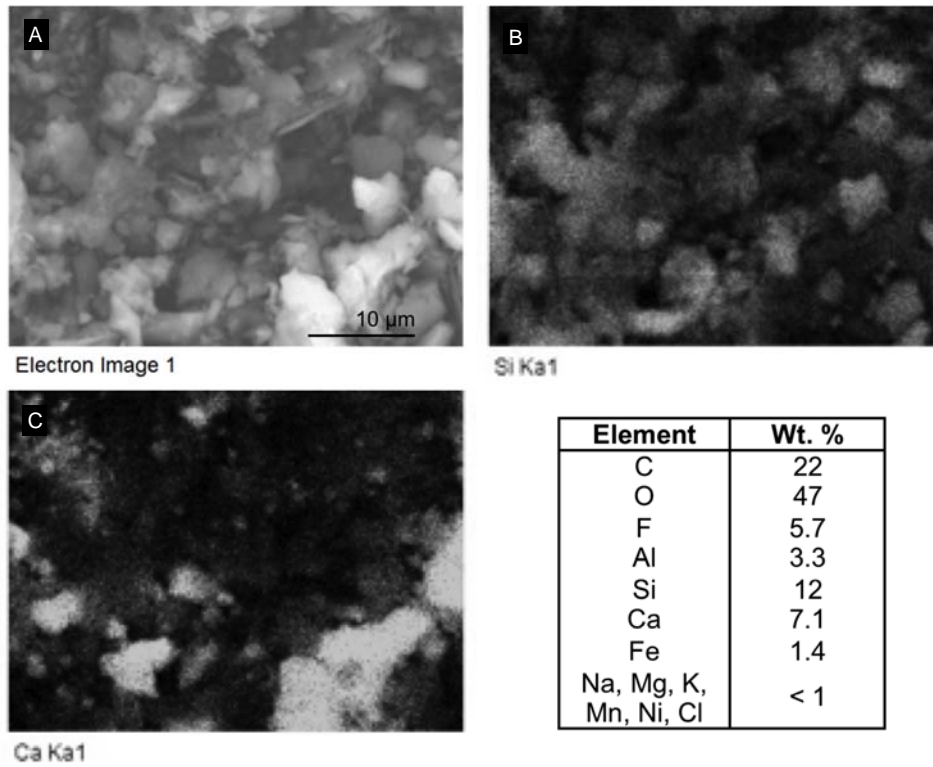
SEM/EDS and XRD was performed on the flaky white deposits found on the external surface of the clamp near crack sites for compositional and phase identification analysis and to determine the source and effect on the material, if any. Deposits were scraped from the clamp surface and mounted on carbon tape for SEM characterization, shown in Figure 8. Aside from carbon and oxygen the deposits were mainly a mix of separate Si-rich and Ca-rich compounds (Figures

8B-C). Fluorine was also seen and typically appeared in the Ca-rich regions, as could be expected given the high affinity fluorine has to calcium. The relatively high fluorine abundance suggests that the water from which the deposits originated was the geothermal water, as it possessed a very high fluorine content (Table 1) compared to tap or rain water. In addition to EDS, XRD was also conducted on the deposits. Powder scraped from the clamp was ground with an agate mortar and pestle then mixed with acetone to properly fill and level the sample holder prior scanning. A Rigaku Miniflex 600 benchtop XRD was used and the diffraction pattern was collected using Cu-K α radiation ($\lambda = 0.1541$ nm) produced at 40 kV and 15 mA in Bragg-Brentano geometry and a 1-dimensional D/teX detector at 3 °/min. The most prominent phases identified included; quartz (sand), calcium carbonate, albite, and calcium fluoride (Figure 9).

Figure 8. SEM and EDS results from deposits found on the surface near to the crack site. A is the secondary electron SEM image of deposits scraped from the crack area and mounted on carbon tape. The EDS maps show spatial composition of the two most abundant elements, Si (B) and Ca (C), apart from carbon and oxygen. Overall EDS data acquired from A are included in the bottom right.

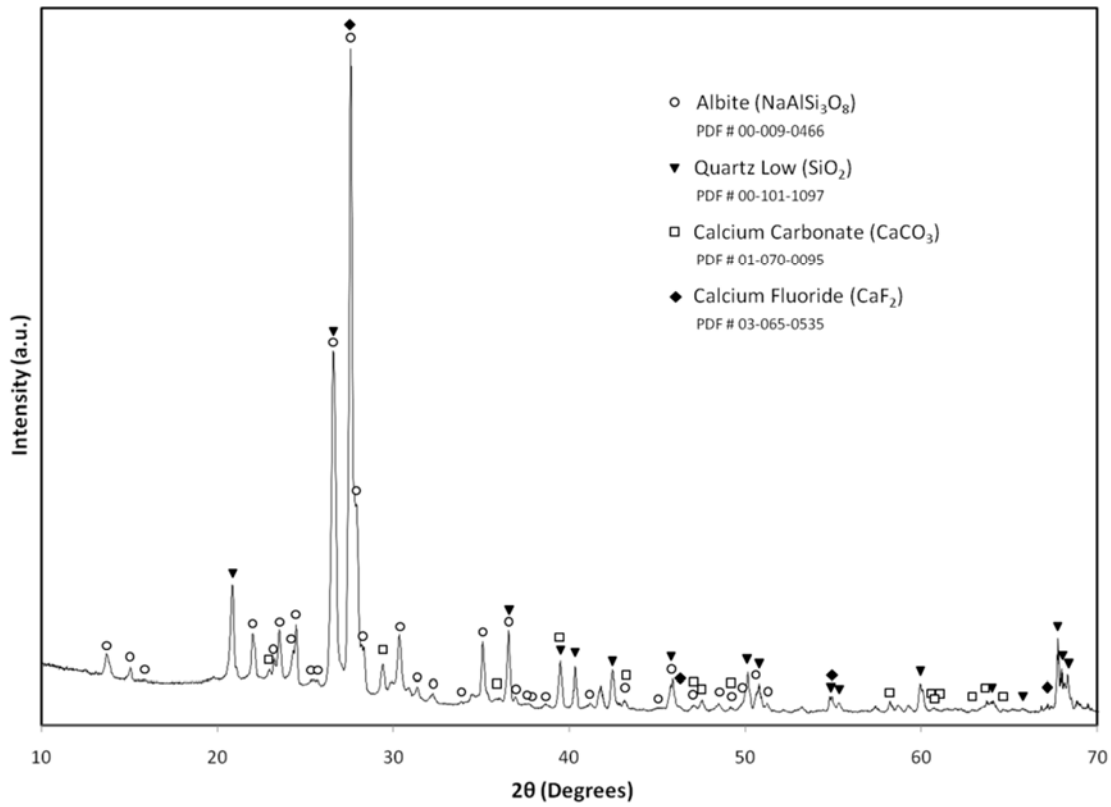
EDS and supporting XRD data indicated that the deposits were likely a mix of backfill sand incorporated into mineral precipitates (Figures 8-9) during intermittent wetting from leaked geothermal water. Moreover, reduction of dissolved oxygen at cathodic sites will produce a slightly alkaline local surface chemistry that would also promote precipitation of mineral compounds, and would also explain why the deposits were typically found near crack sites. Such mineral deposits and adhered sand particles may also have provided an occluded region where conditions to support localized corrosion could preferentially develop, and subsequently act as crack initiation sites. Also, no evidence was seen of microbiological activity, such as black tubercules or extracellular matrix material [11] and the low SO $_4$ content of the geothermal water is unlikely to support significant populations of sulfate reducing bacteria (Table 1). Hence, it is unlikely any degradation or SCC initiation sites were directly microbiological in origin.

Figure 9. X-ray powder diffraction pattern of deposits collected from the external surface of the stainless steel pipe clamp (also characterized with SEM/EDS in Figure 8). The compounds were identified according to the PDF listed in the legend from the International Center for Diffraction Data (ICDD) database.
