INVESTIGATING THE CAUSES OF A LANDSLIDE IN TERRA NATIVA  
SUBDIVISION AND DESIGNING SLOPE STABILIZATION USING RECYCLED  
PLASTIC PINS

submitted in partial fulfillment  
of the requirements for the degree of  
Master of Science in Civil Engineering  
Boise State University

August 2023

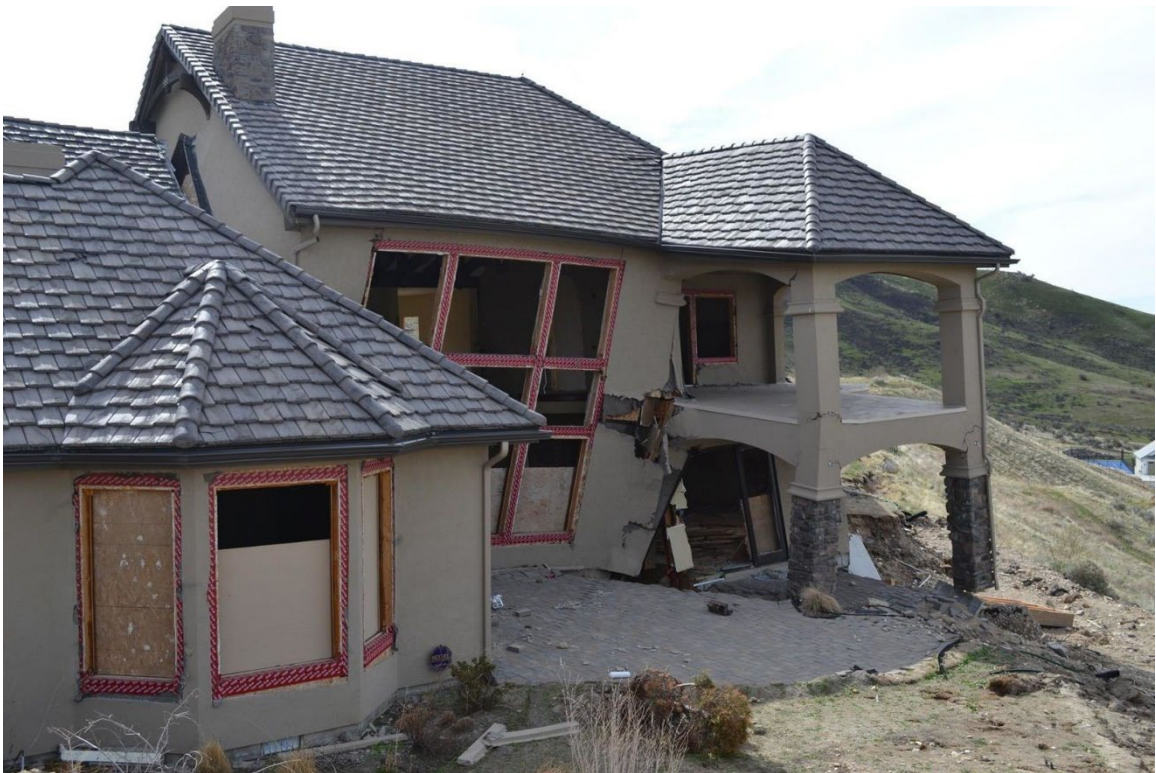
In early 2016, five homes along Alto Via Court in the Terra Nativa Subdivision of Boise, Idaho began to move. The damage continued to worsen over the following months. By the beginning of May, Alto Via Court had been closed to the public (Shelton, 2016). By September, the damage was described as looking “like an earthquake” (McFarland, 2016). Homes fell apart, pavement cracked, and sidewalks buckled, as shown in Picture 1 (Idaho News, 2017).

**Picture 1. Damage at Alto Via Court**

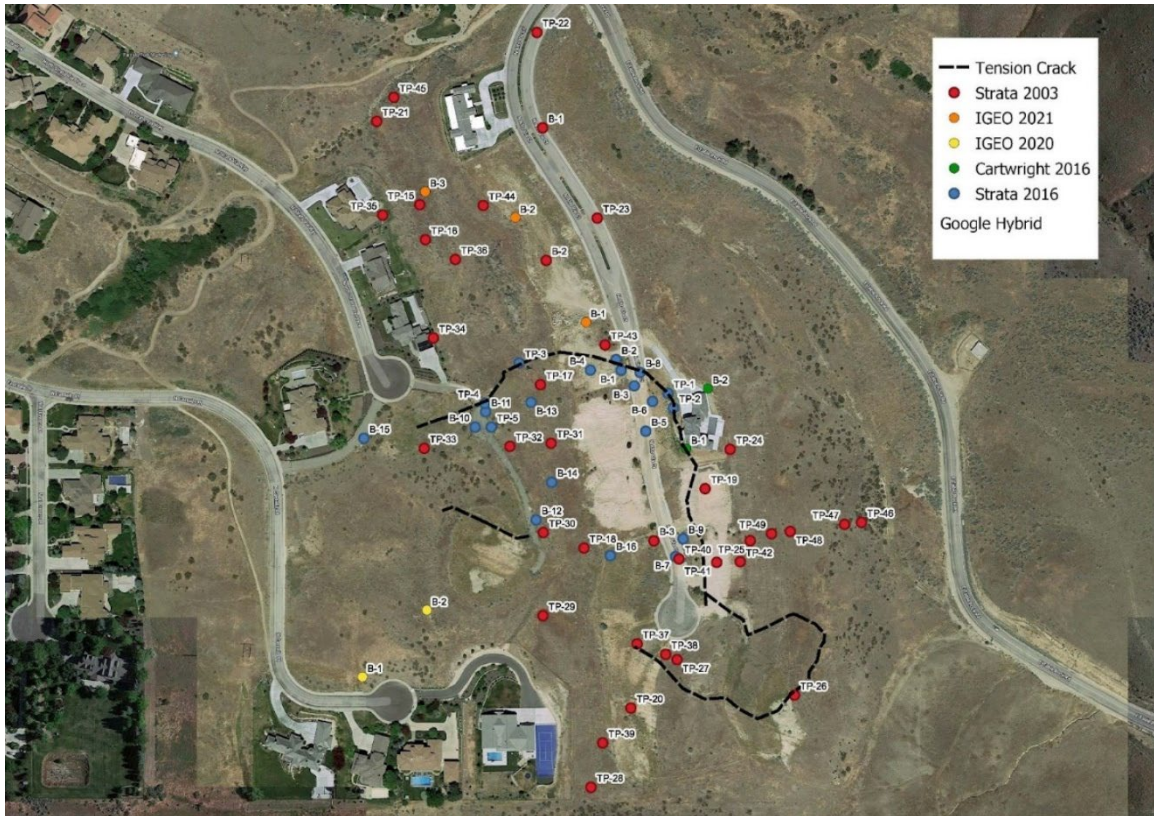
Picture 3 shows what is known about the extent of the failure at the site with the black dotted line denoting the approximate location of the tension crack. The picture also shows the locations of the explorations performed from 2003 through 2021. Many of these were performed by Strata with additional field investigations by Cartwright Engineers and Innovate Geotechnical (IGEO).

**Picture 3. Extent of Failure and Exploration Locations (Courtesy QGIS)**

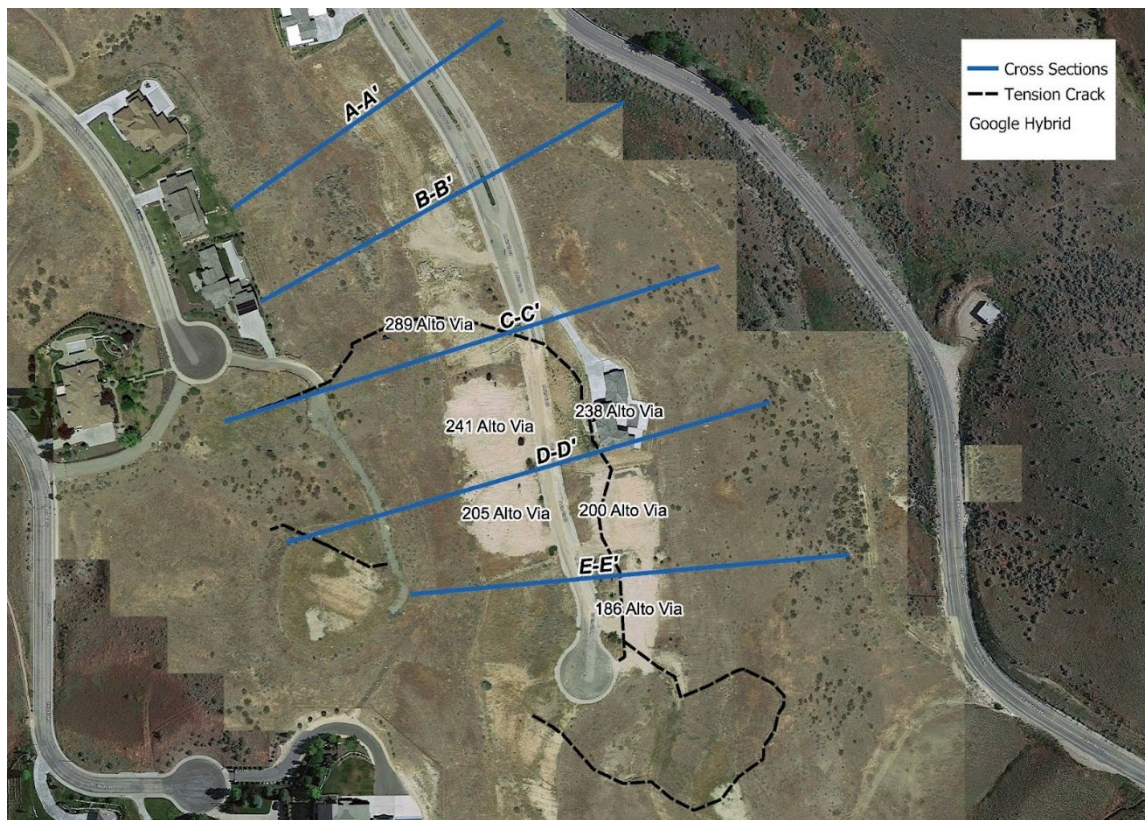
Five cross sections of the site at Alto Via Court were selected for analysis, as shown in Picture 6. The tension crack denoting the approximate extent of movement is also shown in the picture as the black dotted line.

**Picture 6. Cross Sections and Failure Area (Courtesy QGIS)**

Failure began first at 289 Alto Via, or cross section C-C', before continuing south to cross sections D-D' and E-E'. For this reason, cross section C-C' was first focused on,

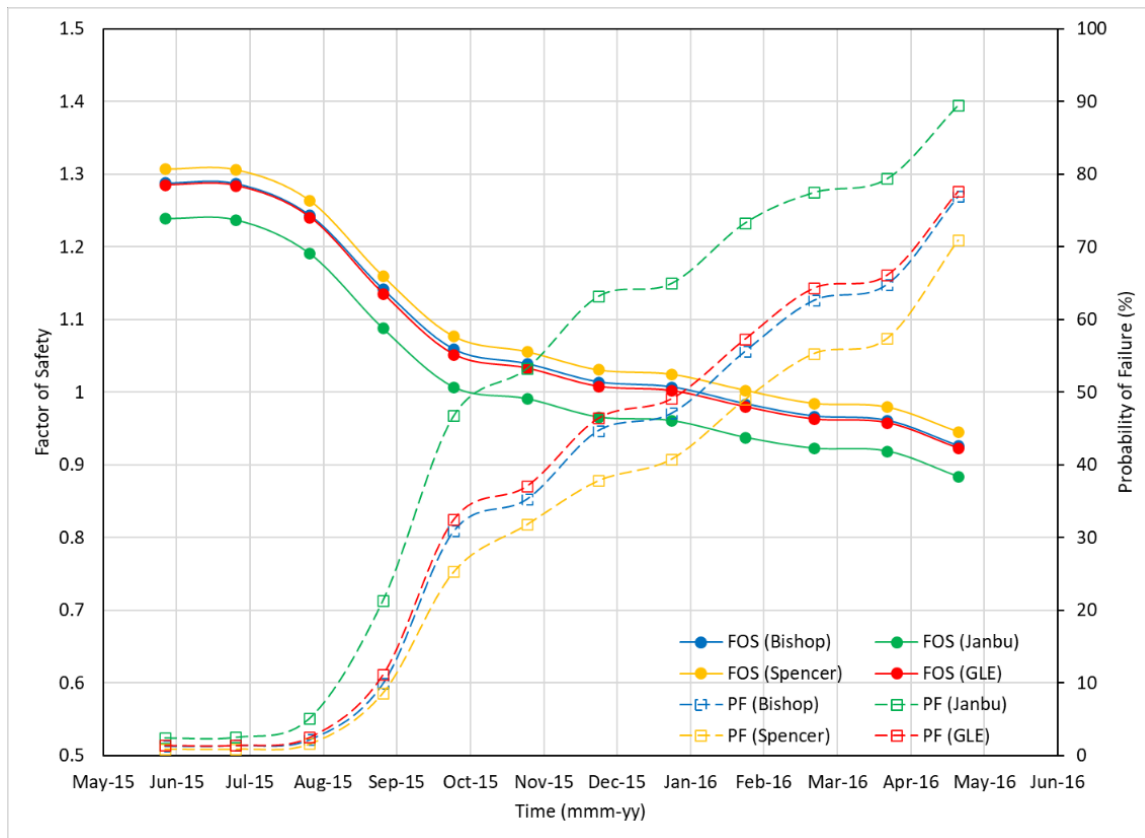
As discussed in Chapter 3, the FOS was found using four methods: Bishop simplified, GLE/Morgenstern-Price, Janbu simplified, and Spencer. Figure 4.1 reports the values for each of these methods as they change over the course of the year from May 2015 through April 2016. The figure also presents the accompanying PF, which has an inverse relationship to the FOS.

**Figure 4.1 Change in Factor of Safety and Probability of Failure with Time**

As can be seen from the figure, there is a reasonably close agreement between all four methods. Bishop and GLE/Morgenstern-Price have a very close agreement, while Spencer is slightly higher and Janbu is slightly lower. The level of agreement between the methods suggests a lack of modeling issues or problems resulting in erroneous data. In general, FOS and PF values reported in the graphs and tables of this document are for the Bishop simplified method.

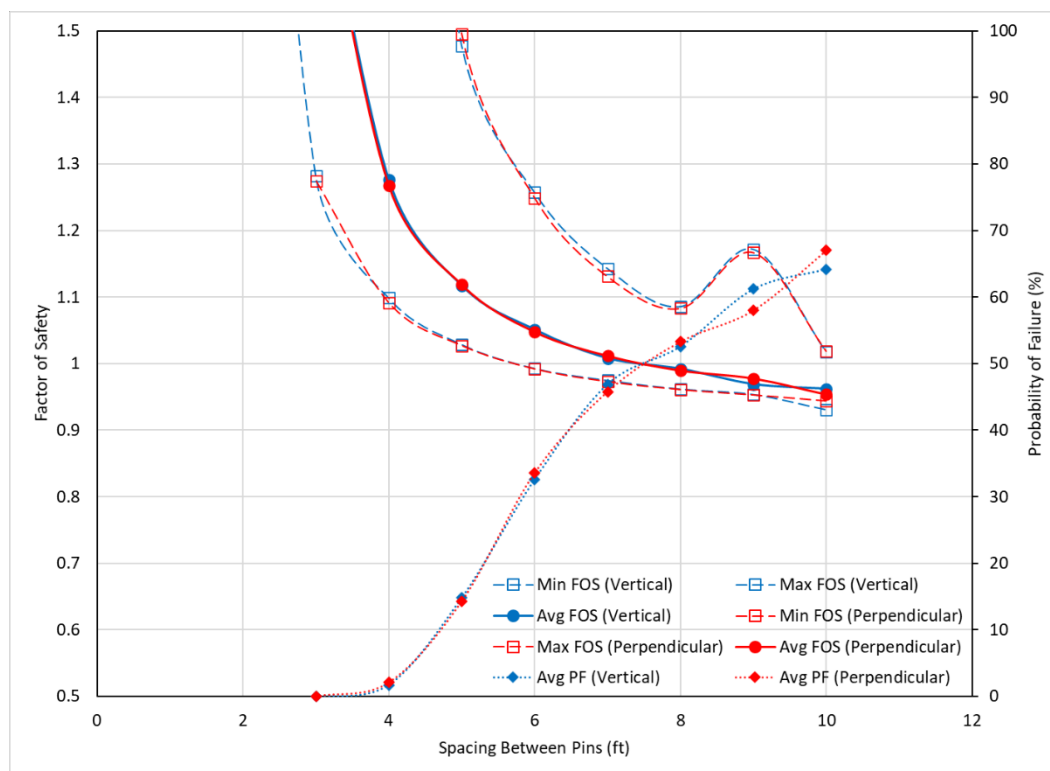
As has been mentioned and can be seen from Table 4.3, all spacing patterns were analyzed for RPPs installed both vertically and perpendicular to the slope face. Figure 4.2 gives the change in FOS and PF for different continuous reinforcement spacing distances. The graph reports the FOS for average, minimum, and maximum RPP strengths, as well as the PF for the average RPP strength. In particular, however, the graph shows these values for RPPs installed both vertically and perpendicular to the slope face, with vertical reported in blue and perpendicular reported in red. There is extremely close agreement between the two angles of placement. Essentially, it makes no significant difference in the final stability whether RPPs are installed vertically or perpendicular to the slope face.

**Figure 4.2 Change in Factor of Safety and Probability of Failure with Pin Spacing**

Note that there is an increase in the FOS at the 9-foot pin spacing, resulting in a bump in the graph. It is unclear why this would be the case, as the increased FOS occurred only for the maximum strength RPPs. Most likely this is an anomaly in the computer program's calculations. As has been discussed, an anomaly was also observed with the FOS of the combined groundwater scenarios versus the FOS for surface runoff and irrigation only. Overall, the computer program was found to provide reliable, accurate data that fall within expectations; these slight anomalies are not considered to be a detriment to the research or an invalidation of the results.

spacing and the 2-foot spacing at the crest and toe with no center reinforcement. 2-foot spacing at the crest and toe with no center reinforcement is recommended due to having the smallest area that requires reinforcement.

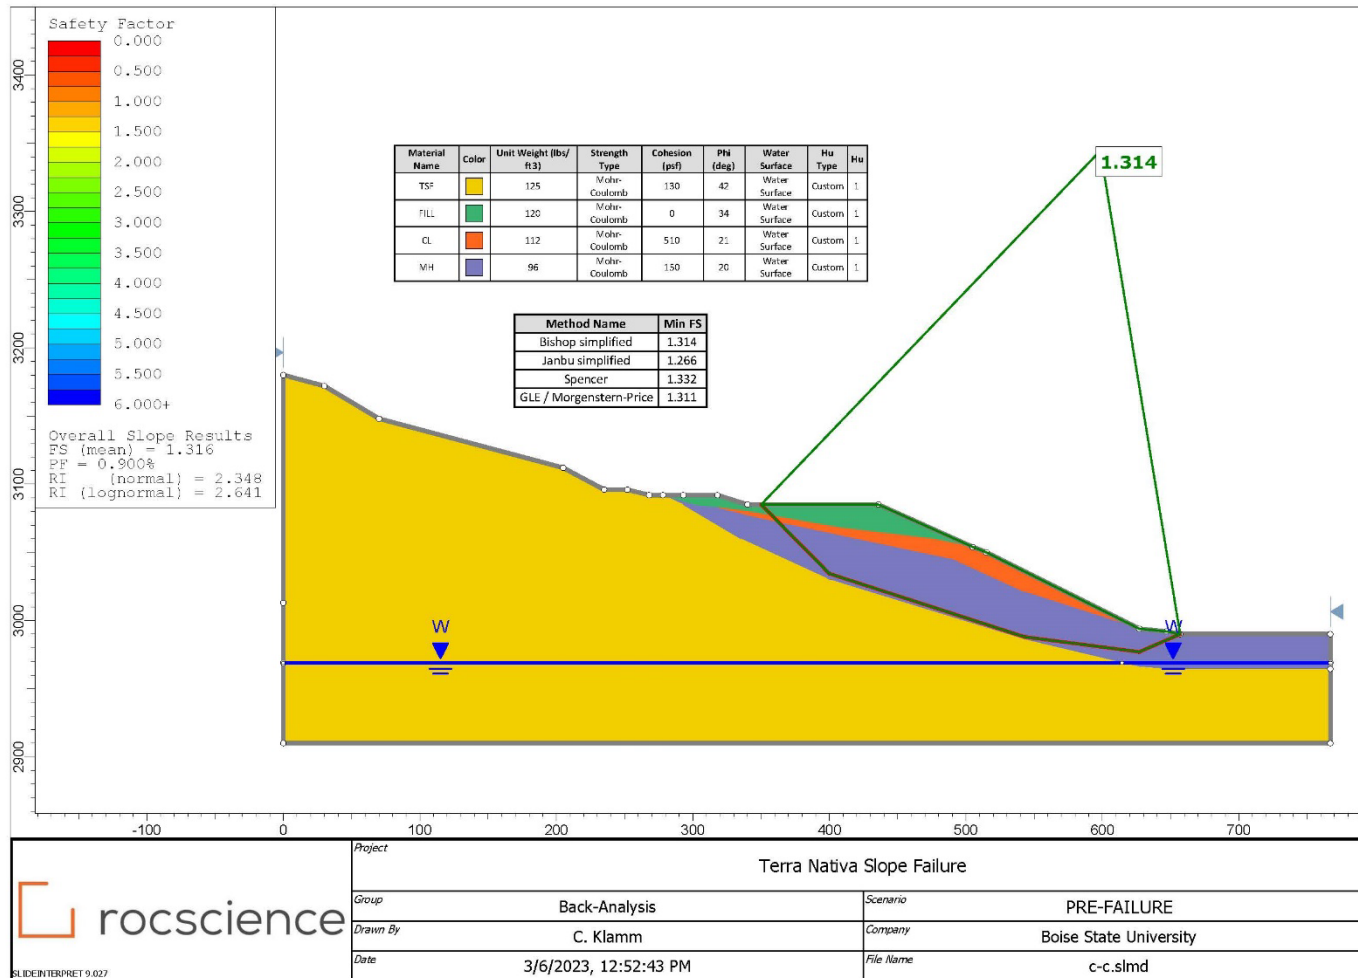
Figure A.3 Cross Section C-C' Before Failure

When the pre-failure analyses were performed for each cross section, it was found that cross section C-C' had the lowest starting FOS. This is consistent with what was seen at the site; movement occurred first at cross section C-C', before moving south to D-D' and E-E' (Eberhart, 2016; Woodworth et al., 2016). Hence, the back-analysis was performed for cross section C-C' and results were applied to the remaining cross sections afterwards.

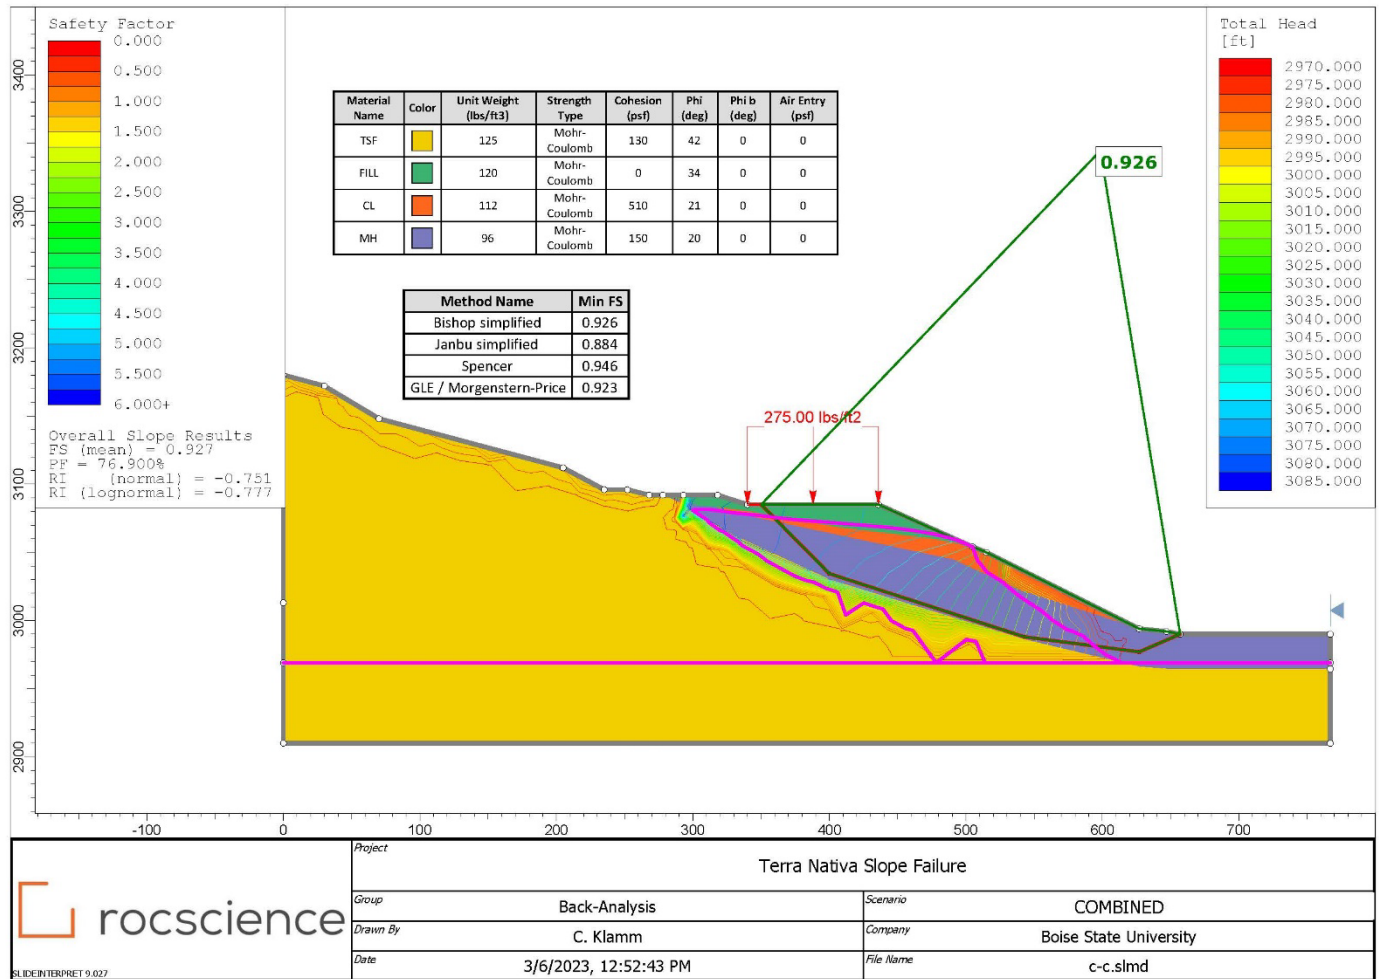
Figure B.3 Cross Section C-C' After Failure

When loading from the homes was applied, it did not result in a FOS below 1, indicating that loading from the homes alone did not cause failure. Similarly, failure due to a leaking utility or stormwater infiltration from Table Rock Rd did not cause a decrease in the FOS. However, surface runoff from roofs and lawn irrigation did cause a significant decrease in the FOS, indicating that, according to this research, it had the greatest contribution towards failure of the slope. These numbers are reported for cross section C-C' in Table 4.1 below.

An analysis of four modes of failure including loading from homes and three groundwater scenarios—surface runoff and irrigation, leaking utility, and stormwater infiltration—revealed that, according to this research, surface runoff and irrigation played the largest part in leading to failure. Table 5.1 presents the FOS for each of these potential modes of failure and the percent decrease in FOS from the original pre-failure value. As can be seen, leaking utility and stormwater infiltration did not affect the FOS, loading from homes resulted in an approximately 2 percent decrease in FOS, and surface runoff and irrigation contributed by far the largest decrease in FOS at approximately 31 percent.

For the remaining cross sections—C-C', D-D', and E-E'—reinforcement with RPPs is recommended, using 2-foot spacing at the crest and toe that extends 1 foot into the dense TSF layer. Cross sections D-D' and E-E' were analyzed for this reinforcement
