Northeast Florida: A New Hotspot for Hurricane Damage?

Northeast Florida – A New Hotspot for Hurricane Damage?

Until recent Hurricanes Matthew and Irma struck northeast Florida, Hurricane Dora had been the first and only hurricane-strength storm in recorded history to strike the region. The area had gradually become regarded as a safe spot as storms at that latitude generally curved away from Jacksonville and northeast Florida and turned north to make landfall in the Carolinas. Unknown to most, Vilano Beach had been experiencing steady yet chronic beach erosion and was already in a highly vulnerable state in many places when the recent storms struck. The cause of the ongoing background erosion continues to be a source of contention among residents and some experts. This paper presents pre-storm historic beach conditions, the potential causes and progression of erosional events surrounding Hurricanes Matthew and Irma at three locations in northeast Florida, and an assessment of protection measures implemented by homeowners. Observations made during field investigations show that bulkheads constructed to protect single or multiple houses exacerbate erosion at the ends of the bulkhe

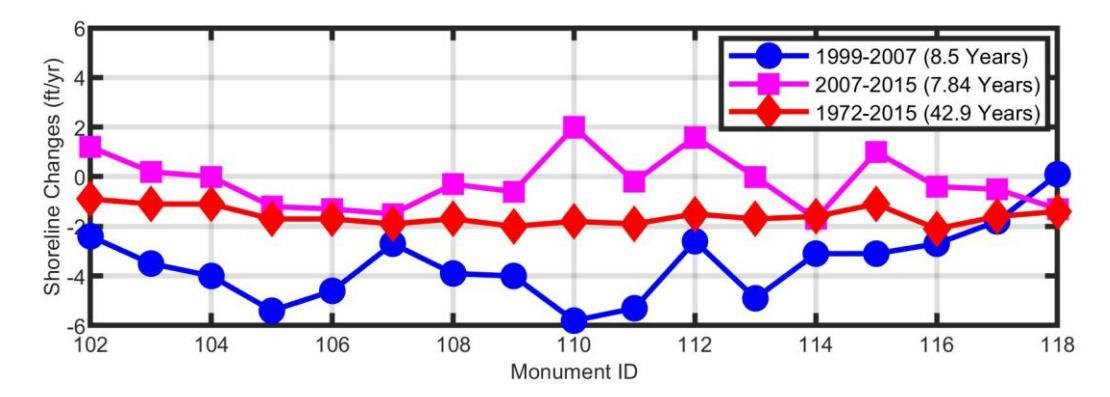
As noted, prior to Matthew and Irma, Vilano Beach had been chronically eroding along much of its shoreline. As shown in Fig. 3, the historic shoreline changes from R-102 to R-118 can be subdivided into three time-series: 1) the long-term average from 1972 through 2015 (red), 2) just before, during, and after dredging of the ebb shoal at St. Augustine Inlet between 1999-2007 (blue), and 3) after dredging but before Matthew and Irma struck from 2007-2015 (purple). Mean erosion rates for this stretch of shoreline were -1.58 ft/yr, -3.51 ft/yr, and -0.18 ft/yr for the 1972-

2015, 1999-2007, and 2007-2015 time periods respectively. However, between 1972 and 1999 (not shown) the mean erosion rate was -0.89 ft/yr. The notably higher erosion rate between 1999 and 2007 does coincide with dredging of the inlet shoal, which could possibly have exacerbated the already chronic erosion problem. However, it also coincides with the 2004 hurricane season in which Frances and then Jeanne inflicted severe erosion along much of Florida's east coast. However, since 2007 the erosion rate had abated to less than historic levels before the Matthew and Irma hurricane events.

Figure 3. Mean erosion rates (ft/yr) in southern Vilano beach during most erosive period from 1999-2007 (blue), most accretive/stable period from 2007-2015 (purple), and long-term average from 1972-2015 (adapted from USACE, 2017).

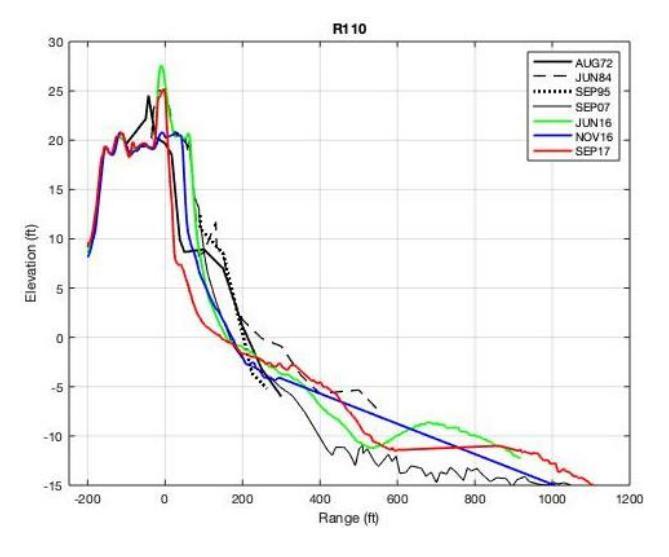
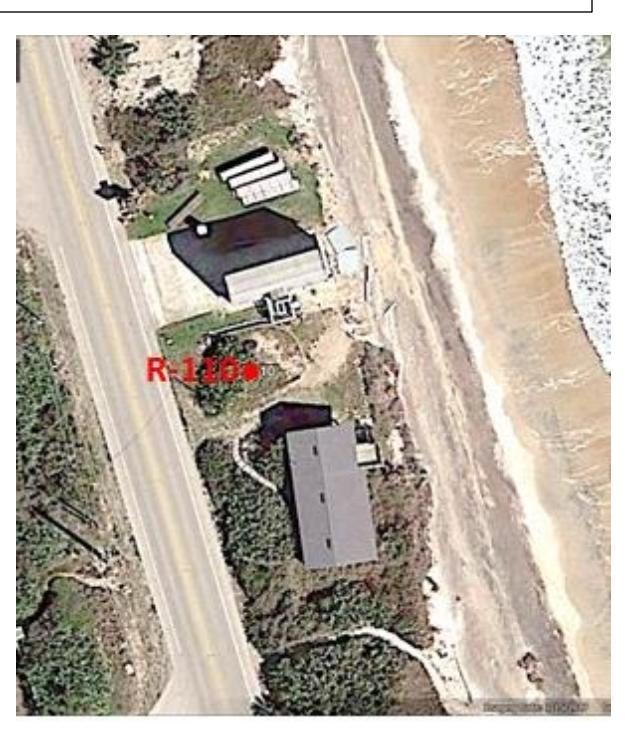
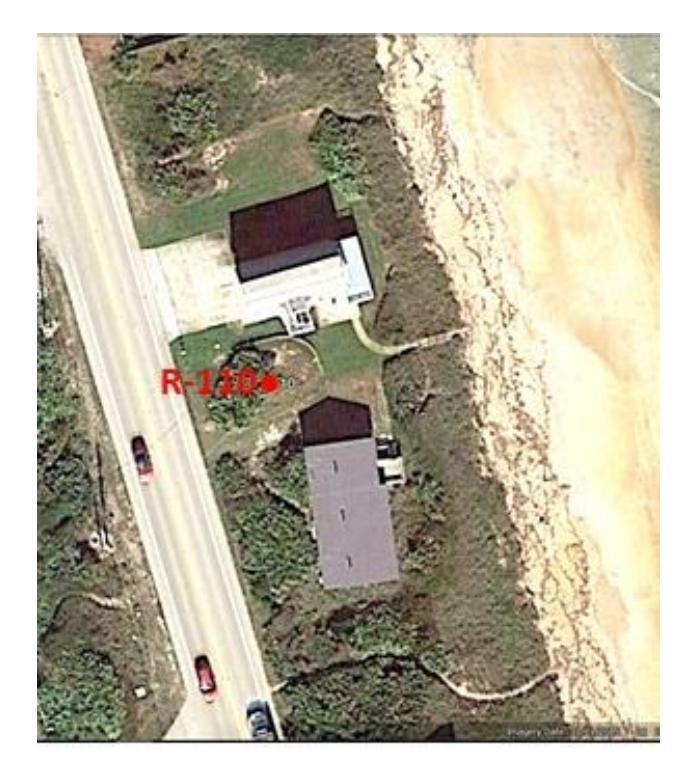
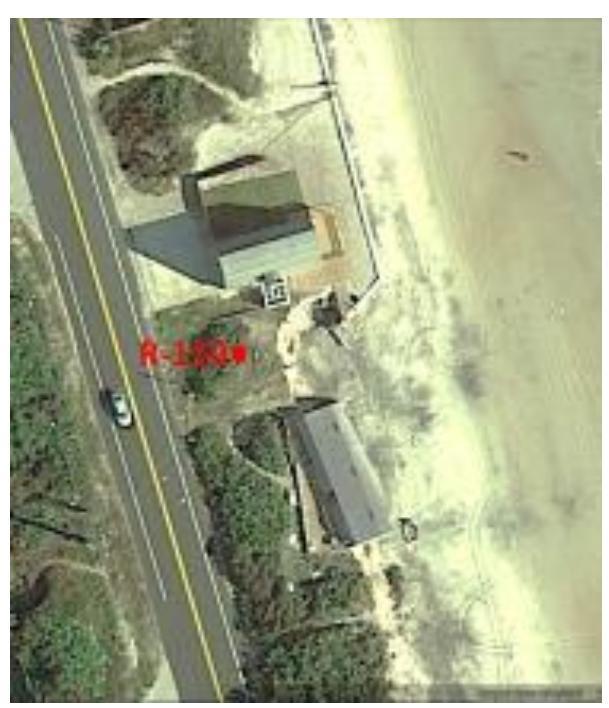
Three distinctive sites have been selected to further illustrate the pre-storm historic beach conditions, and progression of events surrounding Matthew and Irma. The site at R-110 (Fig. 4) was first selected due to its close proximity to the now well-known, slab-on-grade house that actually fell off the bluff during Irma and, as indicated in Fig. 3, is where one of the highest pre-storm erosion rates was observed. The other two sites at R-105 (Fig. 5) and R-113 (Fig. 6) were selected because they too had been experiencing some of the highest pre-storm erosion rates. For each of the three sites, both selected historic and pre-and-post-storm beach profiles are presented, as well as aerial photographs that bracketed the two storm events.

a) Historic (black) and pre-and-post hurricane profiles (color).

c) Post Hurricane Matthew (March 2017).

b) Aerial photo of houses adjacent to R-110 pre hurricanes (November 2015).

d) Post Hurricane Irma (September 2017).

Figure 4. Historic and pre-and-post-storm beach profiles at R-110, and pre-storm, post-Matthew, and post-Irma aerial photographs (photos adapted from Google Earth, 2020; profile data adapted from USACE, 2017).

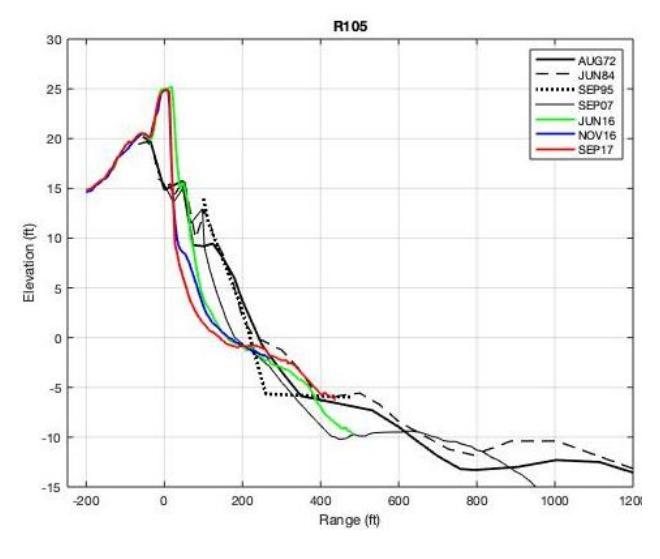
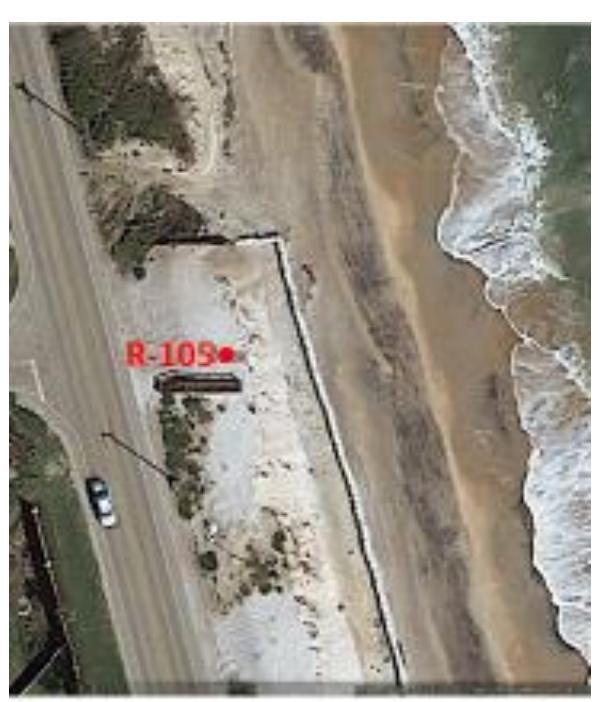
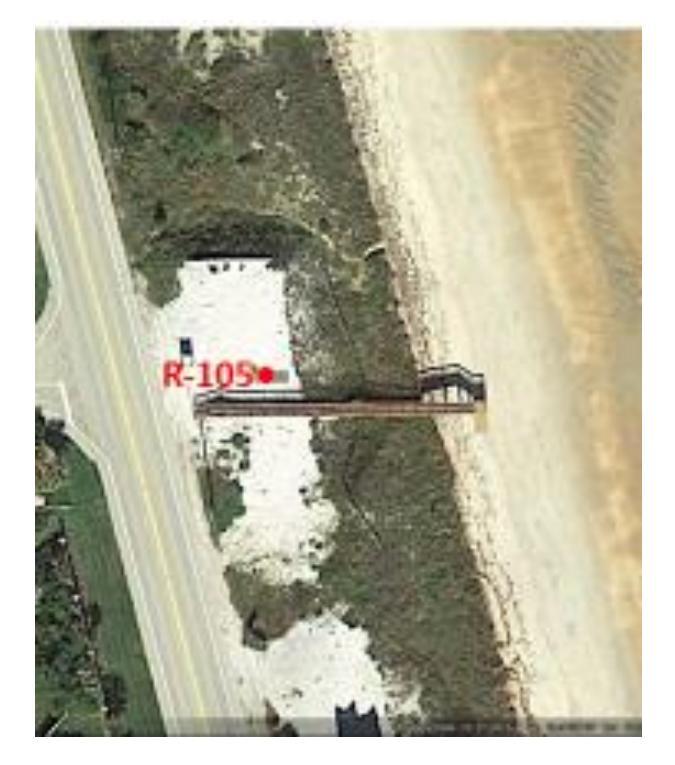
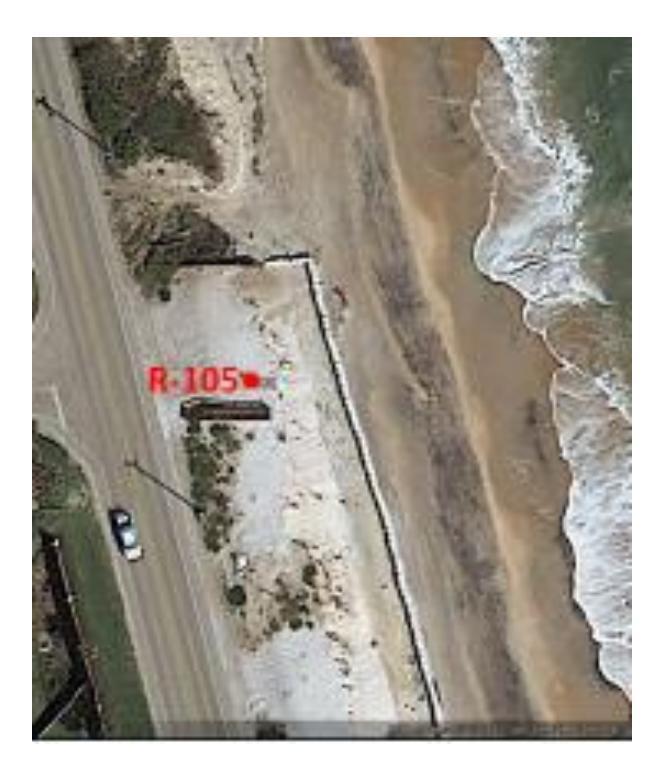
a) Historic (black) and pre-and-post hurricane profiles (color).

c) Post Hurricane Matthew (March 2017).

b) Aerial photo of dune cross-over adjacent to R-105 pre hurricanes (November 2015).

d) Post Hurricane Irma (September 2017).

Figure 5. Historic and pre-and-post-storm beach profiles at R-105, and pre-storm, post-Matthew, and post-Irma aerial photographs (photos adapted from Google Earth, 2020; profile data adapted from USACE, 2017).

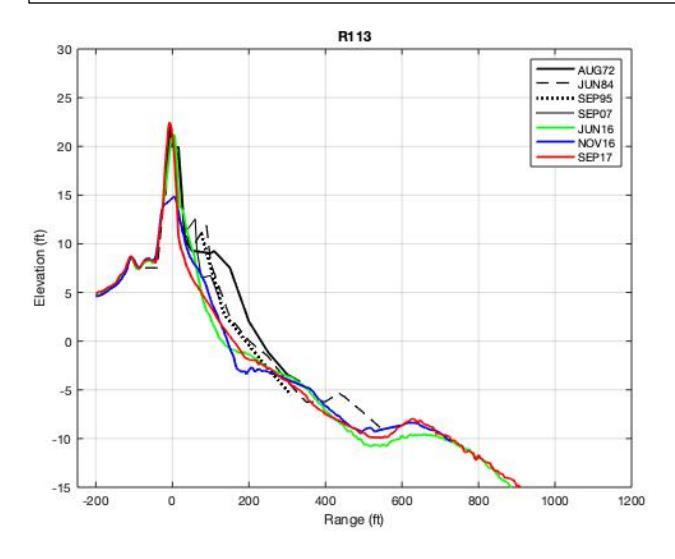
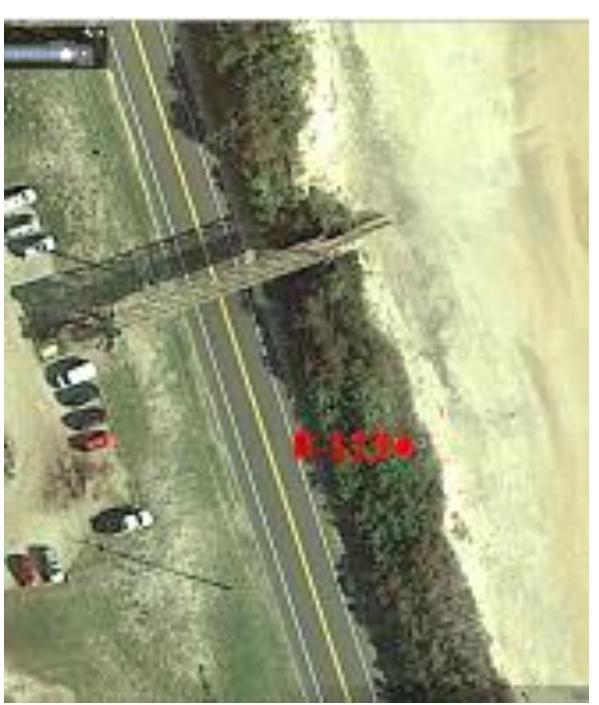
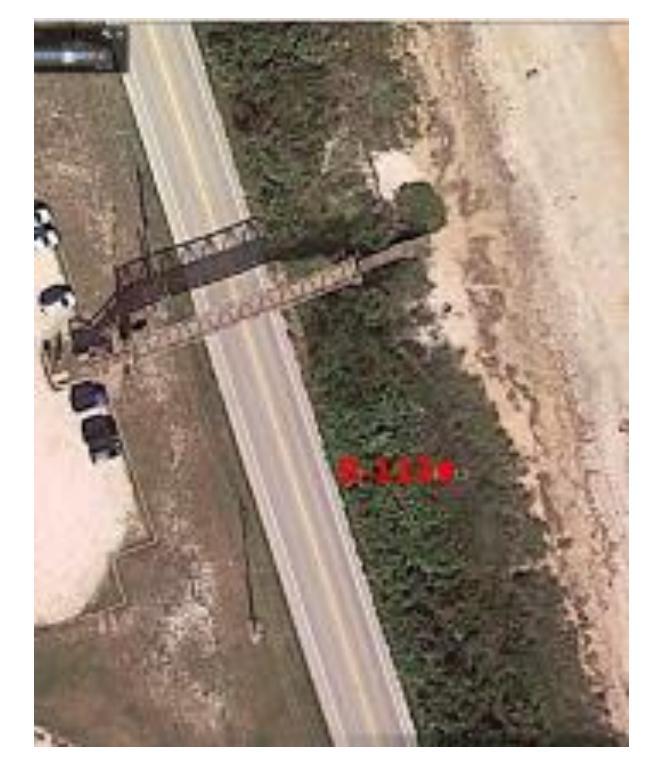
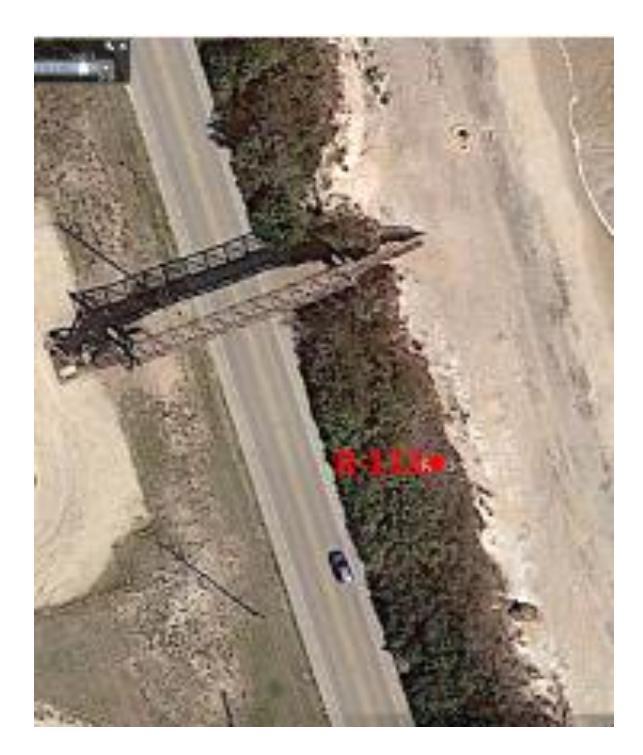
a) Historic (black) and pre-and-post hurricane profiles (color).

c) Post Hurricane Matthew (March 2017).

b) Aerial photo of pedestrian bridge adjacent to R-113 pre hurricanes (November 2015).

d) Post Hurricane Irma (September 2017).

Figure 6. Historic and pre-and-post-storm beach profiles at R-113, and pre-storm, post-Matthew, and post-Irma aerial photographs (photos adapted from Google Earth, 2020; profile data adapted from USACE, 2017).

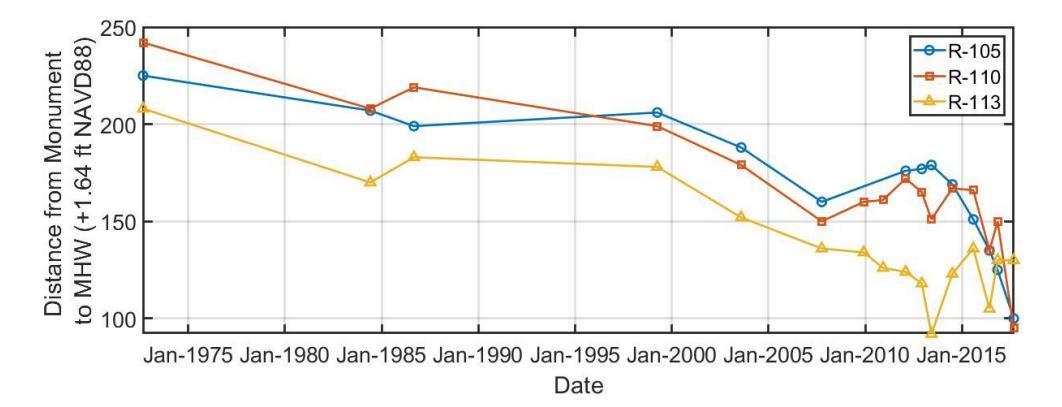
As shown in the beach profile data (Figs. 5a, 6a, and 7a) and based upon all available surveys at each of the three sites, Fig. 7 presents time histories of the distance from each R-monument to the location of MHW (nominally +0.71 m NAVD88). The selected sites were experiencing chronic erosion from 1972 until just prior to Hurricanes Matthew and Irma, with Matthew and Irma then greatly compounding the problem. Aerial data support this conclusion in the sense that the beach width appeared to shrink after each storm.

Figure 7. Time histories of the distance from selected R-monuments to mean high water (adapted from USACE, 2017).

Anecdotally, the first author of the paper interviewed a former owner of this residence and she remembers in the 1970s having to walk "a couple hundred feet" to get from the house to the beach. As shown in Fig. 7 the distance from the R-110 monument to the mean high-water mark steadily decreased over time at this location, with only slight variation before the hurricanes struck.

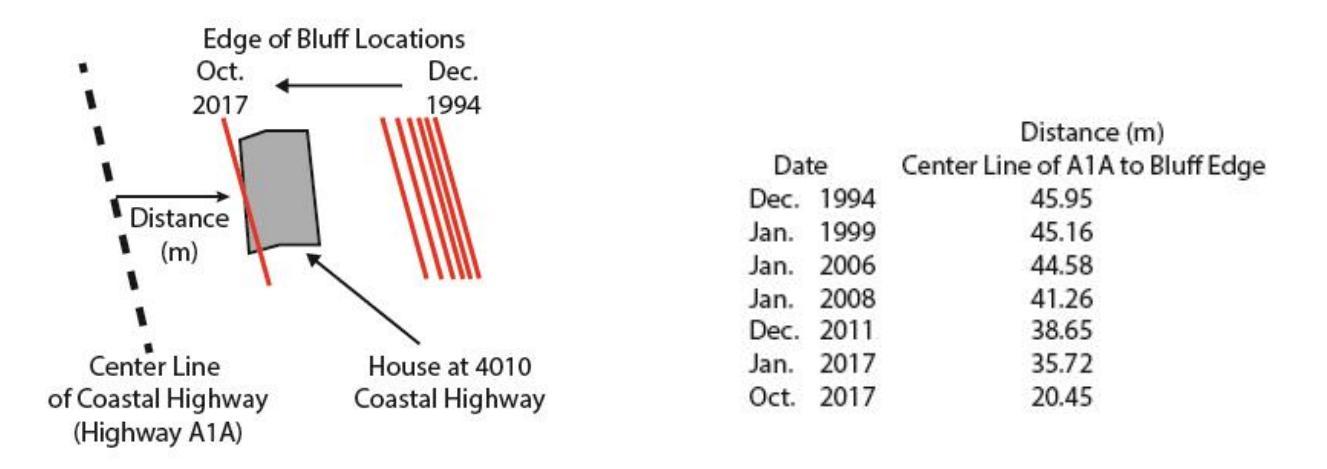
Bluff line regression provides further evidence to show that Hurricanes Matthew and Irma accelerated alreadyoccuring chronic erosion. Fig. 8 (below) shows the regression of the bluff line at 4010 Coastal Highway (approximately the location of R-110). Data were generated using Google Earth® historic images from December 1994 through October 2017 by measuring the distance from the centerline of Coastal Highway A1A to the approximate edge of the bluff. As seen in Fig. 8, there has been consistent regression of the edge of the bluff over time at this location, with the rate appearing to accelerate.

Figure 8. Edge-of-bluff locations for house in Fig. 4 taken from aerial photographs (Google Earth, 2020) from December 1994 through October 2017.

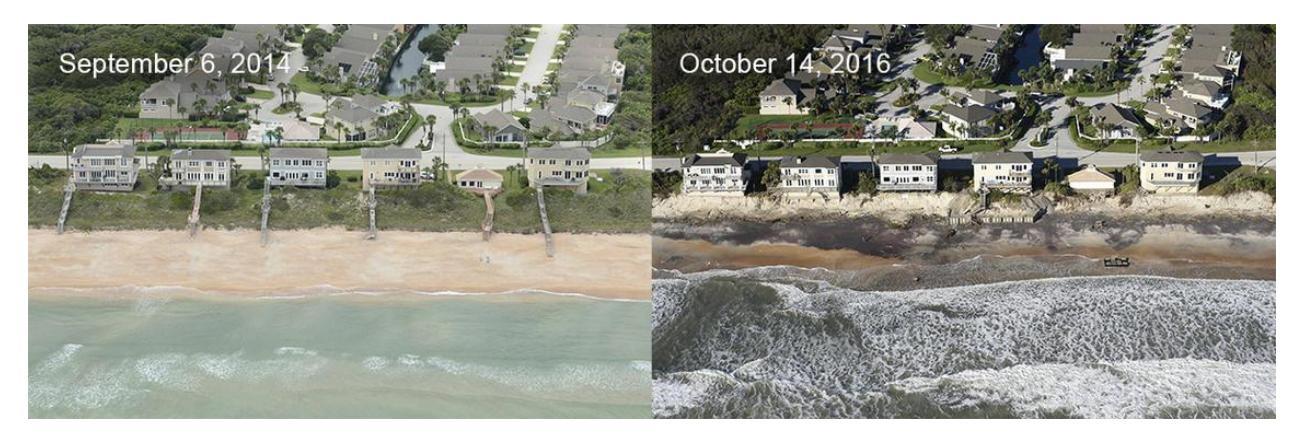
Prior to Hurricane Matthew, for an individual beachfront homeowner to obtain a permit from FDEP to construct a seawall, the structure firstly had to be within 20 ft of the existing bluff-line, and secondly it had to be demonstrated that it was threatened with undermining by the 1-in-5-year storm event. This usually required hiring of coastal consultants (to apply the use of numerical beach erosion models) and was an expensive and time-consuming process (Antigua, 2013, personal communication). However, with Matthew's severe impacts, FDEP could now issue an "emergency" permit for any house that was imminently threatened, as seen in Fig. 9.

Figure 9. Photographs of Vilano Beach both before (left) and after (right) Hurricane Matthew (USGS 2020a).

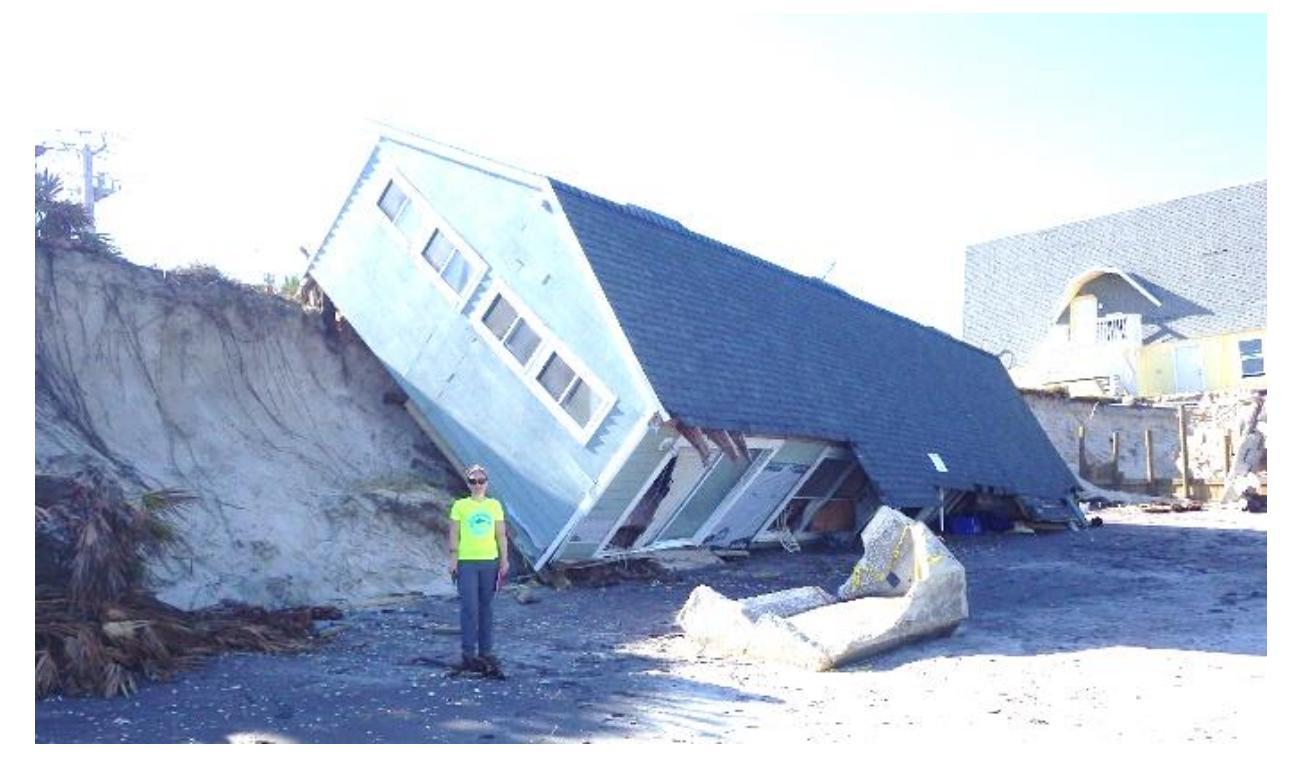
Figure 10. Ground-level photograph of slab-on-grade house at 4010 A1A (adjacent to R-110) destroyed by bluff erosion. However, as shown in Fig. 6d, failure was not due solely to cross-shore erosion processes, but due to downdrift impacts of neighbor's post-Matthew-constructed seawall.

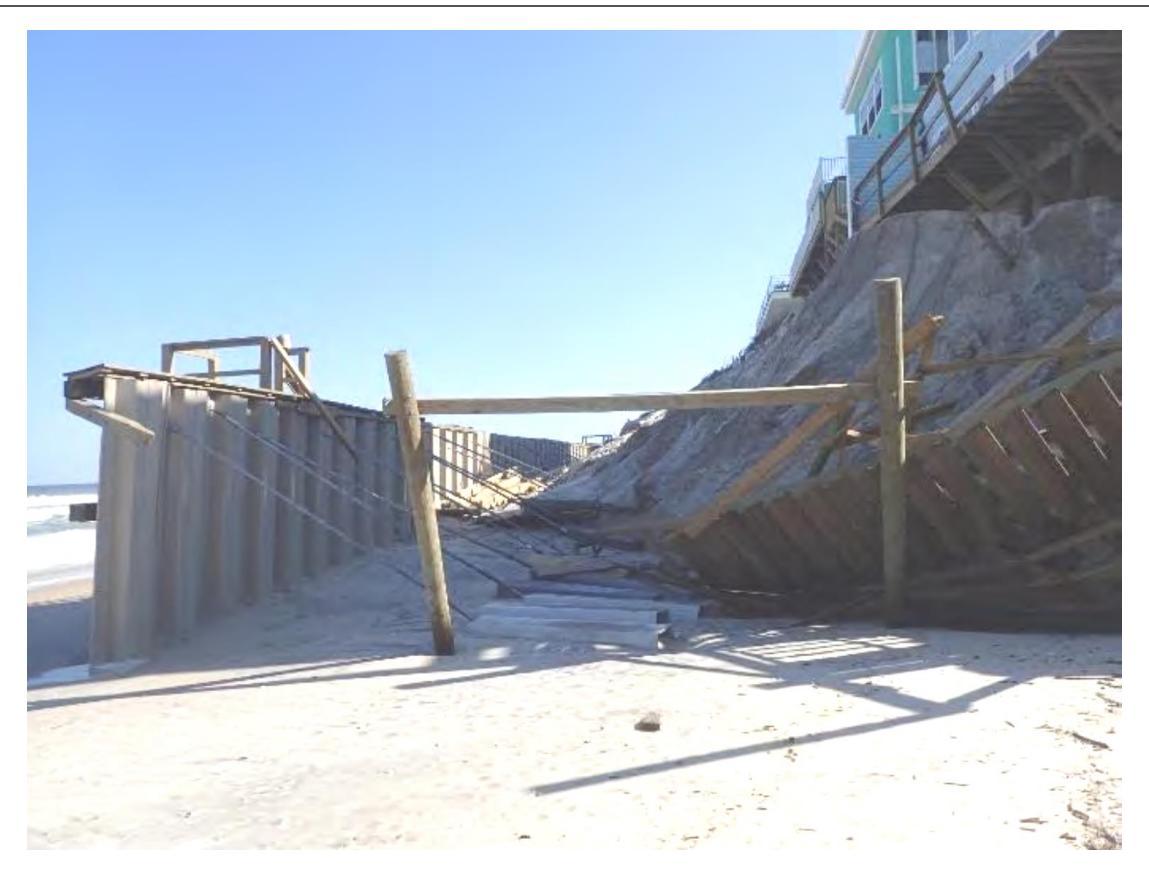
Fig. 11 shows seawall failure typical of many such new structures, and it is interesting that the anchored sheet piles exhibited minor distress at the face (parallel to the shoreline) but failure initiated at the wingwalls (perpendicular or sub-perpendicular to the shore line). The faces of

anchored sheet piles were noticeably bowed; below the anchor line the sheet piles bowed outward towards the ocean due to lowering of the dredge line (material being removed from the face of the sheet pile below the anchor line) which resulted in the sheet pile becoming bowed inward towards the dunes above the anchor line. Another important aspect to consider in the orientation of the anchors. Fig. 11 shows the inclined anchors still in place after the material behind the sheet pile wall was removed. Horizontal ties connected to deadman anchors failed because of the loss of supporting soil behind the sheet pile walls.

Figure 11. PVC anchored sheet pile failure due to Hurricane Irma.

Finally, sheet pile wall construction should be a community effort, not just a single homeowner endevor. A long sheet pile structure which protects a whole community minimizes the number of wingwalls which are successful to failure. Anchors should be inclined and anchorage provided below the dredgeline. Deadman anchors should not be used. The depth of sheet pile penetration, in terms of both vertical depth and extent into the dunes, must be based on the worst case scenario, which is the location of the dune and the beach elevation *after* the storm event.

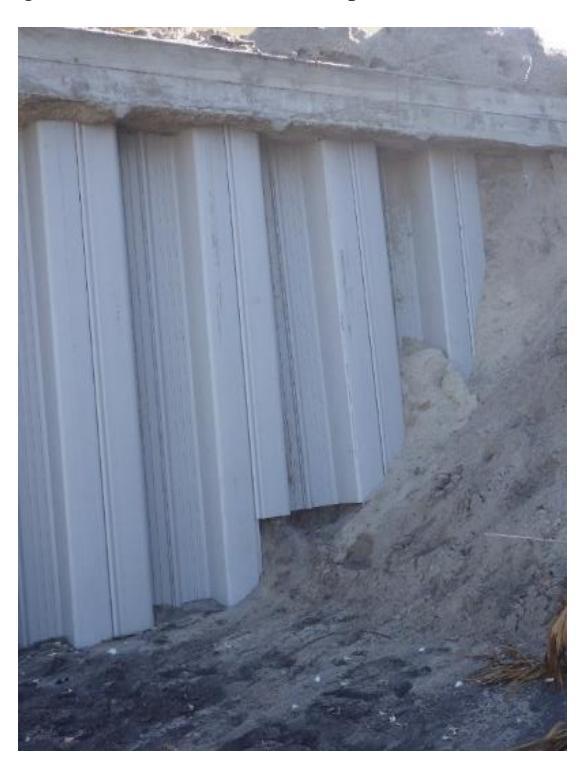
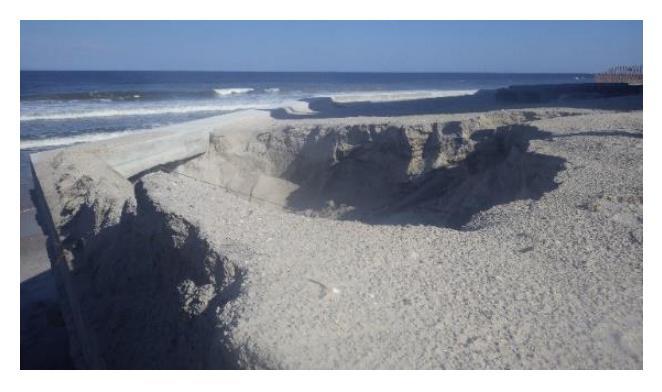
The initiation of sheet pile failure at the wing walls was due to improper embedment of the sheet piles into the dunes, both in terms of the depth of the sheet pile from the ground surface but also how far the sheet pile extended into the dune. Fig. 12 demonstrates the beginning of the failure of a sheet pile. In the left image in Fig. 12, removal of the dune material coupled with improper depth embedment allowed sand to be removed from behind the sheet pile wall. The removal of the sand from behind the wall resulted in a funnel shaped depression on the soil surface behind the face of the wall (right side image of Fig. 12). This is akin to sand flowing through an hourglass. If the storm had continued, this sheet pile structure would have failed. As noted, Fig. 6d shows the failure of a wingwall from an aerial view, whereas Fig. 11 shows the complete removal of the sheet pile wingwall.

Figure 12. Initiation of sheet pile failure. Improper depth embedment allowing soil to escape from behind the sheet pile wall (left). Resulting funnel shaped depression on the ground surface (right).

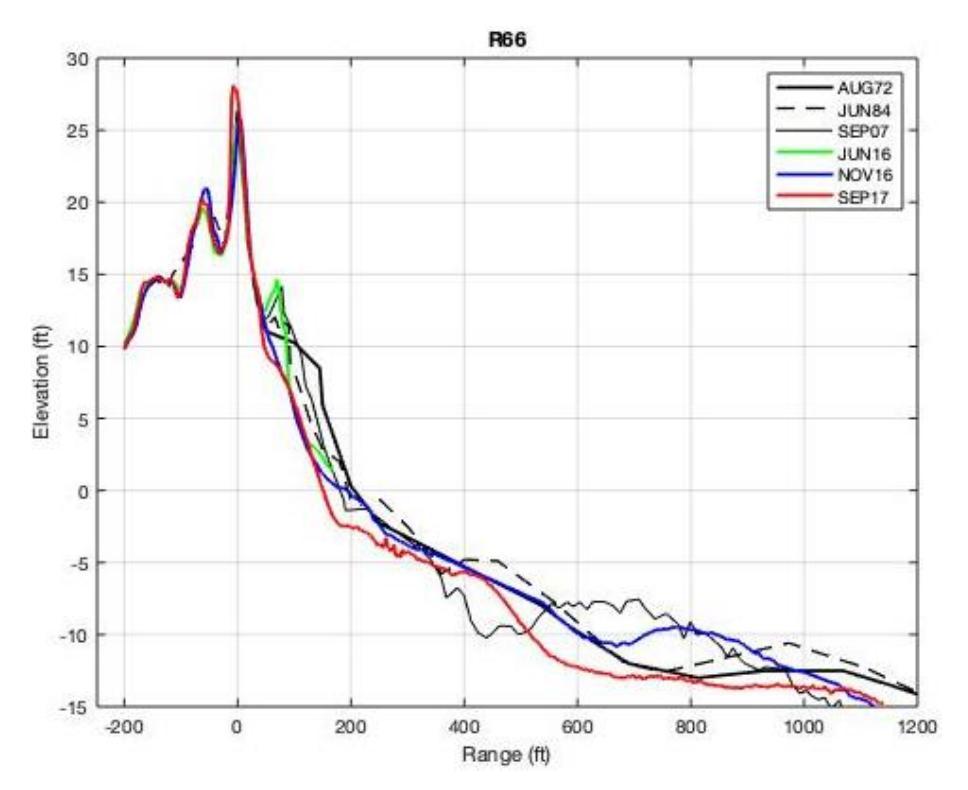
Fig. 13 shows the series of beach profile surveys taken at a location at the southern end of a 6 km stretch of pristine beach in the GTM-NERR (R-66), just north of Vilano Beach. The only notable loss of beach during the hurricanes at this location was the erosion of a small frontal dune that had begun to form between 2011 and 2014. The main dune appeared to receive minimal damage. At this location it has been observed that the upper beach consists mostly of coarse shell material, with median diameters from 0.6-1.6 mm, whereas the dune itself and below the water line are comprised mostly of fine quart sand (0.16-0.2 mm). This shell-based "armor" would appear to be a form of natural protection that formed along this undeveloped beach over time, and it would appear that this protection is both reducing the degree of chronic, long-term erosion, as well as severe erosion during worst-case storm events like Hurricanes Matthew and Irma.

Figure 13. Historic beach profiles (black) and pre-and-post hurricane profiles (color) at the southern end of the pristine, undeveloped shoreline of the GTM-NERR (just north of developed shoreline at Vilano Beach starting at R-70).
