## Floodplain Sediment from a 100-Year-Recurrence Flood in 2005 of the Ping River in Northern Thailand

# Floodplain sediment from a 100-year-recurrence flood in 2005 of the Ping River in northern Thailand

**Abstract.** The tropical storm, floodwater, and the floodplain-sediment layer of a 100-year recurrence flood are examined to better understand characteristics of large monsoon floods on medium-sized rivers in northern Thailand. Storms producing large floods in northern Thailand occur early or late in the summer rainy season (May–October). These storms are associated with tropical depressions evolving from typhoons in the South China Sea that travel westward across the Indochina Peninsula. In late September, 2005, the tropical depression from Typhoon Damrey swept across northern Thailand delivering 100–200 mm/day at stations in mountainous areas. Peak flow from the 6355-km<sup>2</sup> drainage area of the Ping River upstream of the city of Chiang Mai was 867 m<sup>3</sup>s<sup>−1</sup> (river-gage of height 4.93 m) and flow greater than 600 m<sup>3</sup>s<sup>−1</sup> lasted for 2.5 days. Parts of the city of Chiang Mai and some parts of the floodplain in the intermontane Chian

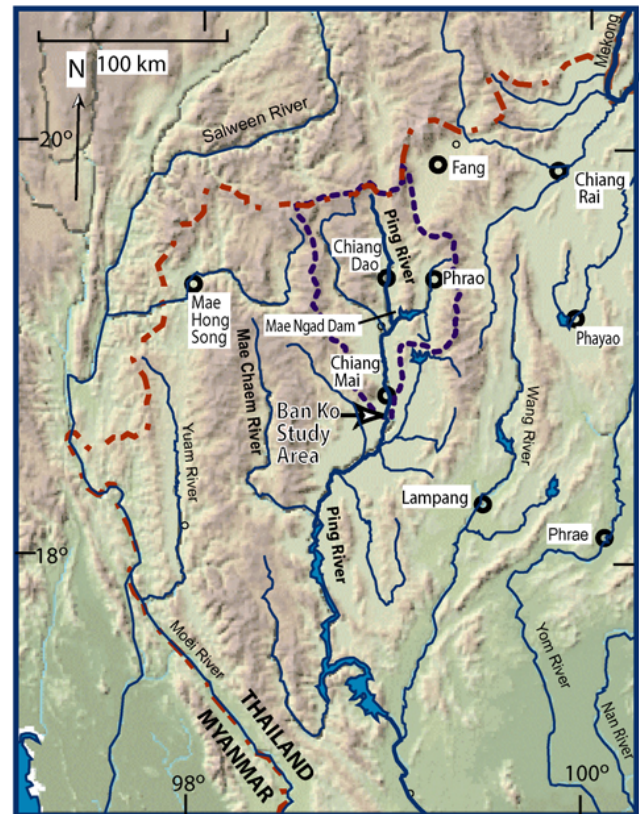
**Fig. 2.** Outline of the Ping River drainage (dotted line) upstream of the study area showing the location of the dam on the Nam Mae Ngad which regulates flow from 1/5 of the drainage. Labeled cities are those which reported major flooding 12 August–4 October 2005.

The Ping River drains a mountainous area of northern Thailand with steep hills up to elevation 1500 to 2000 m, and valleys at 330 to 500 m (Fig. 2). The Ping River basin is underlain by older Paleozoic gneissic granites, Paleozoic sediments and volcanics, Mesozoic granitic rocks, and Tertiary continental basin-fill sediments (Hess and Koch, 1979; Rhodes et al., 2005). The lowlands are underlain by alluvial fan, terrace, and floodplain deposits (Margane and Tatong, 1999). Upland areas and older terrace and fans have deep weathering profiles of saprolite one to tens of meters thick overlain by red-yellow argillic soil horizons one to several meters thick. Surface soils are dark brown loams up to 25 cm thick. Valley bottoms are mostly clayey silt with gleyed soils in the paddy areas.

The Ping River above gage P.1 has a drainage area of  $6355 \text{ km}^2$  (Fig. 2). Of this drainage area, 1/5 is regulated by the Mae Ngad Dam (active volume of 90 million  $\text{m}^3$ , total volume of 302 million  $\text{m}^3$ ), which has controlled drainage from about  $1300 \text{ km}^2$  since 1985.

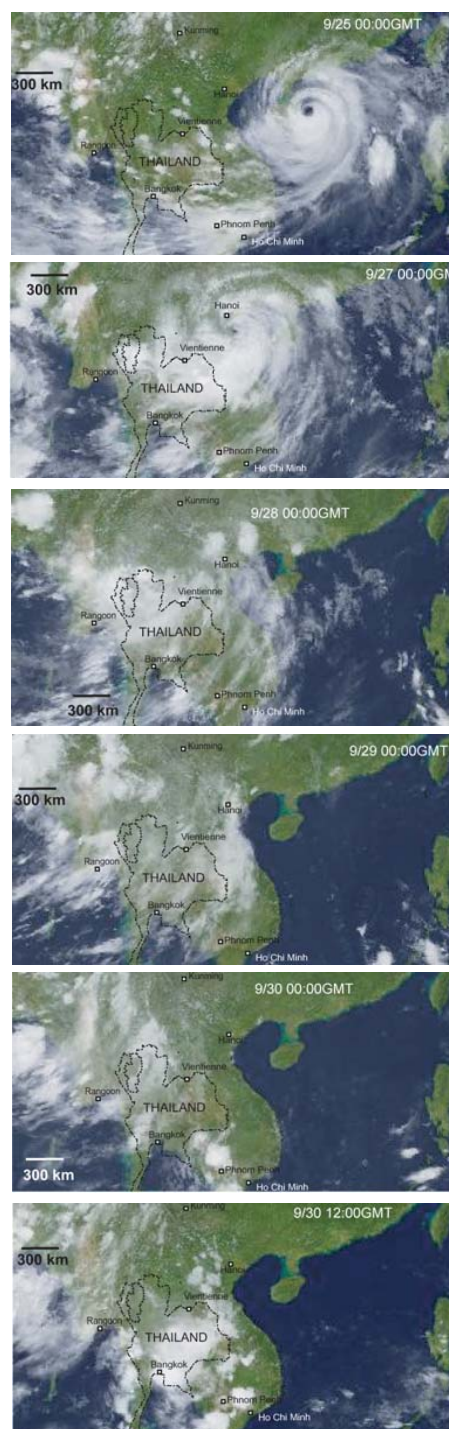
**Fig. 3.** Satellite images showing the westward traveling tropical storm from Typhoon Damrey, 25–30 September 2005. From archive of EEI-lab, Kochi University, MTSAT IR IR1 JMA. Thailand local time is 7 h later than GMT.

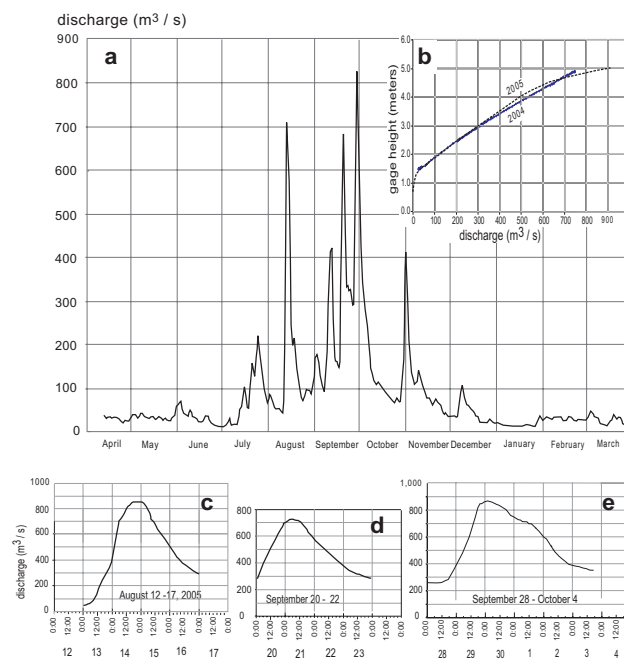
**Fig. 5.** Hydrographs of daily-mean flow readings at the P.1 gage at Nawarat Bridge in Chiang Mai. (a) the mean-daily flow 2005 hydrograph, (b) Stage-flow relationship, (c) hourly flow – 12–17 August, (d) hourly flow – 20–22 September, and (e) hourly flow – 29 September–2 October, (Data from Royal Irrigation Department, Hydrology and Water Management Office).

In the first version of this paper we used flood-flow data provided by the Royal Irrigation Department based upon the 2004 stage-discharge curve for the P.1 gage (Fig. 5b). After the flood, the Royal Irrigation Department re-surveyed the channel and revised the rating curve, which significantly increased the flood flows by about  $100 \text{ m}^3 \text{ s}^{-1}$ . The revised

days when the flood exceeded  $700 \text{ m}^3 \text{ s}^{-1}$  (Fig. 5e). In other words, the water delivered during that time to the point of sedimentation was well mixed from top to bottom. 2) Alternatively, because the flood levels at P.1 gage fell from a peak of 4.9 m, to 4.66 m in that 1.8 days of maximum depth, the height of water over the platform probably declined 0.24 m, and then after 3 days fell below the level of the platform, and sedimentation on the platform ceased. The ground was still inundated with 0.8 to 0.4 m of water and sedimentation continued, thus explaining the greater sediment thickness on the ground.

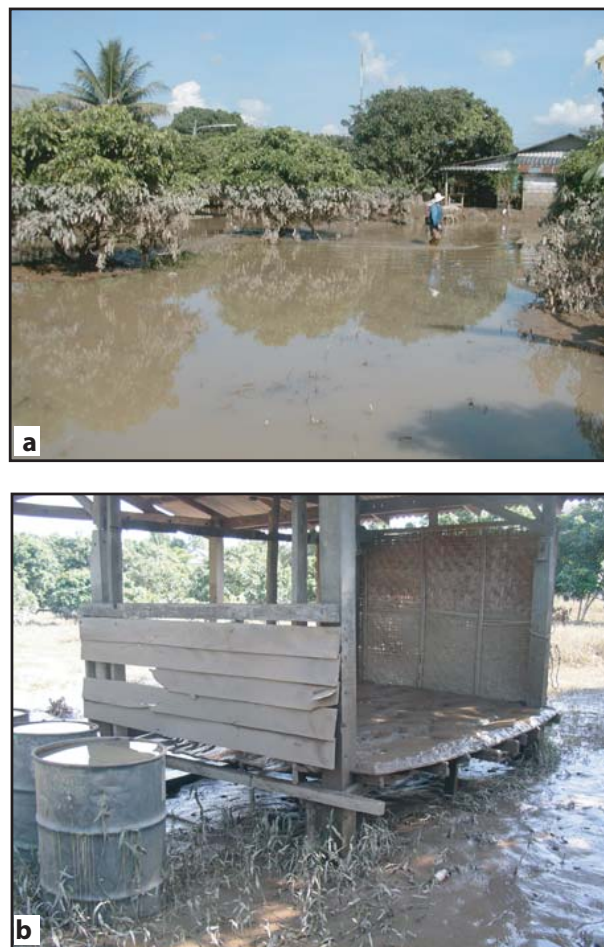
**Fig. 8.** (a) High water line on fruit trees. Floodwater depth was 1.3 m. Location is at point B of Fig. 11. View is to the southeast. (b) hut located at point H1 on Fig. 11. Five cm of sediment deposited on platform elevated 0.55 m above ground and 8 cm of sediment on surrounding ground (see Fig. 12). Photos taken on 2 October.

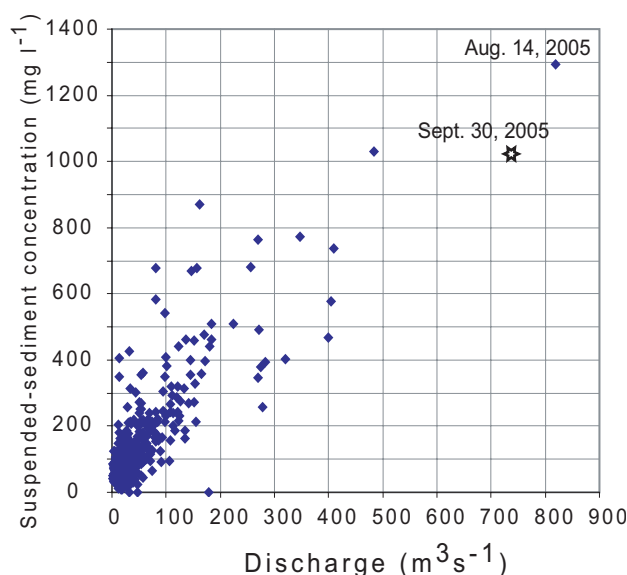
**Fig. 10.** Suspended-sediment rating data for the Ping River at the Chiang Mai P.1 gage site from Royal Irrigation Department for 1991–August, 2005. Samples obtained monthly and bimonthly using a US D-49 depth-integrating sampler. Shown on the graph are the high values of the one near-surface sample taken on 30 September, and also the one depth-integrated sample taken by the Department during the August 14 flood.

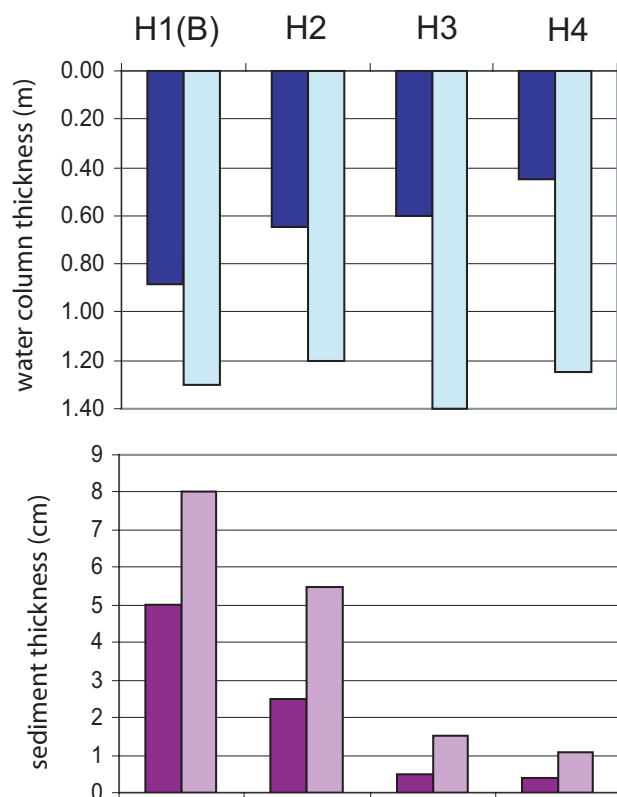
**Fig. 12.** Upper graph shows thickness of the column of water over elevated platforms (dark pattern) compared to the total depth of water at the site (pale pattern). Sediment thickness deposited on elevated platforms (dark pattern) compared to thickness on the surrounding ground (pale pattern) (Photo of typical hut platform shown in Fig. 8b). Locations of H1(B), H2, H3, H4 shown in Fig. 11.

Sediment thicknesses were measured on elevated platforms of 4 huts (Fig. 12). Thicknesses on the platforms are an accurate measure of suspended sediment that settled from the upper part of the water column. The bamboo slats on

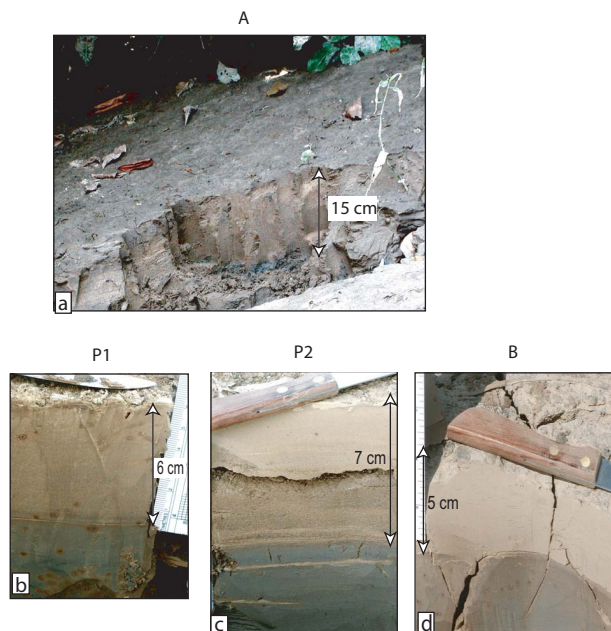
**Fig. 13.** Photographs of 29 September–2 October sediment at locations A, P1, P2, and B, shown in Fig. 11. (a) River-channel-facing levee deposit on a 20-degree slope at site A. Deposit is 15 cm of brown silty fine sand (grain-size analysis shown in Fig. 14). October 7 photo. (b) Brown, massive, clayey coarse silt overlying grey clay of the August flood at point, P1, 100 m from river channel. The 6-cm-thick layer shows slight upward fining, and has developed several tiny rust-stained burrows of macro-organisms when photographed 2 months after deposition. December 4 photo. (c) Sediment shows a basal 3.5-cm layer of brown clayey coarse silt overlain by 3.5 cm of pale brown clayey silt that has dried and parted from the layer below. The underlying gray August sediment has light-brown silty streaks. 4 December photo at point P2, 160 m from river channel. (d) Massive 5-cm layer of brown clayey silt at site B, 200 meters from the river channel (Grain-size analysis shown in Fig. 14). 4 December photo.

Sediment at point P.1 is composed of basal coarse silt with slight upward fining, 6 cm thick (Fig. 13b). The textural difference through the layer, deposited 100 m from the channel, is subtle but it may be detectable as a separate depositional layer in a section of floodplain sediment.

Sediment at Point P2 shows two distinct layers emphasized by drying, shrinking, and parting of the upper layer of clayey fine silt from the lower layer of faintly laminated coarse-medium silt (Fig. 13c). Point P2 is 160 m from the channel edge. This 7-cm thick layer is so conspicuously layered, it would likely be preserved within floodplain strata.

Sediment at Point B, 200 m from the channel edge, is 5 cm of massive clayey silt similar to the upper layer at Point P2 (Fig. 13d). Grain-size analysis shows this sediment to be 28 percent clay (Fig. 14). More distal sediments were massive clayey silt for which grain-size analyses show similar clay content, but finer silt size (Fig. 14).

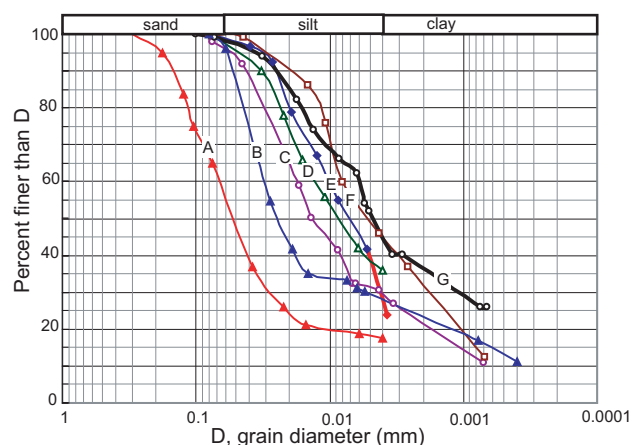
**Fig. 14.** Sediment grain-size analyses for sample locations shown by points A, B, C, D, G, and F in Fig. 11. Analyses by standard hydrometer and wet-sieving methods.

Although the sample from point E was only 90 m from the channel edge, it had a fine grain size (Fig. 14) similar to the more distal sediment. Probably irregularities in the floodplain topography isolated this site from moving flood water, so that it received only deposition from slowly moving floodwater.
