Application of Infrared Thermography in Pavement Inspection

Aidin J. Golrokh
Boise State University

Application of thermography in pavement inspection

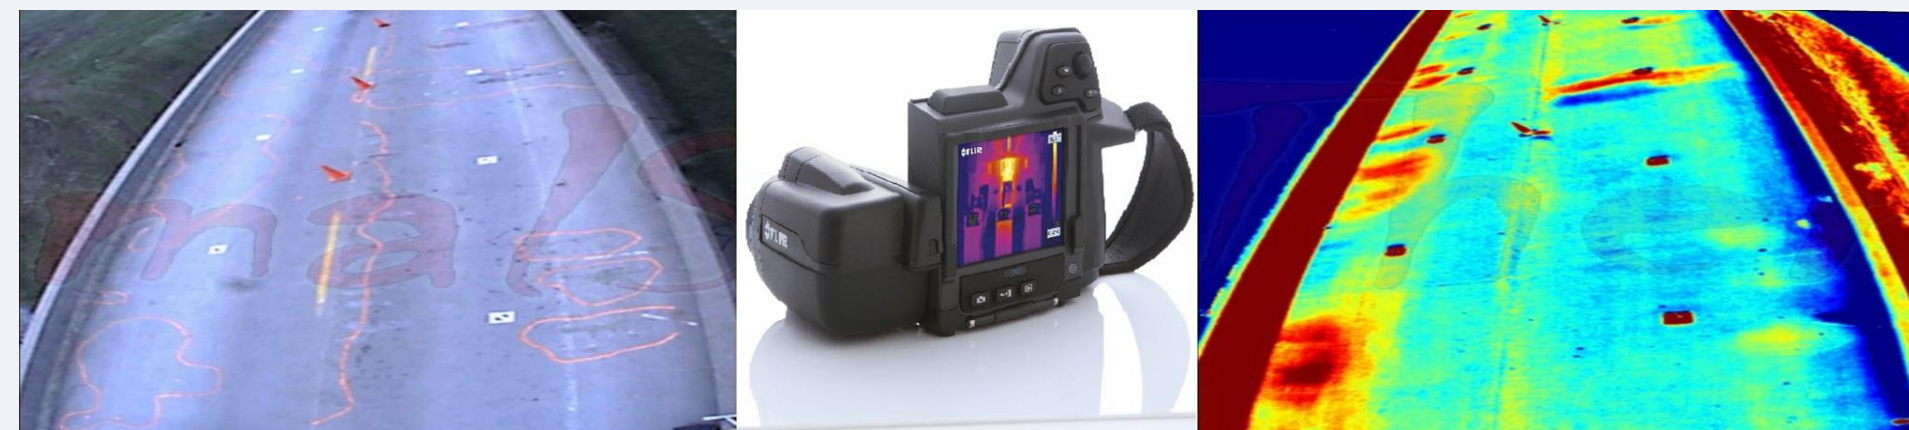
- IRT captures the temperature gradient of concrete pavement surfaces. When exposed to heat, delaminated parts of concrete will interrupt the heat transfer which will cause temperature gradient on top of the surface of the pavement which can be picked up by thermal camera.

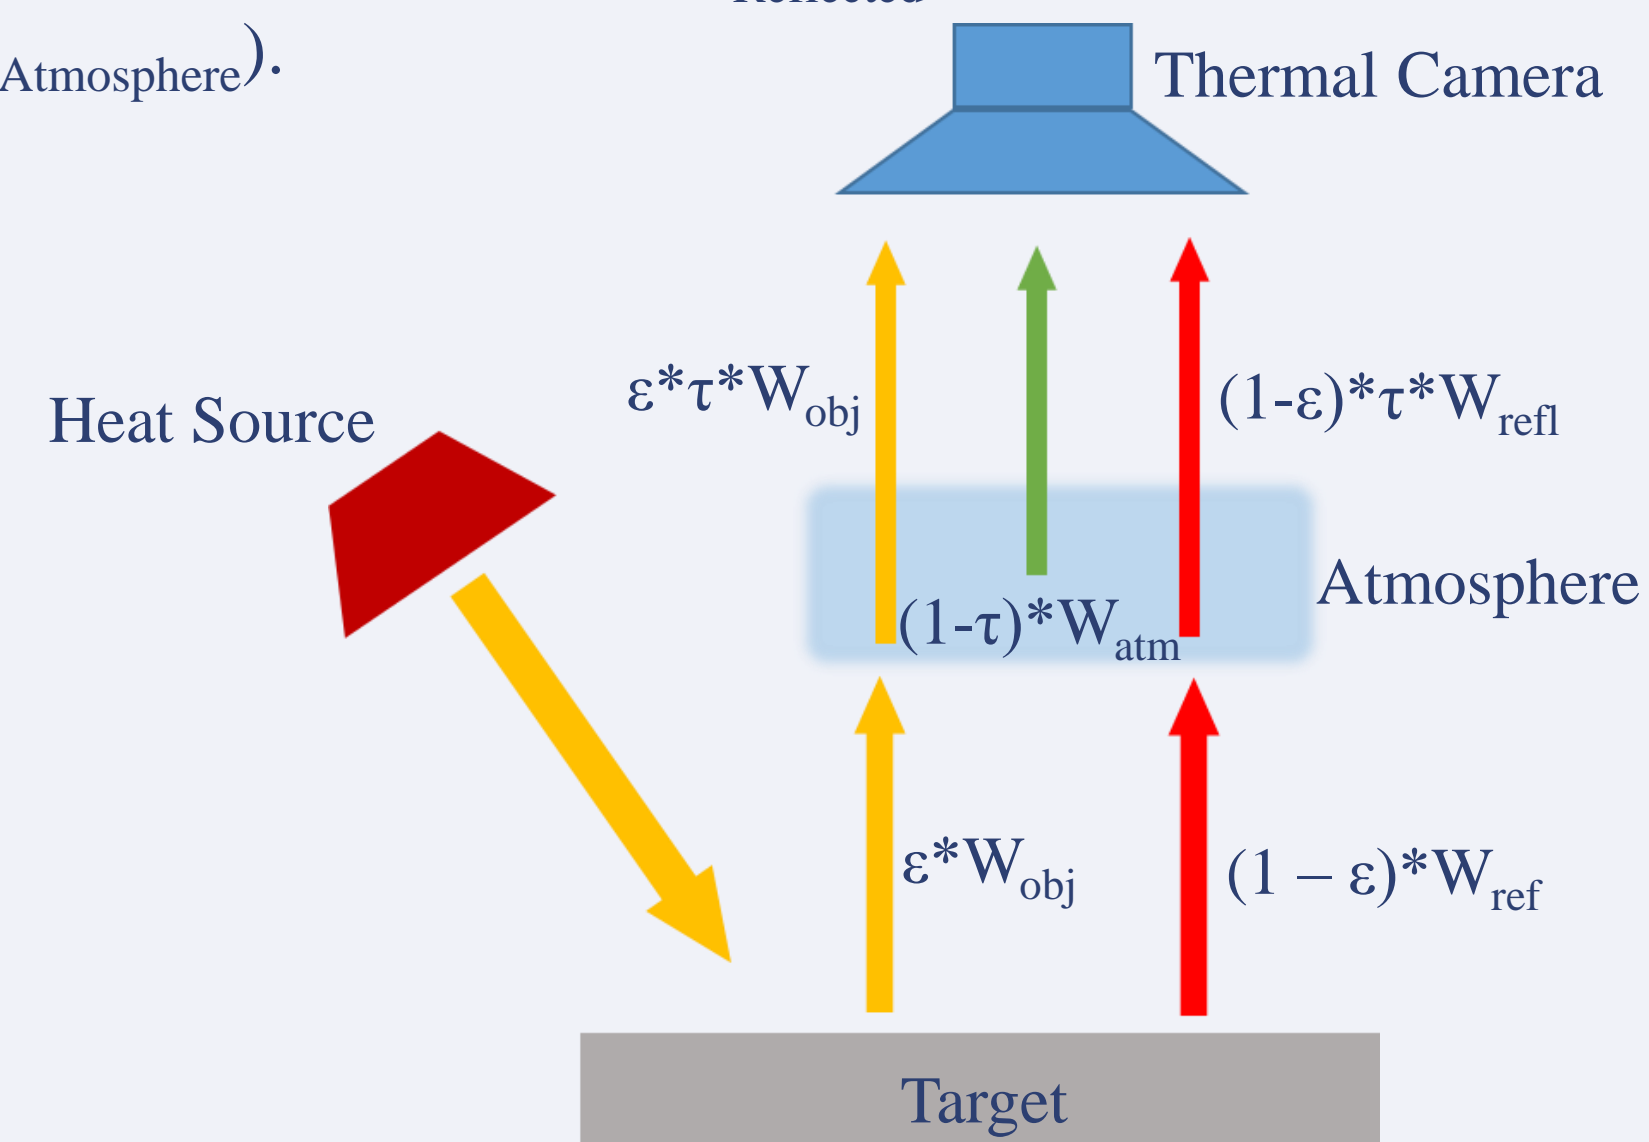
- Each pixel of infrared thermal image is representing the temperature identity of that specific location on the surface of the specimen. However, this temperature value is not a direct result of converting emitted energy to temperature reading. The major emission entities that are received by the thermal camera are Target emissions (E_{Object}), Surrounding emissions reflected from the surface of the object ($E_{Reflected}$) and atmosphere emissions ($E_{Atmosphere}$).

$$T_{Object} = \sqrt[4]{\frac{W_{Total} - (1-\epsilon) \cdot \sigma \cdot \tau \cdot (T_{Reflected})^4 - \sigma \cdot (1-\tau) \cdot (T_{Atmosphere})^4}{\epsilon \cdot \sigma \cdot \tau}}$$

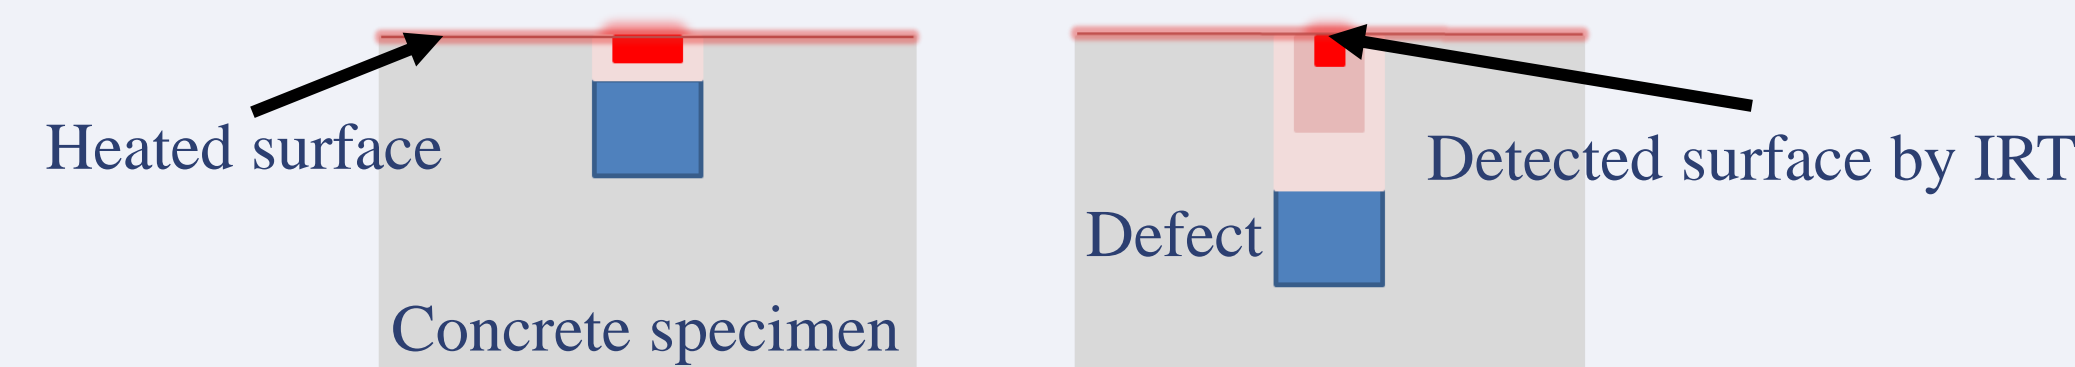
- Subsurface delamination (such as air void) has a different thermal conductivity compared to bulk concrete and asphalt hence acts as an heat insulator.
- Depth of delamination has an effect on the temperature gradient that it generates on the surface of specimen. Delaminations located deeper from the surface have lesser effect on the generated temperature gradient.

- In order to mimic air void defects, styrofoam cubes were inserted in different depths inside of the concrete domain.

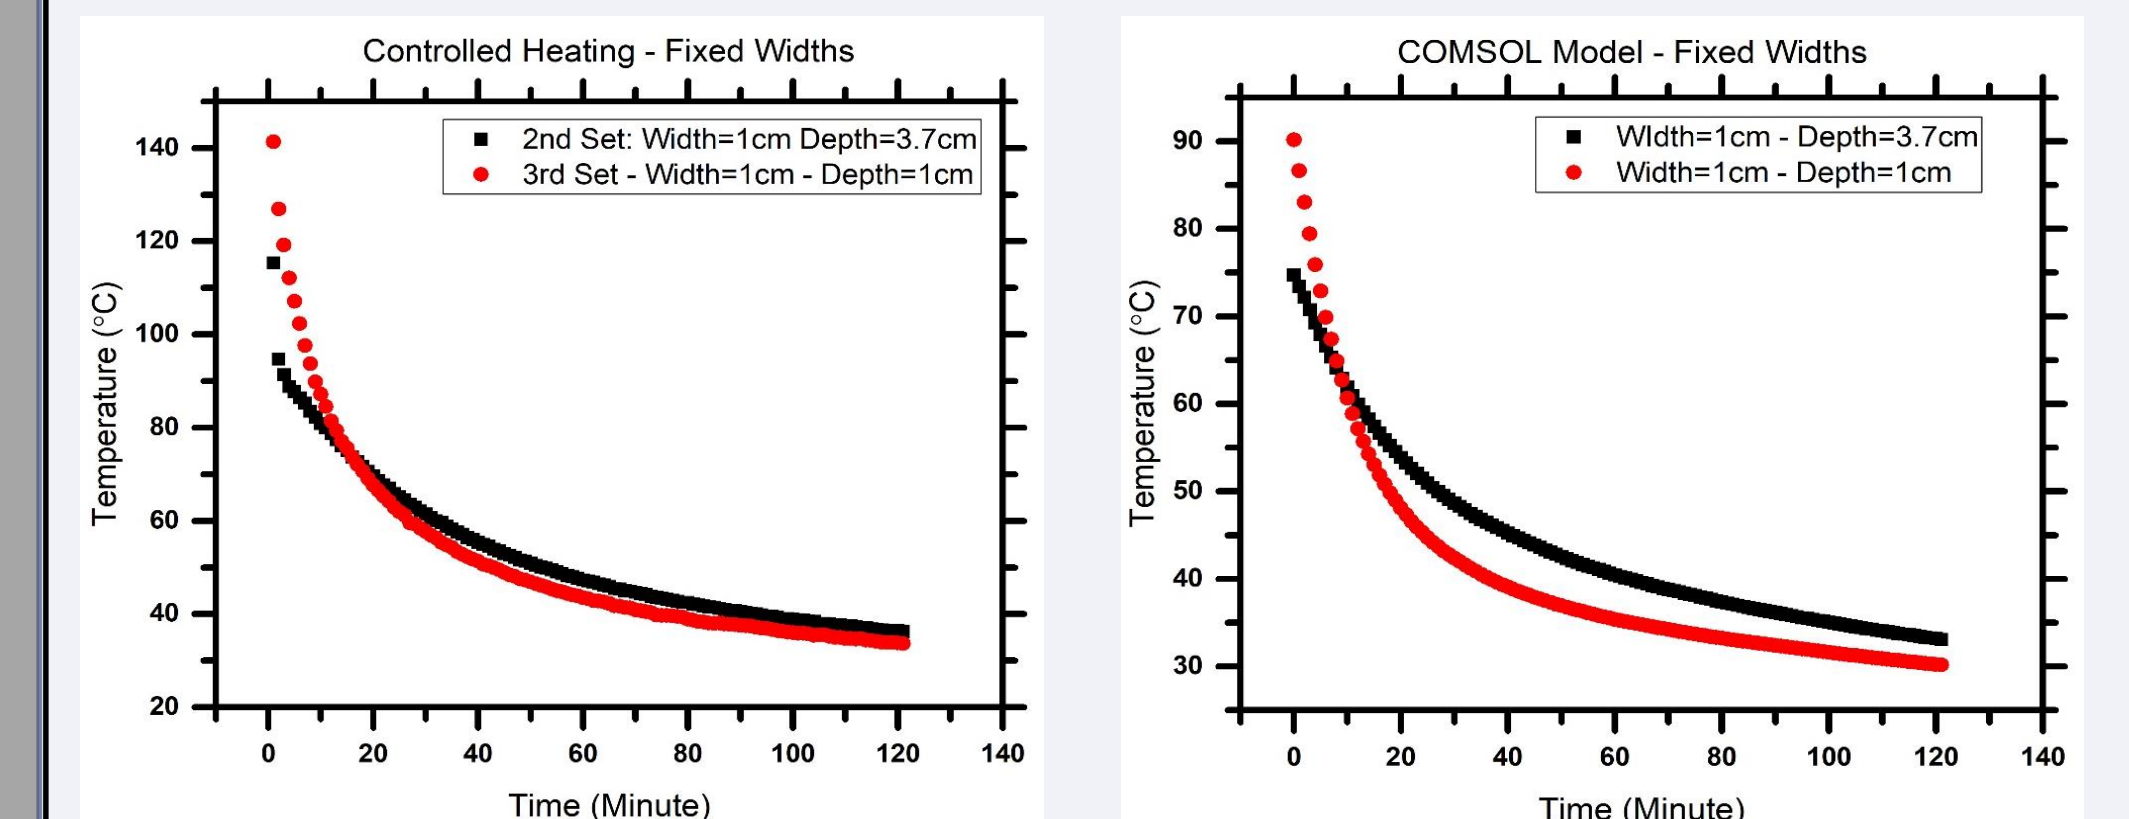
- Temperature readings for cracks with different depth sizes based on the results from experimental data and the computer model are show in following graphs
- Temperature change during the cooling cycle follows the same trend in both the experiment and the simulation.
