2018 Graduate Student Showcase

3D Crack Profiling Using Real-Time Thermography

Department of Civil Engineering

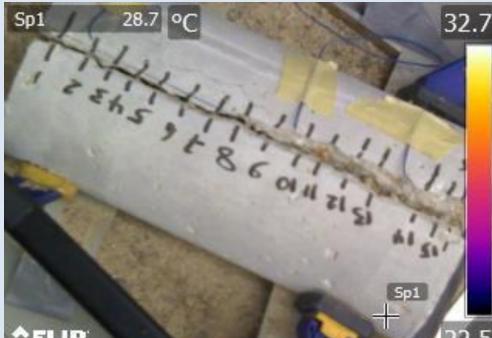
Thermography of asphalt pavement crack

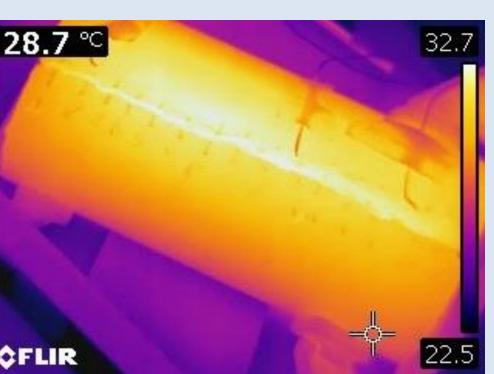
Thermography of cracked concrete sample

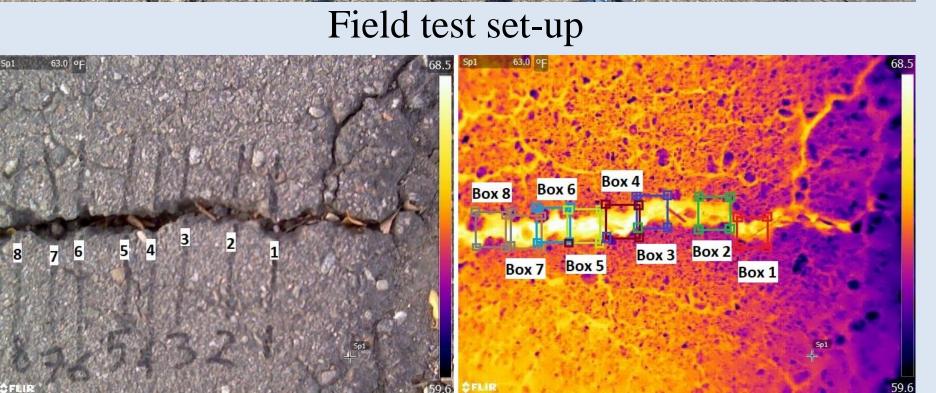
Thermal image of asphalt pavement crack

Utilizing apparatus listed in upper-left picture below, the field test was implemented, and four different types of roadway were analyzed: deteriorated roadway, pedestrian sidewalk, parking lot and major roadway. Thermal images were taken 2 hours prior to the sunset period (cooling process). Both temperatures inside the crack and surrounding points were taken to normalize the temperature, so that data can be compared regardless of locations and time of the collected data. At the same time, depth and width were measured and collected. Bottom-left picture shows thermal image taken in the field test. Test setup shown in upper-right picture represents laboratory test with 21" x 6" x 6" concrete sample. Multiple thermal images of modified concrete cracks were taken with infrared thermal camera connected to ResearchIR software after heating up the concrete sample for 2 hours. In addition, humidifier and fan were employed to replicate ambient condition outside. In a similar way to the field test, temperature inside the crack and surrounding points were measured as well.

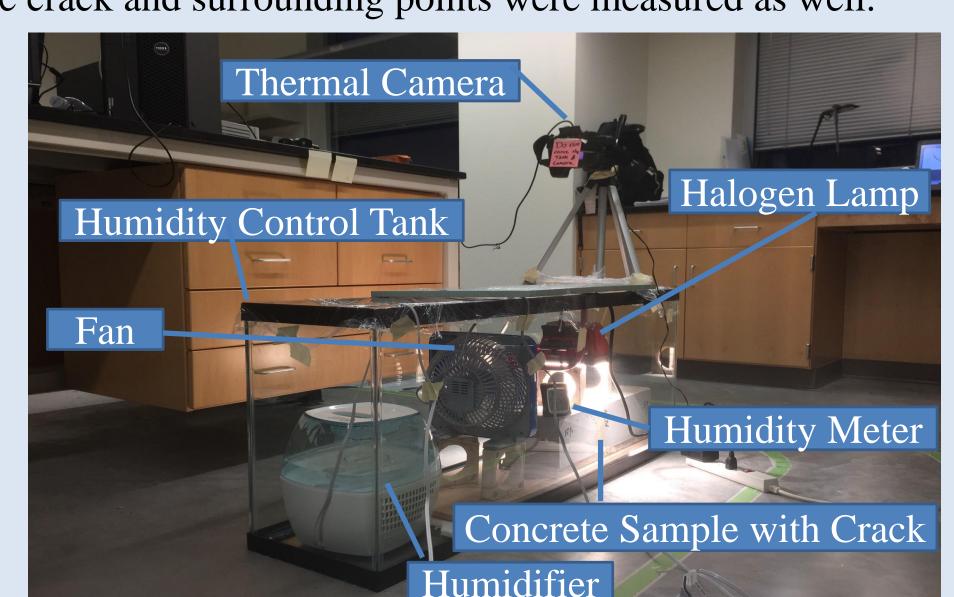
Laboratory test set-up

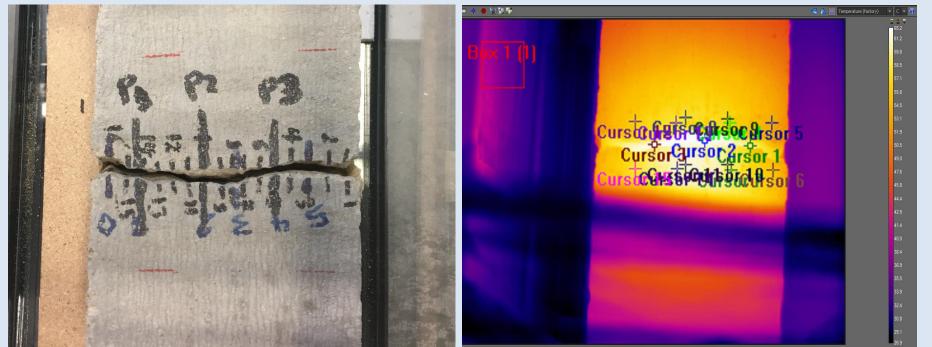
Thermal image of concrete in ResearchIR

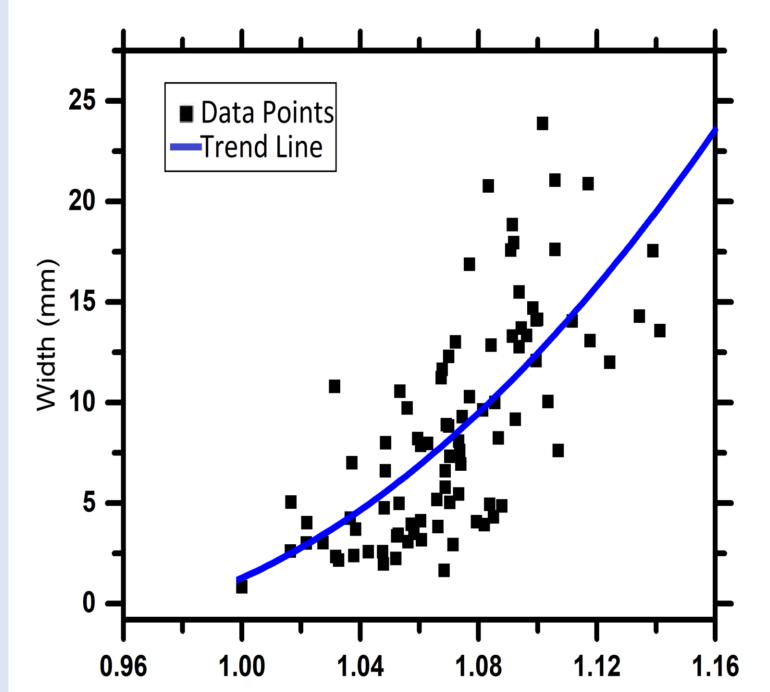
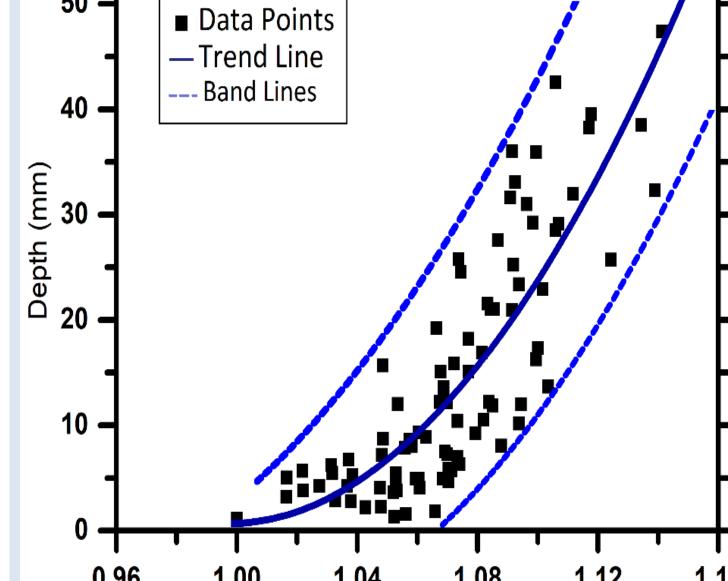
The normalized temperatures never went below 1.00 as clearly shown in the graphs on the right, meaning that temperatures inside the cracks were always higher than or equal to the sound areas around them. Also, trend line was drawn for each graph and the R^2 values for the these trend lines were found to be 50% for width and 70% for depth.

Point-wise normalized temperature based on ambient surface tempreture

- Based on the point-wise normalized temperatures, the areas inside the cracks always have higher temperatures than their surrounding areas.
- Graphs plotted from the field tests show that wider and deeper cracks have higher temperatures than narrow and shallow cracks. In addition, it is concluded that depth has more effect on the temperature than the width based on the calculated R^2 values.

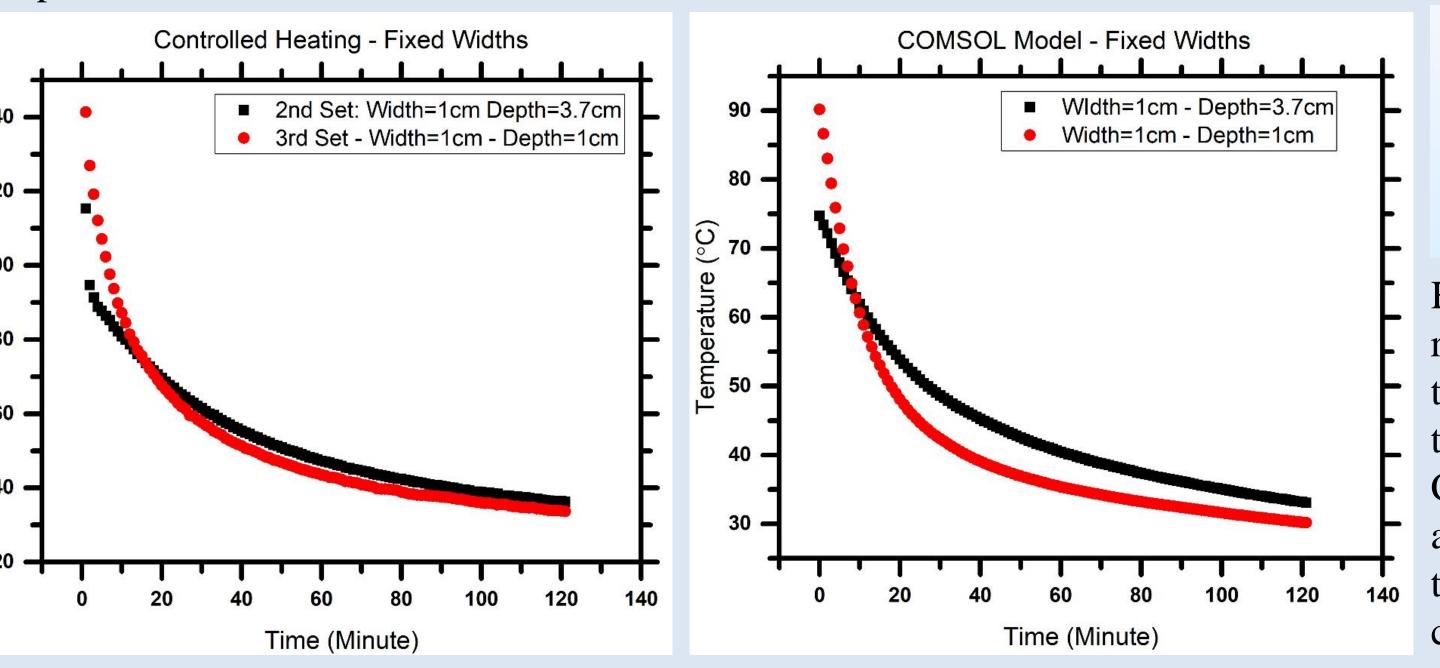
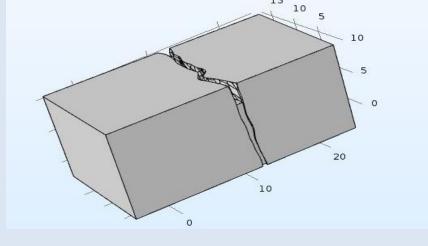
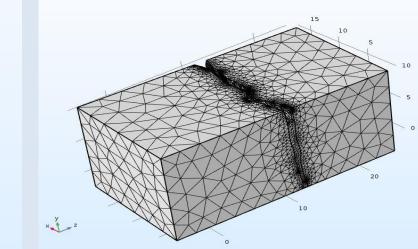
Width=1cm - Depth=7.4cm Width=1cm - Depth=1cm Humid Heating Humid Heating Controlled Heating Controlled Heating Heating With Air Flow Heating With Air Flow

Heat dissipation in concrete crack was analyzed and recorded by varying width & depth in the laboratory test. Additionally, concrete sample was modeled in the Comsol (Figures above) using 3D scanning and Catia software, and simulated with same condition as the laboratory tests to verify outcomes. Graphs on the left side show the heat dissipation behavior of concrete crack for constant width and varying depth.

Influences of different ambient conditions on both heat dissipation of the concrete cracks in different sizes and readings from the thermal camera were also observed and studied. For the variation in ambient conditions, humidifier and fan were employed to the test set-up to see the effects of humidity and air flow in the heat dissipation behavior. By varying one ambient condition at a time for each test, heat dissipations for cracks with constant width and different depths were measured. The left two graphs show the dissipation behavior of two different cracks with varying depths.

- Graphs for the effects of crack depth on heat dissipation demonstrate that deeper cracks absorb heat more during the heating process and reach peak temperatures faster compared to the cracks that have shallow depth.
- Comparing graphs for the effects of crack depth, deeper crack has higher slope throughout the test period meaning that deeper cracks dissipate heat faster and reach their normal temperatures faster than shallow cracks.
- Cracks heat up more and lose heat slower in humid condition. Also, deep cracks are more prone to the effects of humidity than shallow cracks.
- The study on concrete specimen will continue using passive IRT to see the effect of sun on concrete sidewalk cracks.
- In future studies, Pundit Ultrasonic test device will be employed to measure and analyze the depth and characteristics of subsurface anomalies.
