Analysis of Particle Attrition and Material Abrasion at Varying Temperatures for Solar Energy Applications

PRESENTER:
Andrew Russell

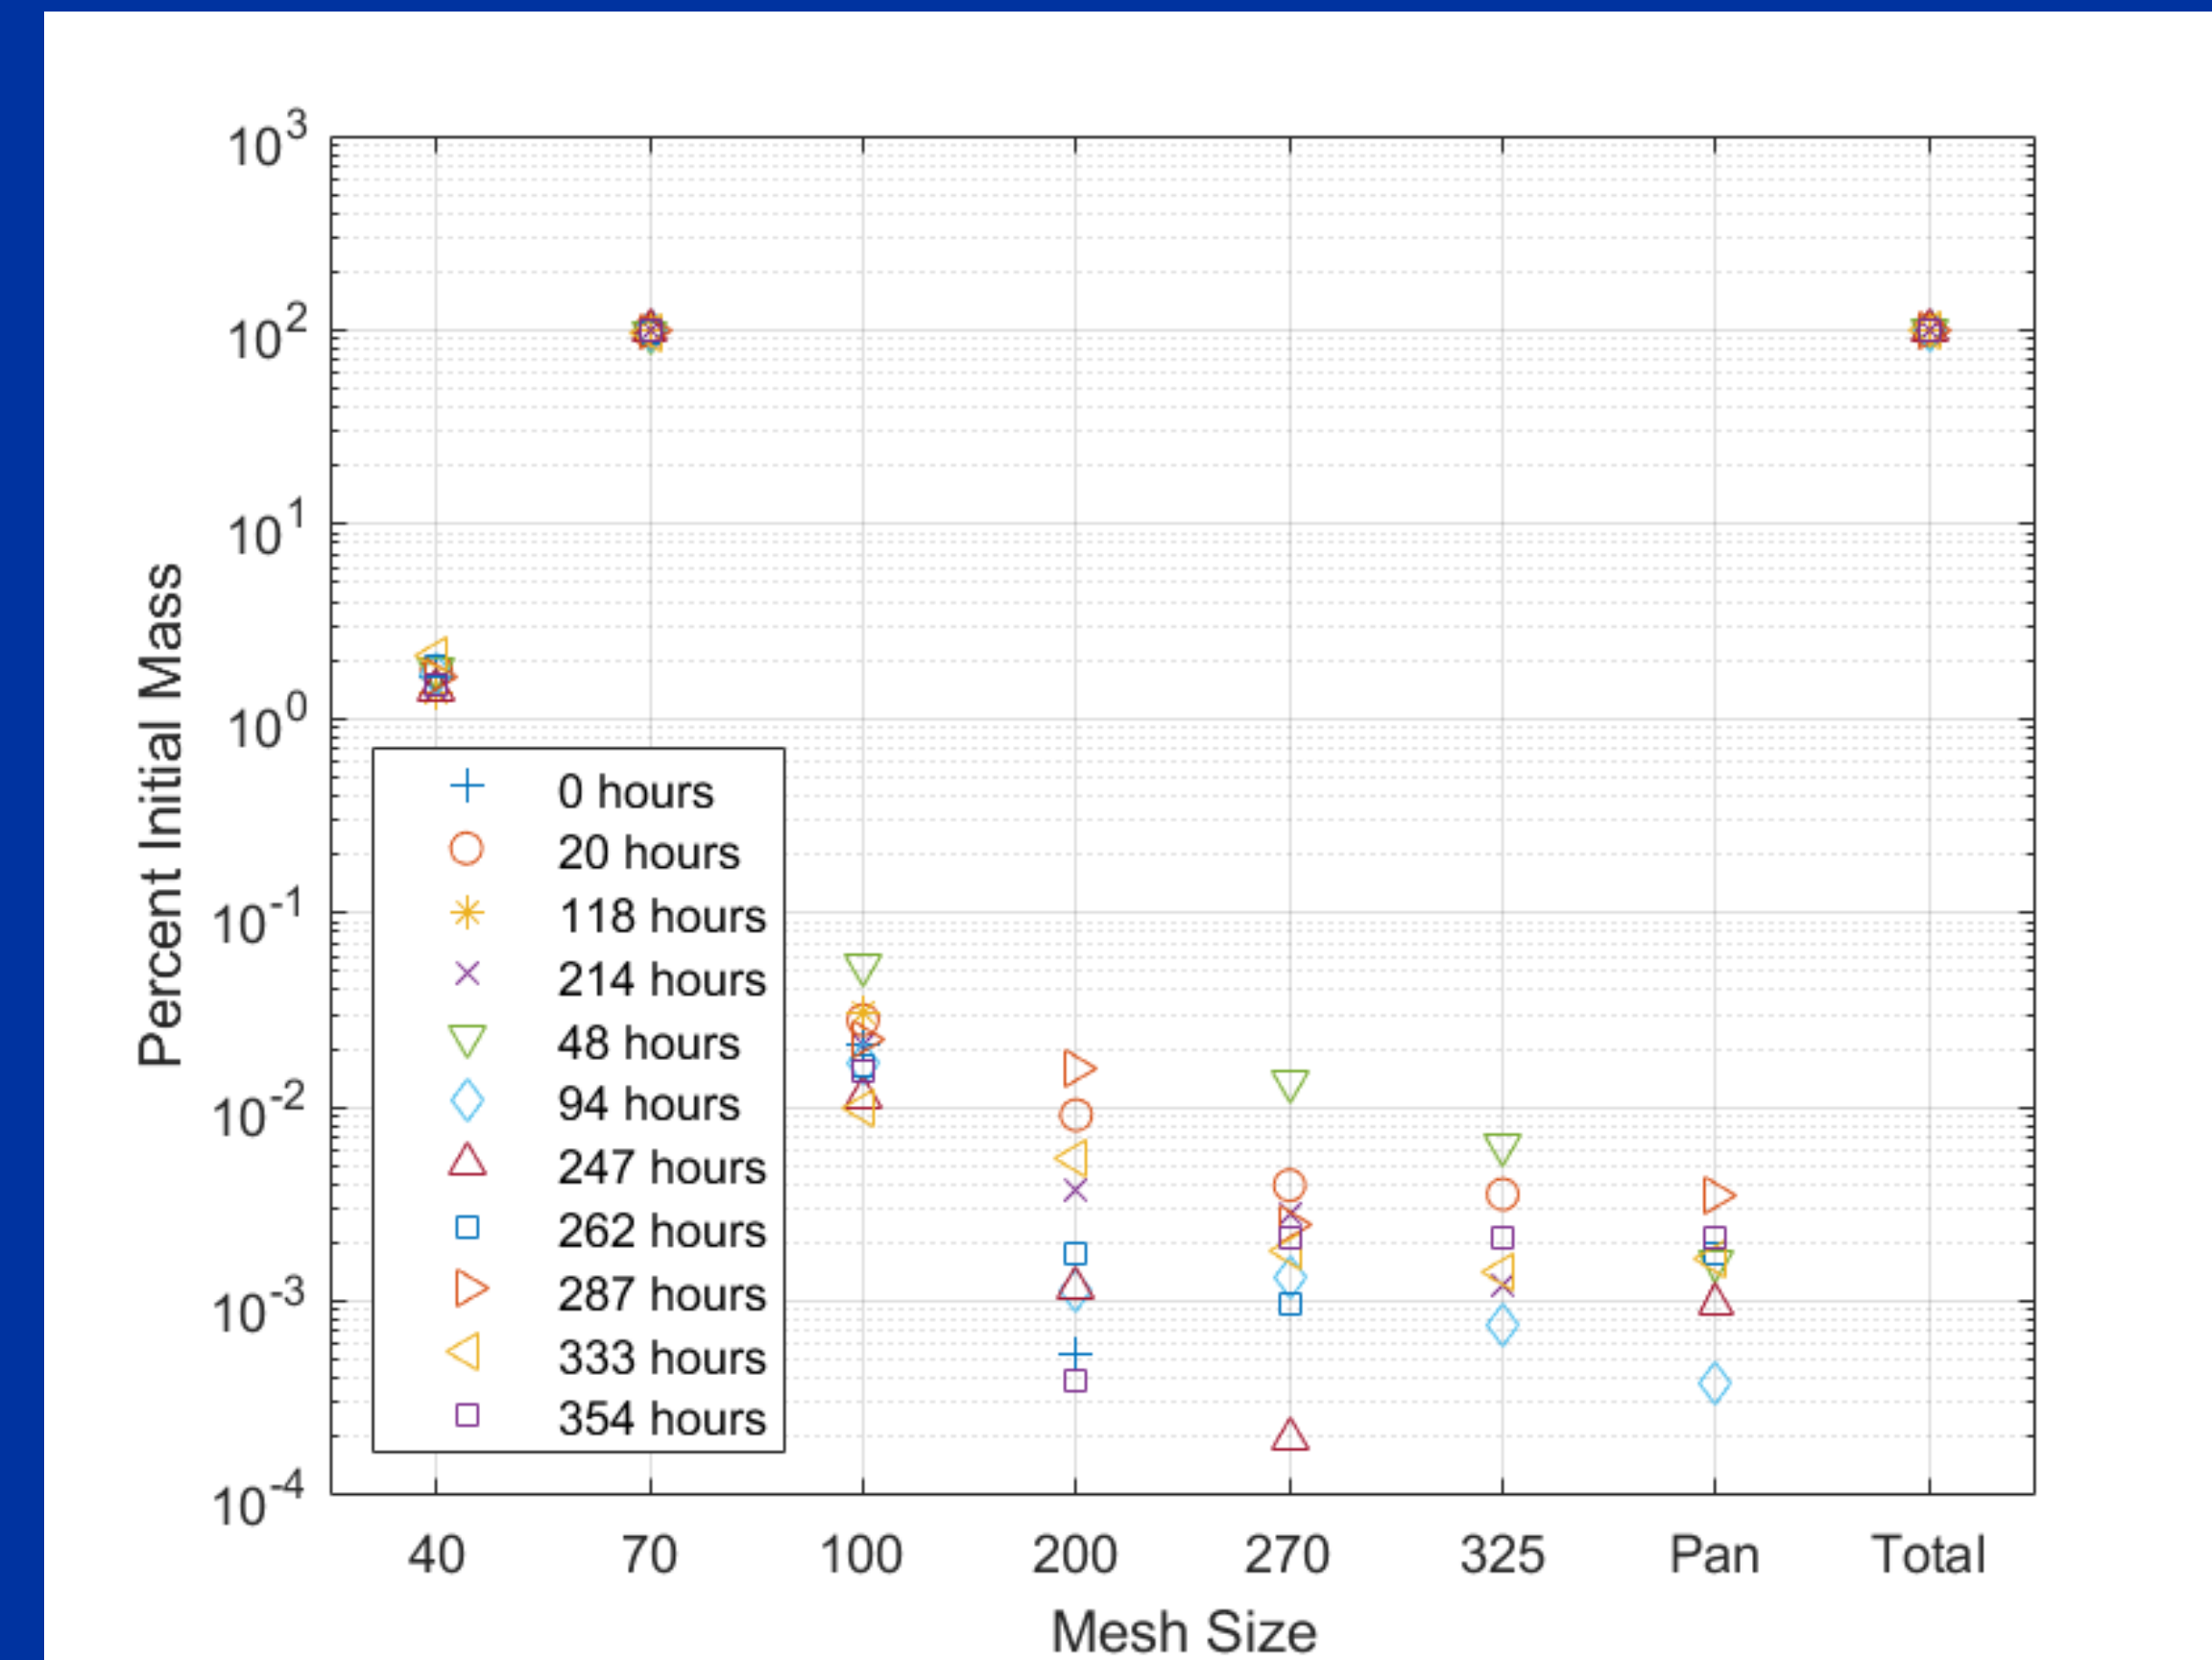
Figure 1: Percent initial mass vs. mesh size for HSP40/70 particles at low temperature.

Particle attrition for HSP40/70 particles was found to be mostly negligible at room temperature. As shown in Figure 1, the size distribution does not vary drastically with time. Identical tests were performed on other particles such as silica, and were found to have significant breakdown. This is important as it shows that HSP40/70 can withstand collisions and does not break down easily. For particle abrasion (Figure 2), all tested samples began to degrade immediately with time. The samples then approached an equilibrium where abrasion slows down significantly. It was found that the concrete sample (TUF60M) abraded the most, whereas the stainless steel (SS316) and Inconel (IN740H) samples did not abrade much after over 700 hours of testing. This shows that refractory composites experience about five times the abrasion of typical metals.

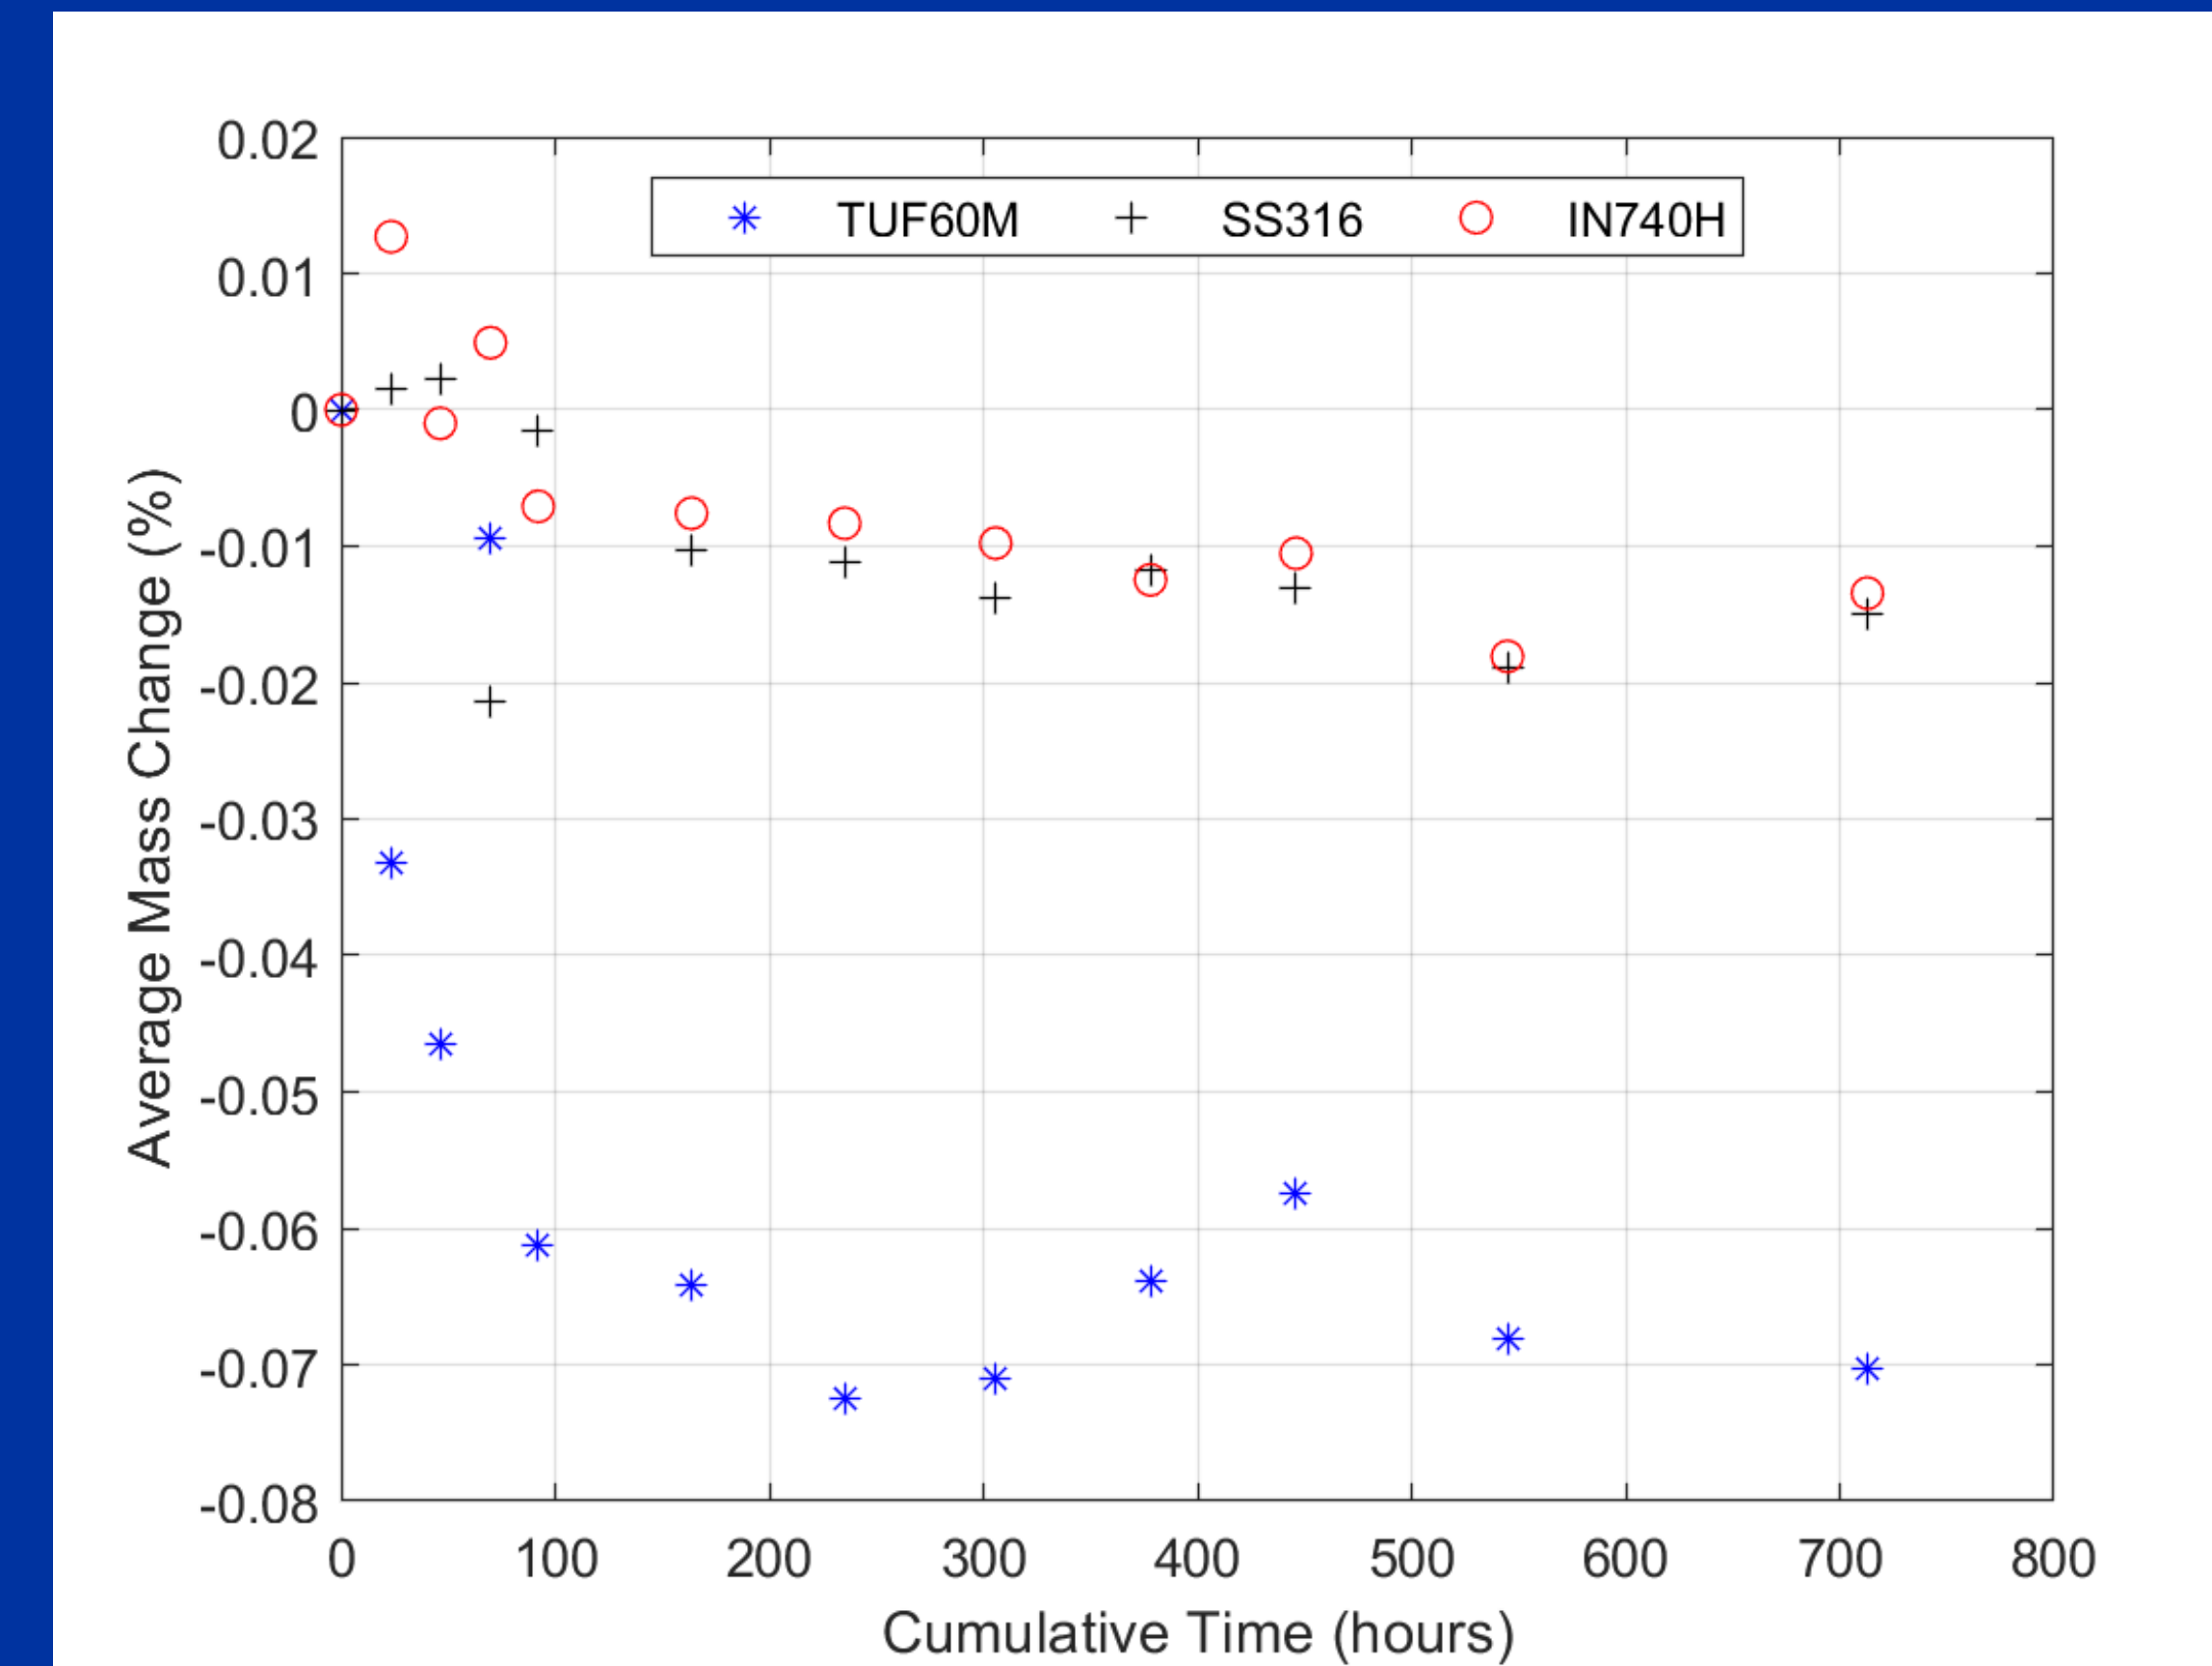
Figure 2: Average percent mass change vs. cumulative time for HSP40/70 particles at low temperature.

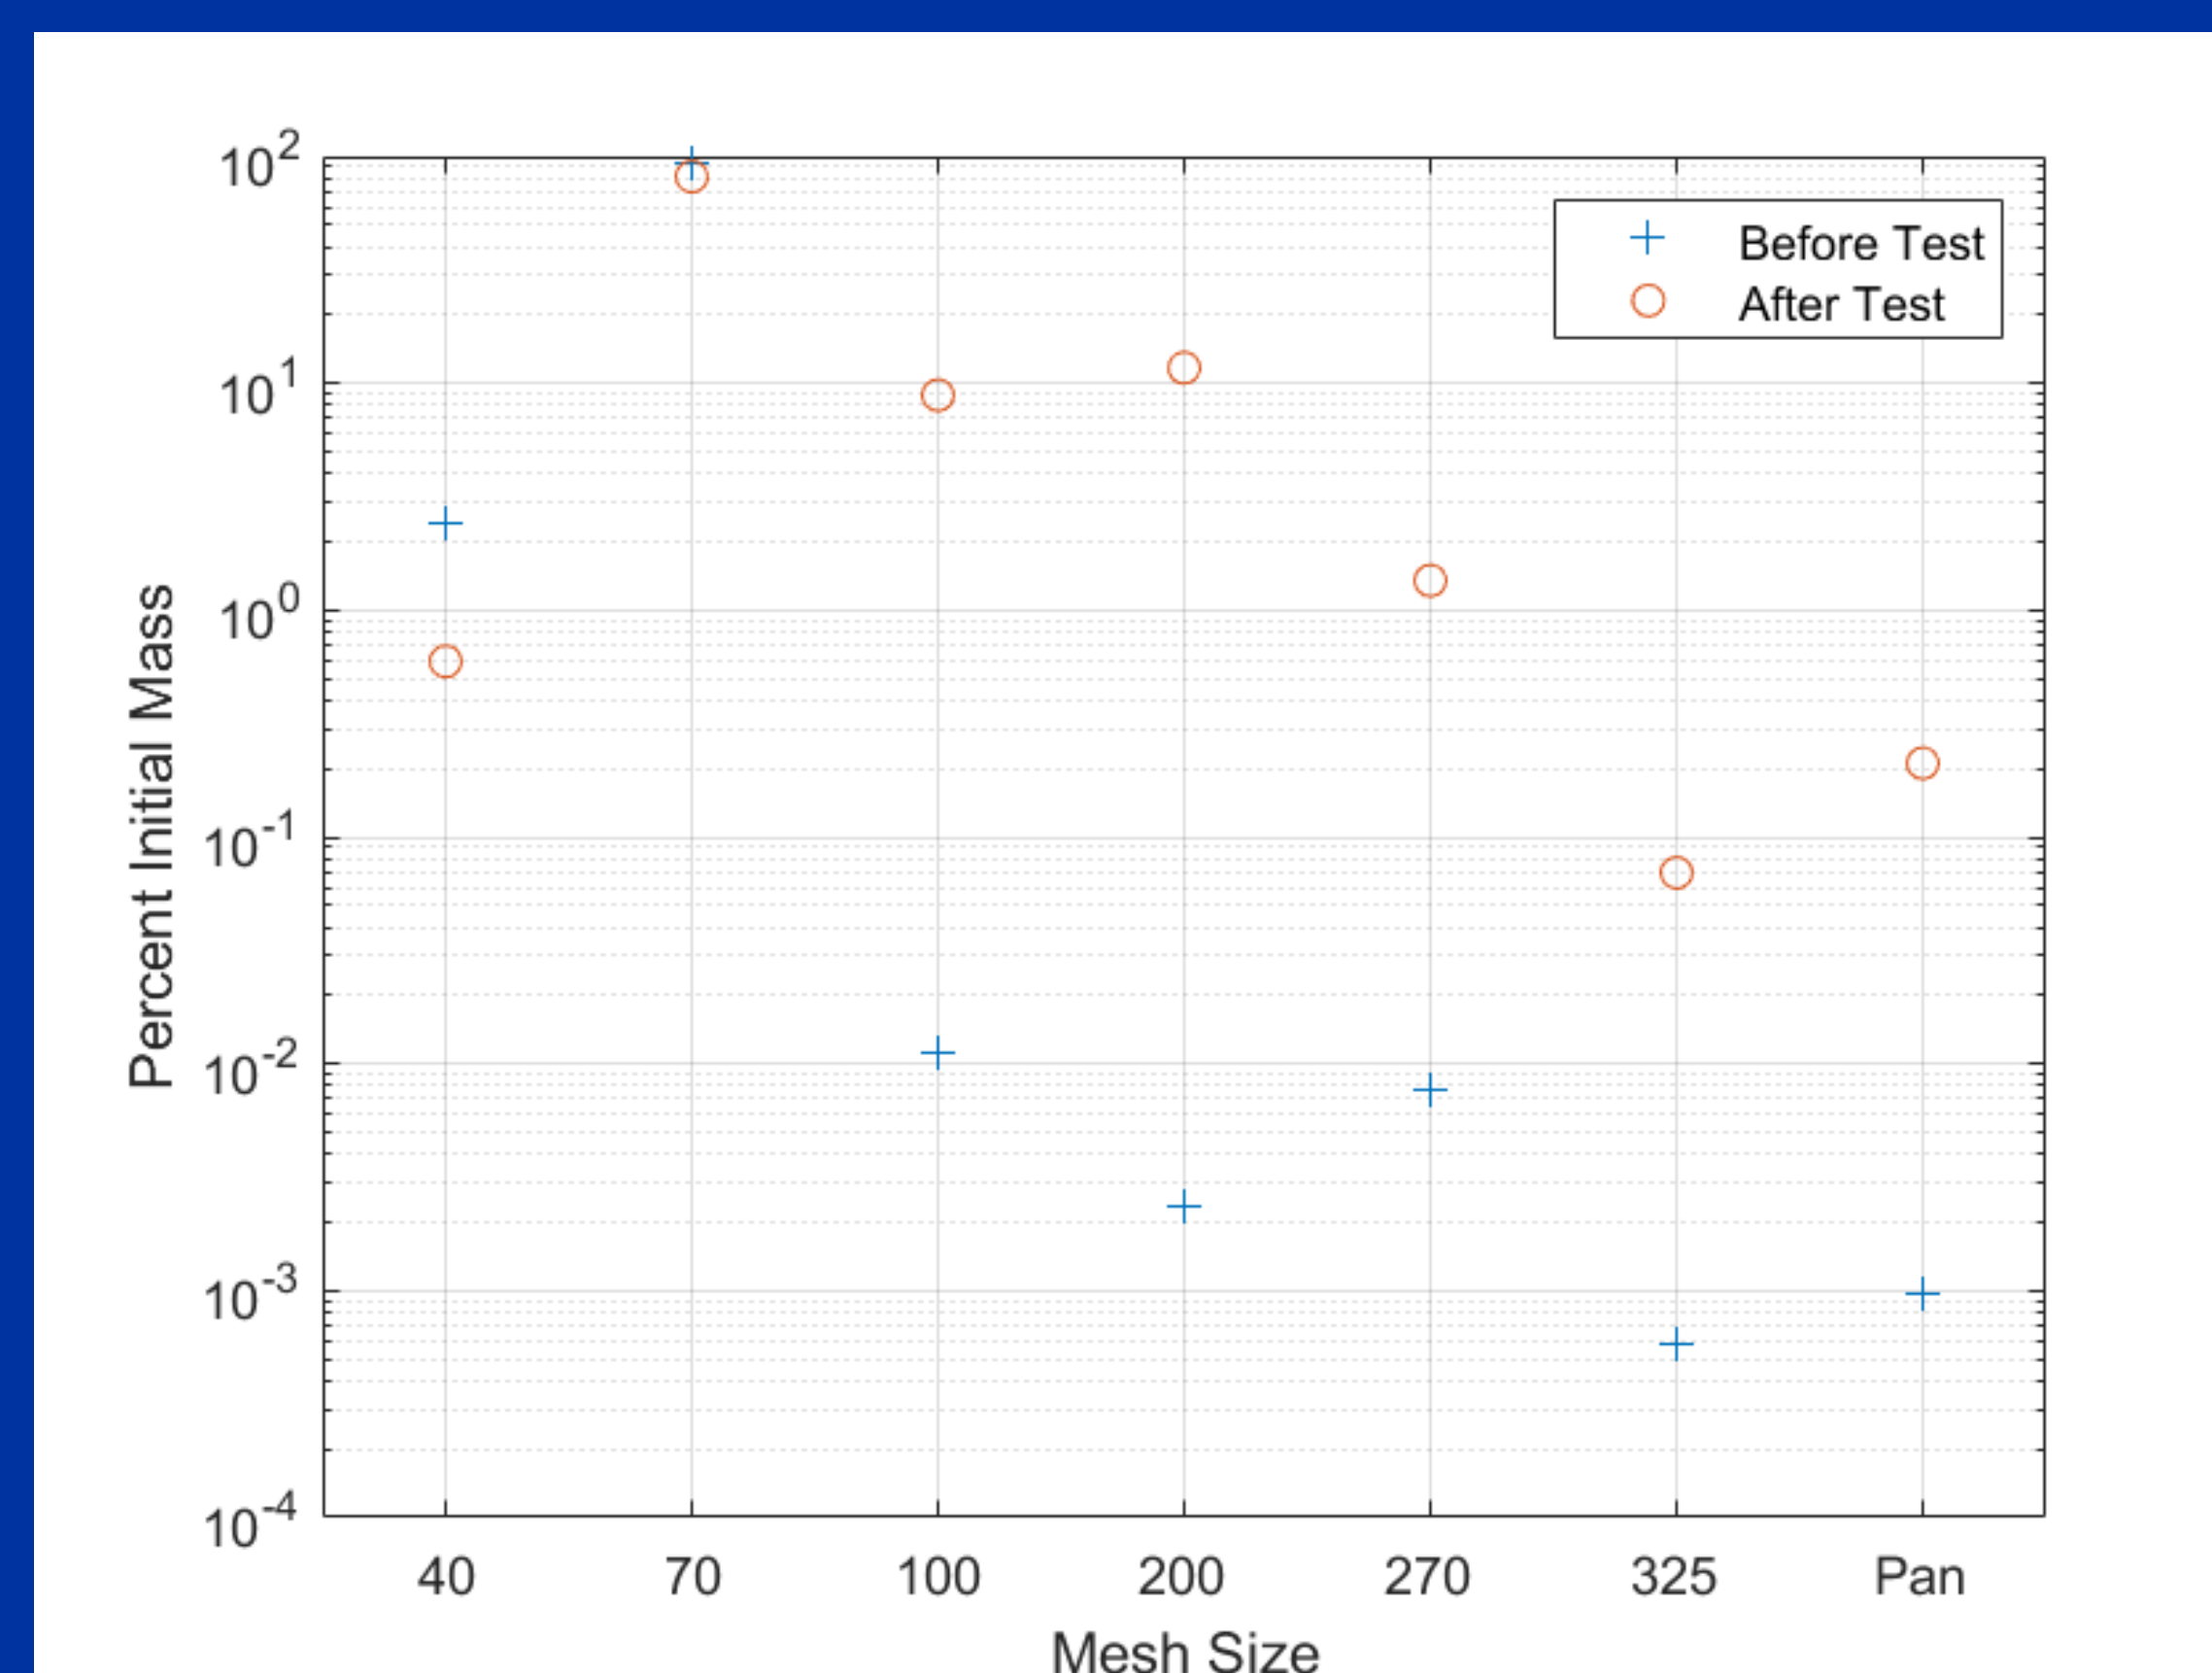
Figure 3: Percent initial mass vs. mesh size for HSP40/70 particles at high temperature.

To understand how these particles function in solar energy applications, they must be tested at operating temperatures. Particle attrition for HSP40/70 particles was measured for 30 hours at 800°C. It was found that the size distribution experienced significant changes when subjected to high temperatures (Figure 3). This change was caused by particle breakdown via collisions, as well as oxidation. This is important because it shows that collisions are not the only thing that can dramatically alter the size distribution. For particle abrasion (Figure 4), the samples were tested at 800°C for about 500 cumulative hours. It was found that the Inconel sample (IN740H) had negligible abrasion after 500 hours, while the concrete and stainless steel samples began to degrade after about 170 hours. Once the stainless steel (SS316) began to degrade, it followed a relatively linear trend, whereas the concrete (TUF60M) began to degrade rapidly.

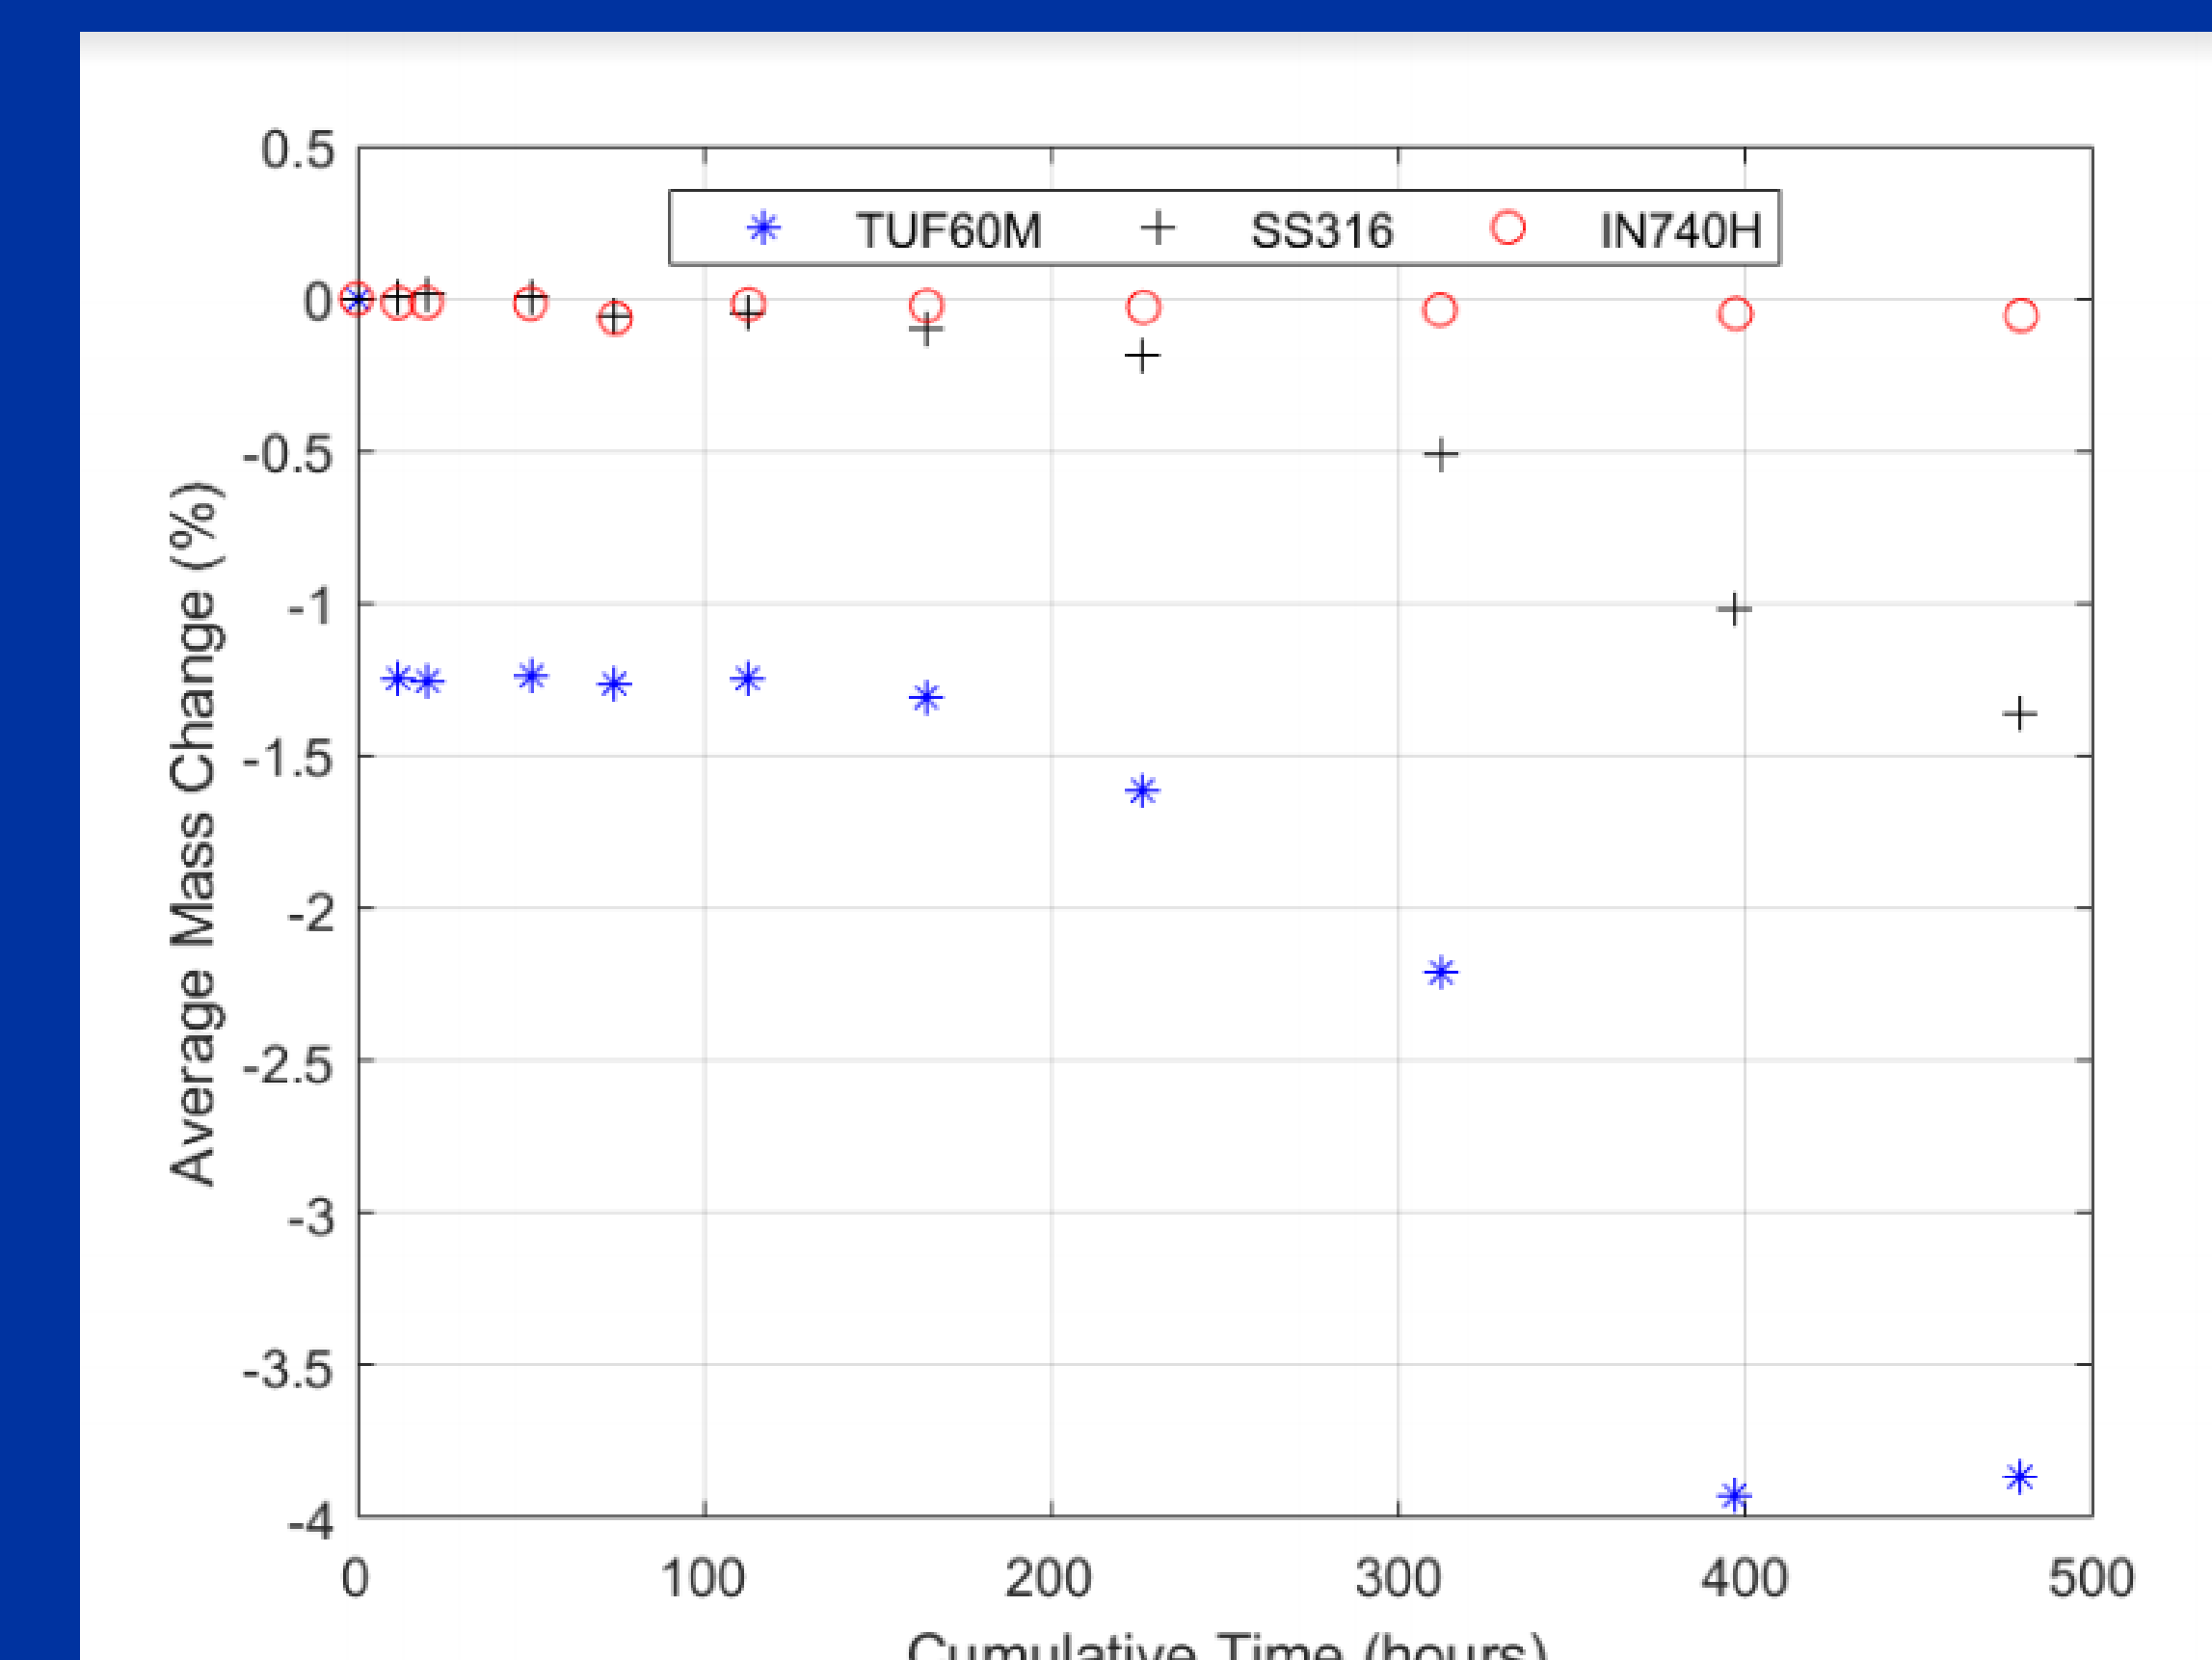
Figure 4: Average percent mass change vs. cumulative time for HSP40/70 particles at high temperature.

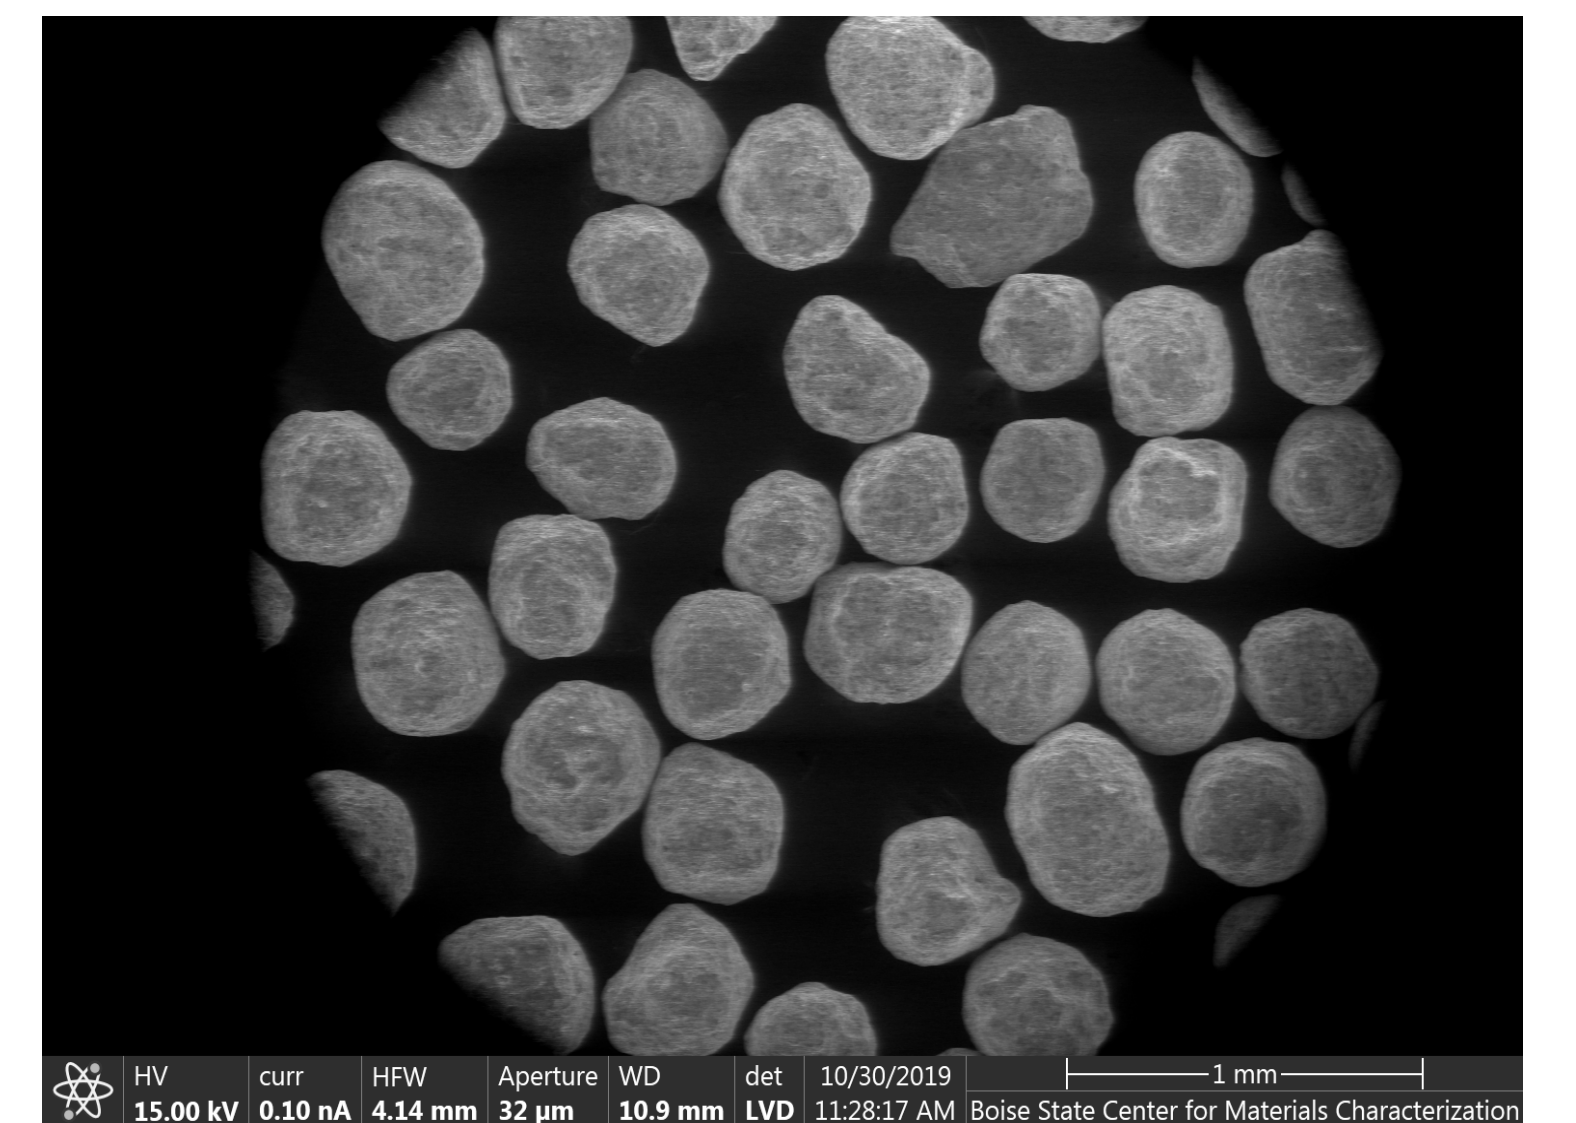
Figure 6: SEM image of HSP40/70 particles.

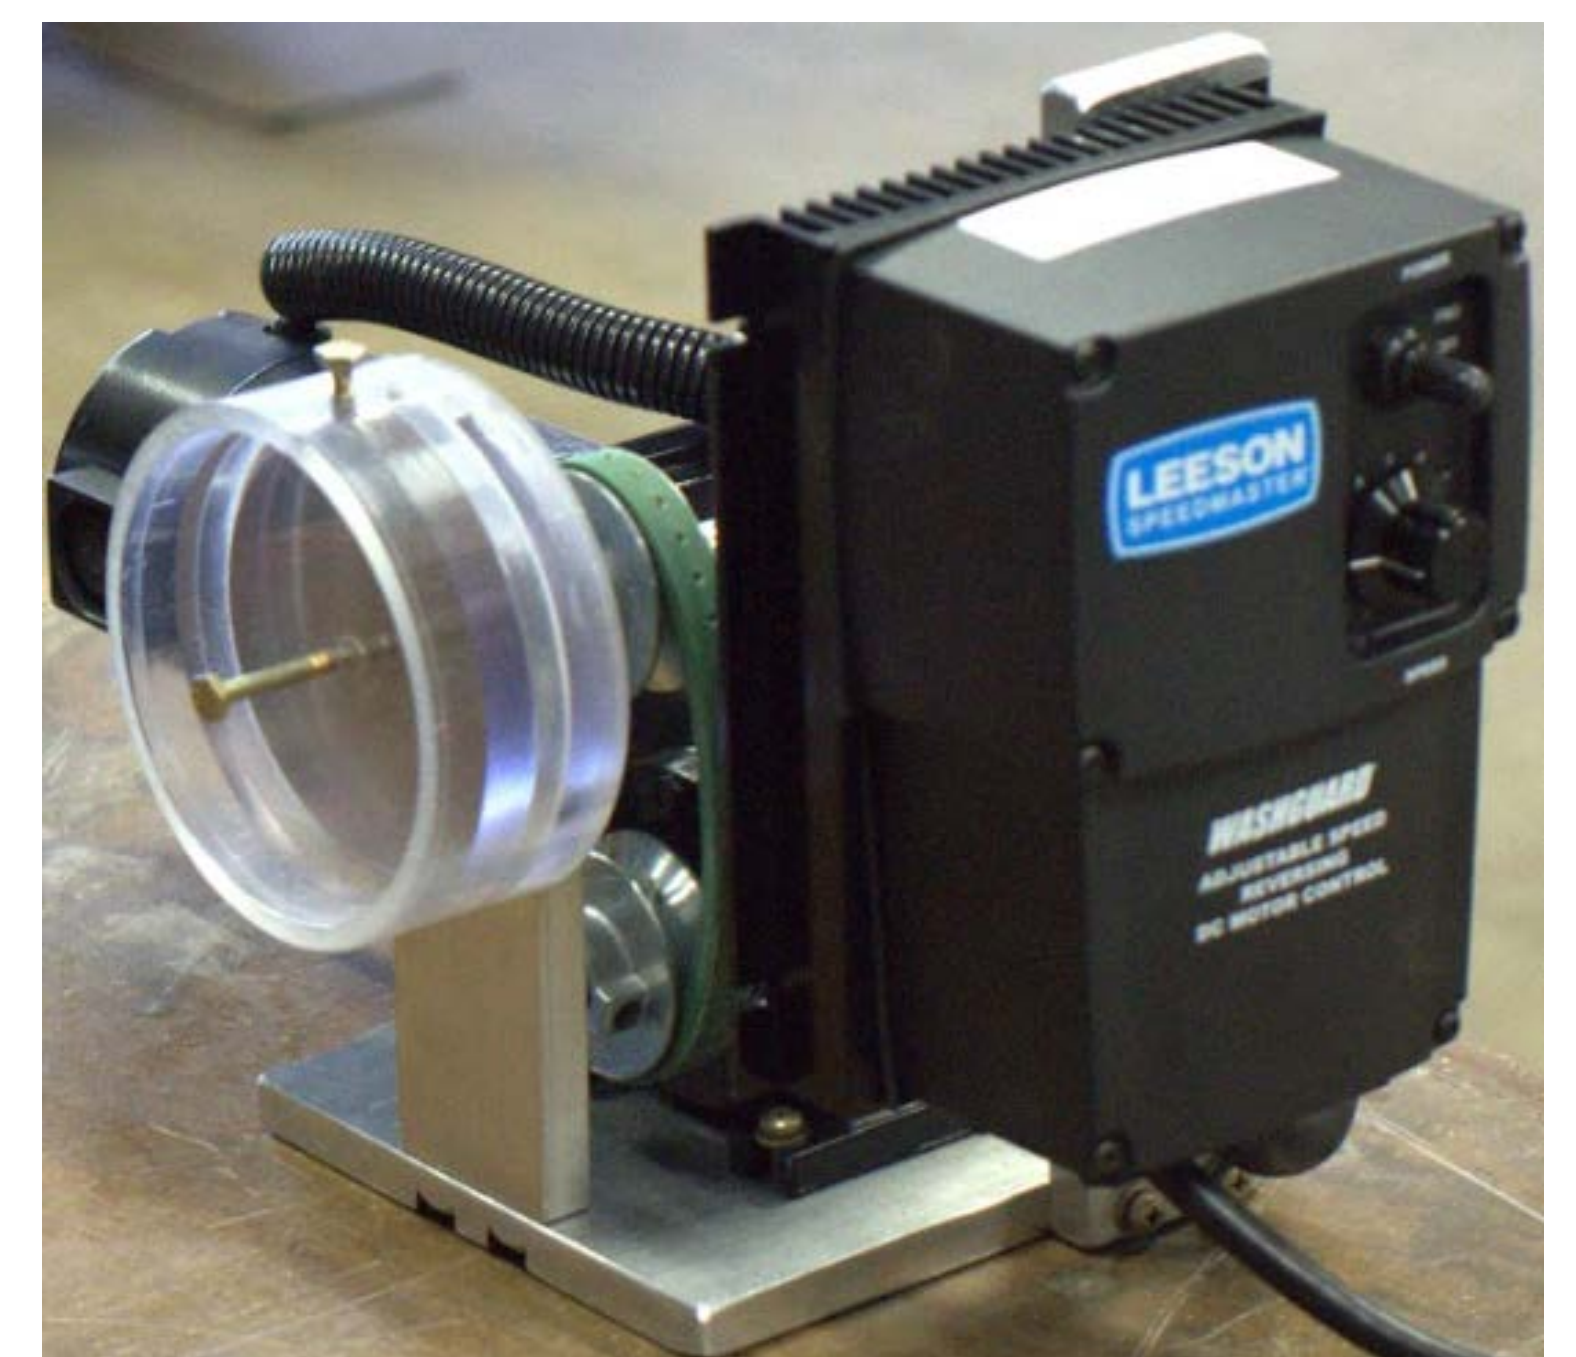
Figure 7: Attrition apparatus.

Particle attrition was measured by placing sample particles onto a rotating disk, forcing them to grind against each other (Figure 7). Sieves were then used to find the size distribution of the particles and determine how the particles break down with respect to time. The change in size distribution is the primary data for measuring attrition.

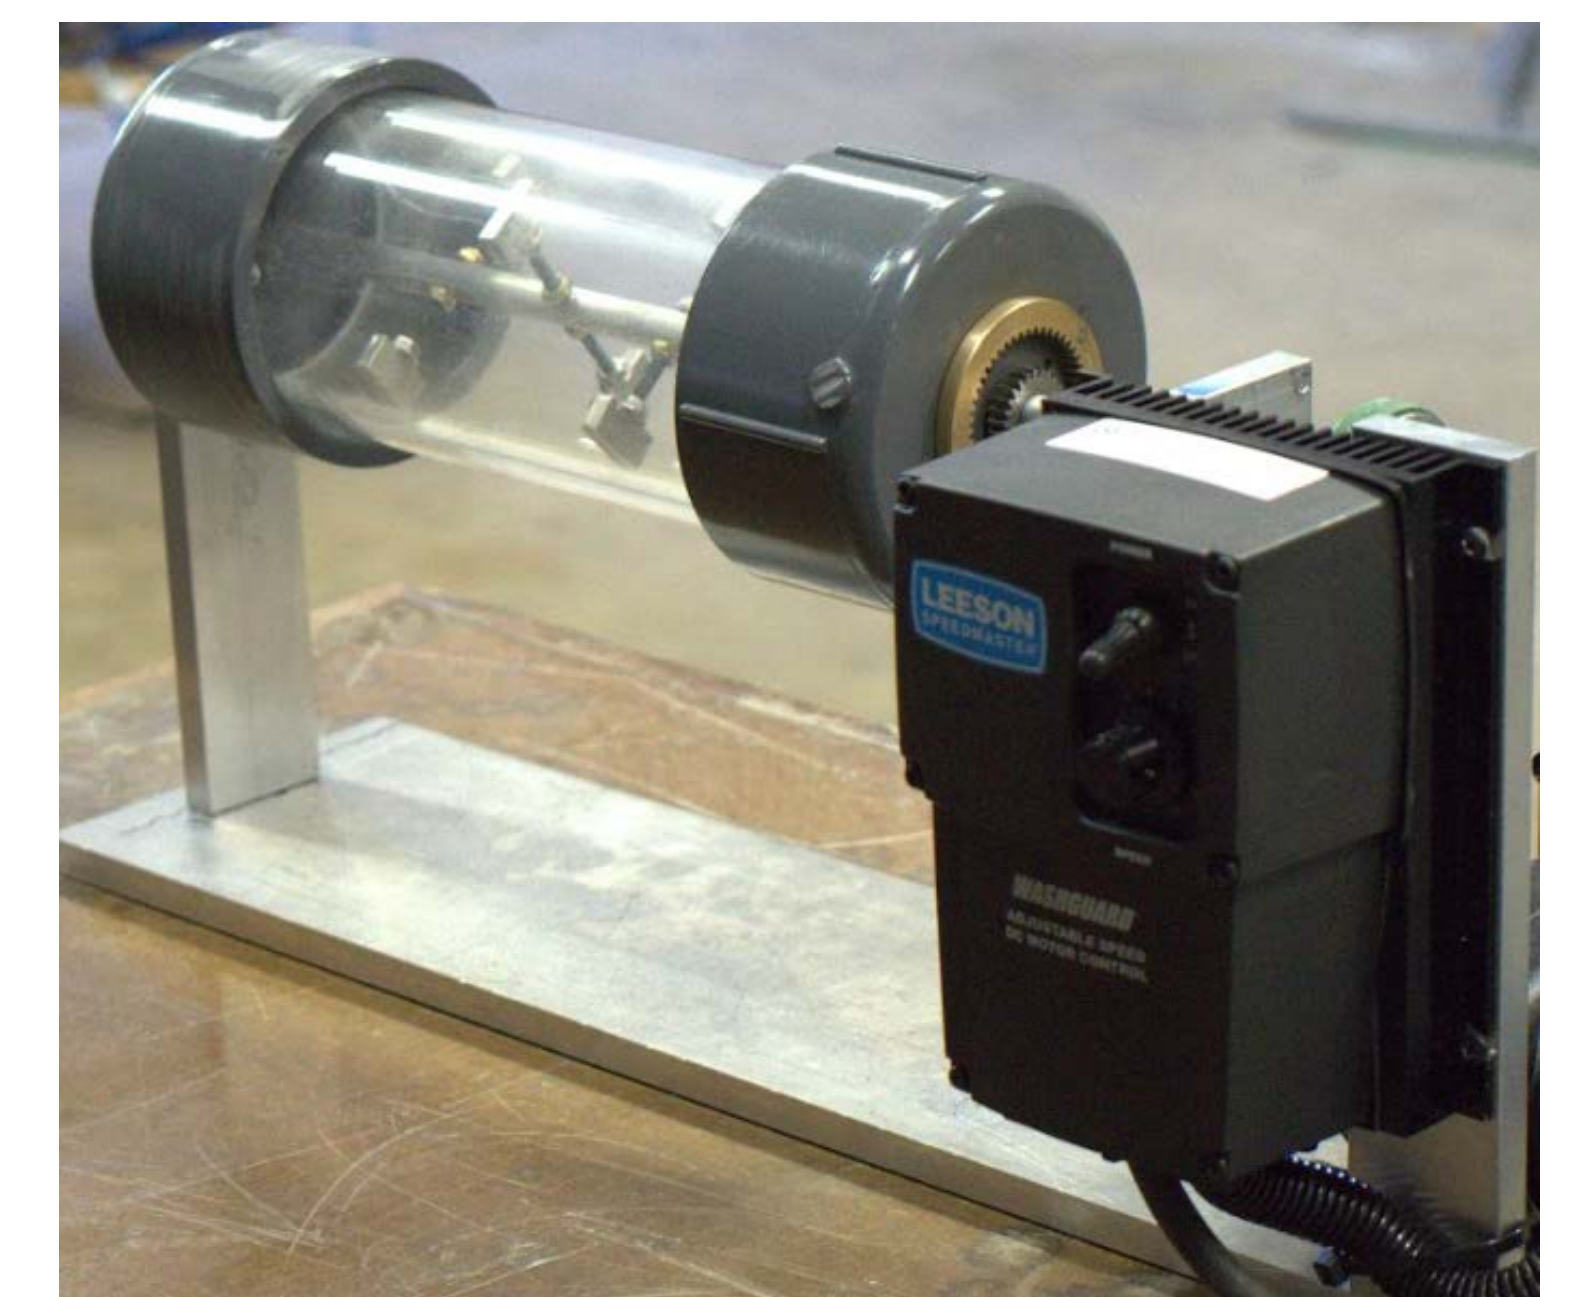
Figure 8: Abrasion apparatus.

Material abrasion was measured by rotating material samples through a bed of particles (Figure 8) and measuring how the surfaces of the samples degrade with time. Each experiment, the mass of the samples was measured to determine the percent mass loss. The percent mass loss is the basis for determining how the material abrades.
