## **Bench-Scale Investigation of Remote Detection of Clay Pockets in Granular Soils**

# Bench-Scale Investigation of Remote Detection of Clay Pockets in Granular Soils

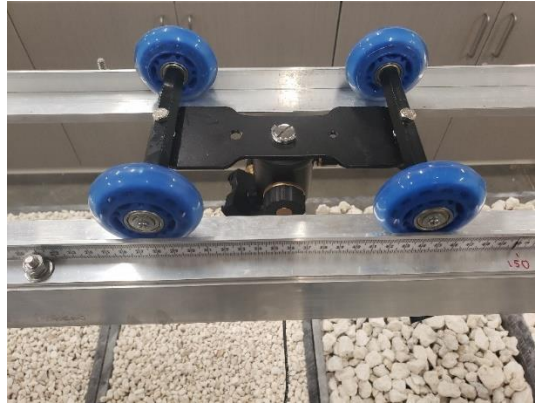
**Figure 2. Rail system and trolley for mounting imaging equipment.**

**Digital Imaging.** A Canon EOS DSLR 200D with an 18-135 mm variable focal length lens was used for the digital imaging. Digital imaging consisted of collecting single overlapping images of the surface of the granular soils within the bins and then developing a single orthomosaic image. The DSLR camera was attached to a trolley using a camera mount and incrementally moved along the rail system to obtain the overlapping images. Multiple camera passes with the rail system near the left and right edges of the bins were required to develop the orthomosaic images.

**Thermal Imaging.** A handheld FLIR E60 thermal camera was attached to a trolley using a camera mount and moved incrementally along the rail system to obtain thermal images. The camera has an image resolution of  $320 \times 240$  pixels. Thermal images were used to determine if the clay pockets could be identified, both at the surface and at depth, based on thermal signatures.

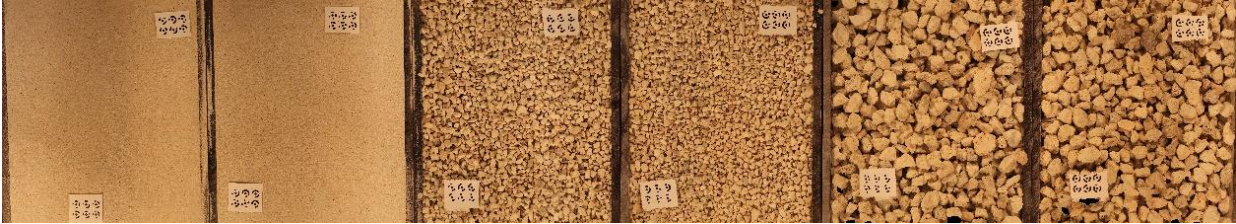
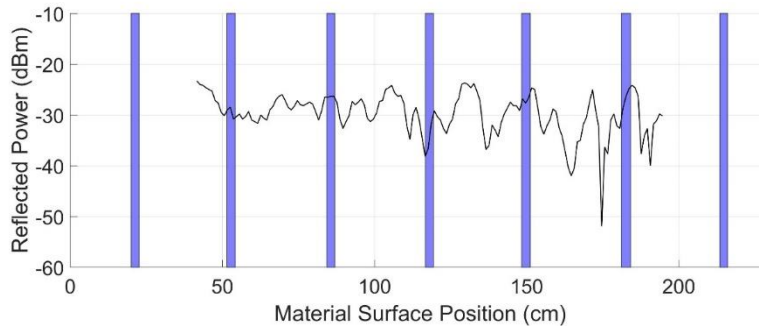
**Figure 4. Results from granular soil imaging.**

**A. Orthomosaic image.**

**B. EM imaging.**

**Granular Soil Imaging.** Baseline imaging was conducted to assess whether the different aggregate sizes could be detected using digital and EM imaging. Results from the two imaging techniques are presented in Figure 4. As expected, it was possible to visually distinguish the three aggregate sizes with digital imaging (Figure 4A). Individual grains could be identified in the pea gravel and the large aggregate, but it was not possible to identify individual grains within the sand.

The EM imaging (Fig. 4B) is presented as a reflected power value with units of decibels relative to one milliwatt (dBm). The colored lines represent the edges of the acrylic bins. The increased roughness of the aggregate surface presents as an increase in variation of the magnitude of the reflected EM wave (Fig. 4B). Although rearranging the more coarse material changed the locations of maximum and minimum received power levels, the variability and the slight decrease in average received power appeared similar. Rearranging the fine sand had no apparent effect on the reflected EM wave power that was received.

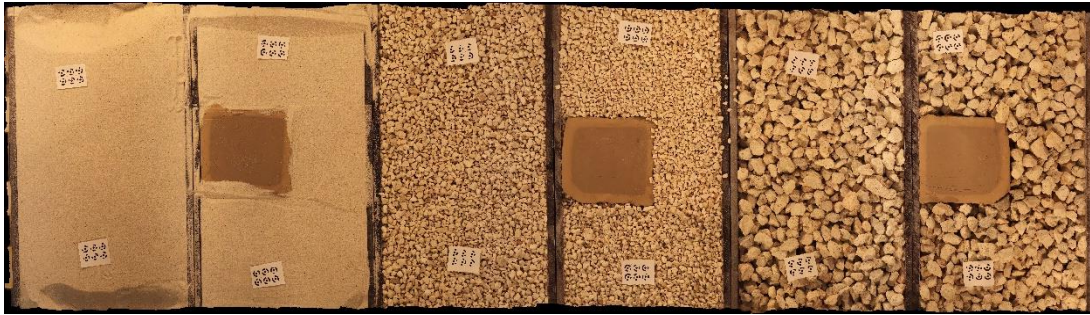
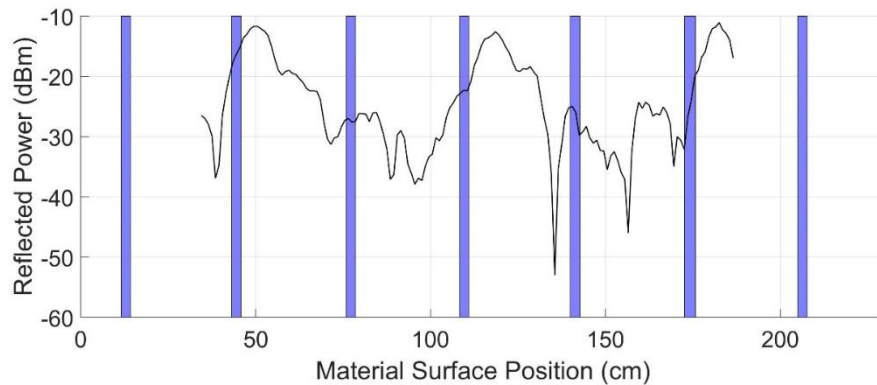
**Figure 5. Results from imaging with clay pockets exposed at the soil surface.**

**A. Orthomosaic image.**

**B. Thermal images.**

**C. EM imaging.**

**Imaging with Clay Pockets Exposed on the Surface.** Digital imaging, thermal imaging and EM imaging were conducted to assess if clay pockets could be detected at the aggregate surface. The clay pockets were 15.24 cm by 15.24 cm by 5 cm thick and centered on the left edge of bins two, four, and six. Imaging results are presented in Figure 5. As expected, using digital imaging (Fig. 5A), it was possible to visually distinguish the exposed clay pockets within the granular soils. The clay pockets have a distinct shape and brown coloring compared to the whitish colored soils.

Thermal imaging was also successful in distinguishing the surficial clay pockets (Fig. 5B). The granular soils were in an oven-dried condition and the clay pockets were moist with a moisture content of approximately 22%. The thermograms clearly show the clay pockets with a cooler temperature than the surrounding dry soil. The resolution of the thermal camera was not high enough to visually distinguish individual particles in the sand and pea gravel.

The EM imaging shows distinct peaks in the reflected power for the surficial clay pockets for all soil sizes. The sand had a reflected power of approximately -30 dBm. The pea-gravel had an average reflected power of approximately -26 dBm. The large aggregate had an average reflected power of approximately -35 dBm. Regardless of the soil size, the reflected power from the clay pocket peaked at approximately -11 dBm.

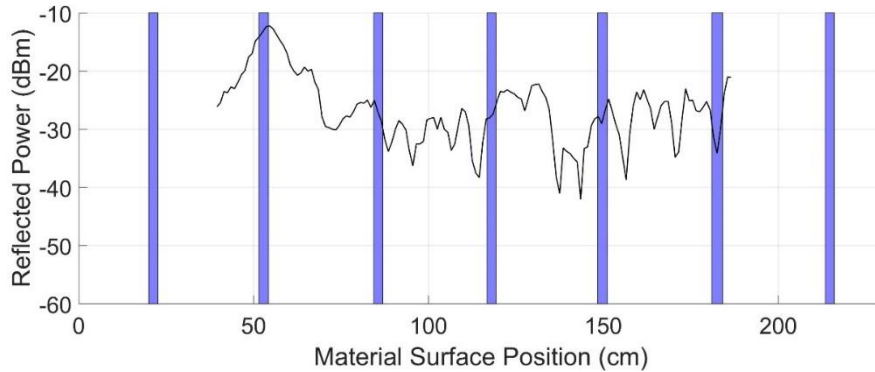
**Figure 6. Results from imaging with clay pockets beneath the surface.**

**A. EM imaging with clay pocket at 2.5 cm depth.**

**B. EM imaging with clay pocket at 15.2 cm depth.**

**Imaging with Clay Pockets Beneath the Surface.** Thermal and EM imaging were conducted to assess if the clay pockets could be detected below the surface of the granular soils. Surprisingly the thermal imaging was not successful in detecting the clay pockets when buried 2.5 cm beneath the surface of the soils. Figure 6 shows the results of the EM imaging with the clay pockets centered on the left edge of bins two, four, and six at depths of 2.5 cm and 15.2 cm.

When buried at a depth of 2.5 cm, the clay pocket was identifiable in the sand. The reflected power was similar to the reflected power obtained from the clay pocket at the surface. There was a reduction in reflected power from buried clay pocket in the pea gravel, but the reflected power was -22 dBm whereas the reflected power received when the clay pocket was at the surface was -11 dBm. The results were inconclusive for the large aggregate.

When buried at a depth of 15.2 cm, the clay pocket was still identifiable in the sand. The results were inconclusive for both the pea gravel and large aggregate. As the clay was buried at greater depths the distance traveled by the trolley was reduced because the incident angle of the EM wave meant the clay was imaged from a progressively earlier trolley position. This explains the shortened graphs.
