FULL-SCALE STUDY OF INFRARED THERMOGRAPHY FOR ASSESSING
SURFACE AND SUBSURFACE DEFECTS IN PAVEMENTS AND OTHER CIVIL
INFRASTRUCTURE

Master of Science in Civil Engineering

Boise State University

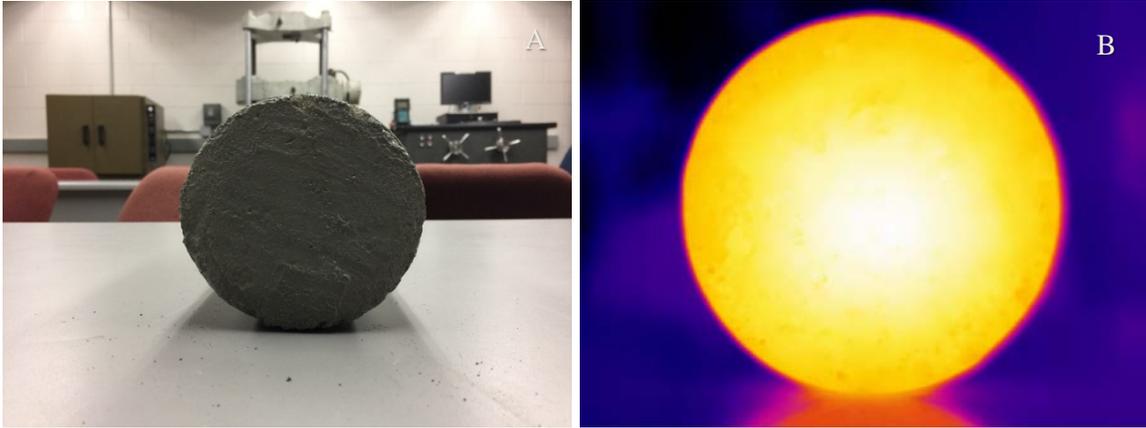
The visible image of the specimen is shown in Figure 2-1(A). The thermal image of the same specimen is on display in figure 2-1(B). Note the temperature difference at the bottom of this image, right under the cylinder, is simply the reflection of the heat from the surface of the table. There is one 4 by 4-cm³ Styrofoam cube used as a delamination that is placed at 2 centimeters deep inside the specimen. The surface is heated up to 45 degrees Celsius. The temperature of the surface that is located on top of the delamination is visibly higher than the sound area that helps us to estimate where the defects are inserted. However, the heat is expanded in a wider area than the actual size of the delamination underneath the surface. As already mentioned, the surface on top of the delamination has a higher temperature. Since concrete has a low heat conductivity, the heat will be trapped in the body of the specimen and there will be a temperature difference between the delaminated area in the middle and the edge of the specimen, which is more exposed to the surrounding air. A similar method of inspection is used inside industrial plants (Harishkumar et al. 2014). Due to this temperature difference, heat defuses from the delaminated area towards the boundary that is colder. This is one reason why the area with a higher temperature is wider than the area of the delamination itself inside the specimen.

Figure 2- 1. (A). Visual image of the specimen, (B). Thermal image of specimen with defects that are inserted in the depth of 2 centimeters (Heated up using heat blower)

Using the type of the thermal camera that we have for this experiment, we can detect defects clearly under the concrete surface up to a depth of 2 centimeters.

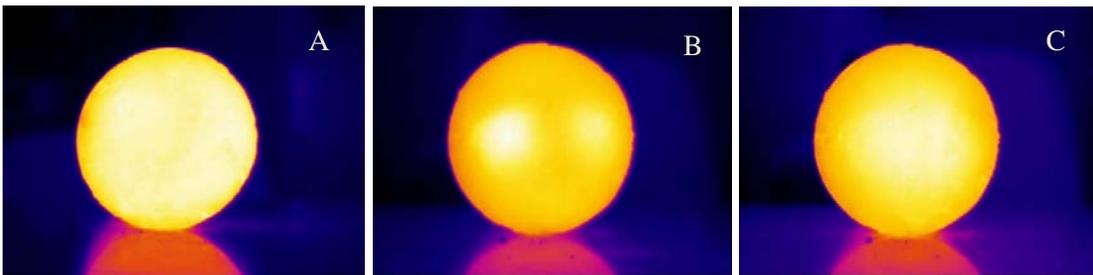
Figure 2- 2. (A). Specimen with defects that are inserted in the depths of 5 and 10 millimeters (Heated up using an oven), (B). Specimen with defects that are inserted in the depth of 5 and 10 millimeters (Heated up using heat blower) – Image is taken 2 minutes into the cooling cycle, (C). Specimen with defects that are inserted in the depth of 5 and 10 millimeters (Heated up using heat blower) – Image is taken 20 minutes into the cooling cycle

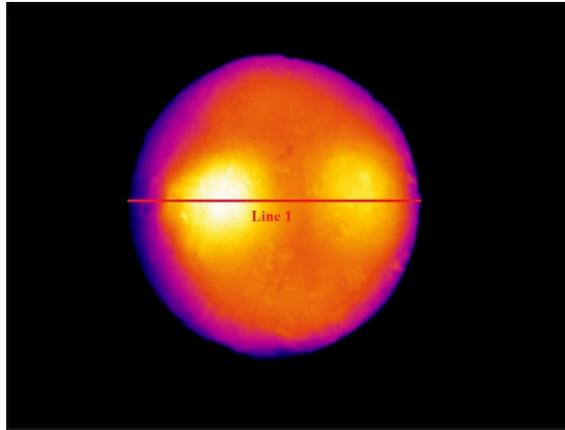
A graph is plotted using the temperatures that are assigned to each pixel on line 1 (shown in Figure 2-3) that is put in the middle of the surface of the specimen. This line intersects the areas with the most temperature gradient inside the IR thermal image. By using this line, we can get the temperature of each pixel located on these areas.

Figure 2- 3. Line 1 is used to plot a temperature related graph of the surface of the specimen

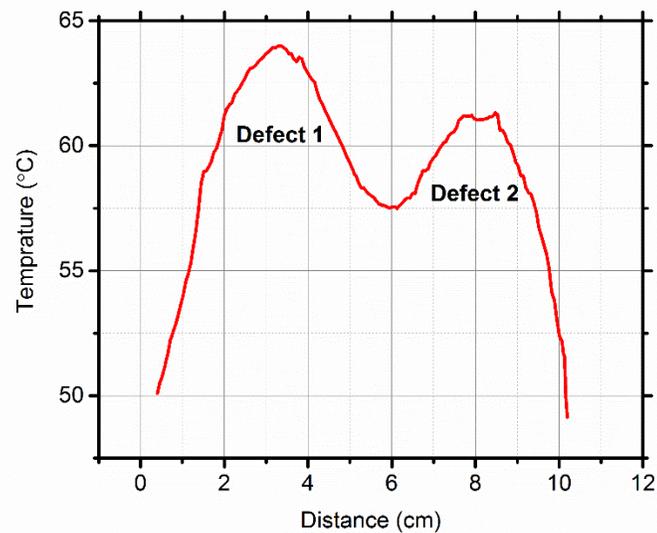
As is shown inside the graph (Figure 2-4), the location of each defect is visible with a very good accuracy. It is also clearly visible that there is a depth difference between the two defects by judging the temperature difference on Y-axis. The pattern inside this graph shows a clear connection between the depth in which the defect is located underneath the surface and the amount of temperature that is reflected from the top of the surface. In the graph, we can clearly see that there is 2 degrees Celsius temperature gap between defect 1, which has the temperature of about 61.5 degrees Celsius, and defect 2, which has the temperature of about 63.5 degrees Celsius.

Figure 2- 4. Temperature versus distance graph assigned to line 1 in Figure 3

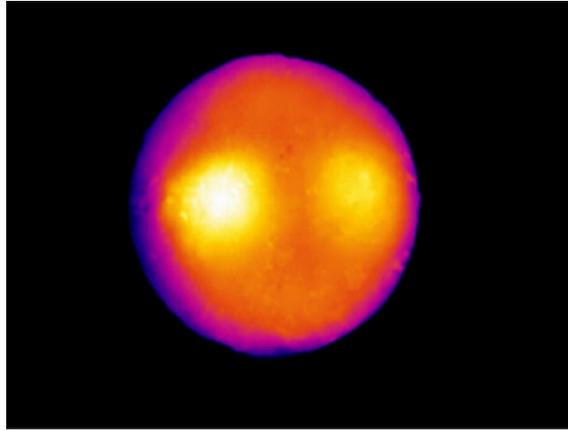
filter only manipulates the coloring that is assigned to each temperature pixel that results in a sharper and clearer temperature contrast inside the image (Figure 2-5).

Figure 2- 5. Thermal image after application of color filter

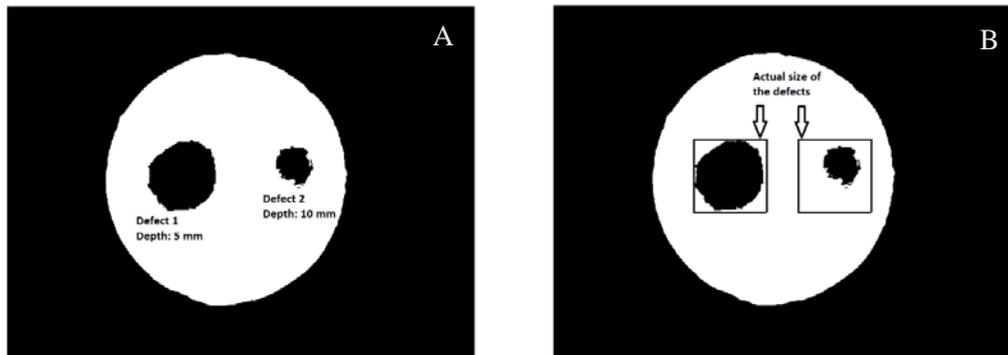
the heated area exceeds the actual area on the left side. This can be due to the heat diffusion that is caused by the temperature differences between the boundary of the cylinder and the middle part of it where the defects are located.

Figure 2- 6. (A). Processed image using a 37 degrees of Celsius threshold, (B). A comparison between the actual size of the delamination and its size in the processed image

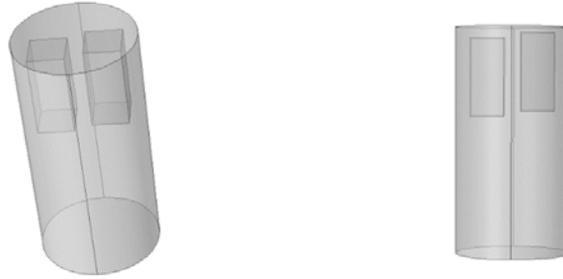
Heat transfer in solids is simulated inside the computer to further understand the IR test setup (Cannas et al., 2012). Concrete is the main material and Styrofoam cubes are used as for the defects underneath the surface. A heat source of 300 watts per meter cubed is applied on top of the concrete in a uniform pattern and the bottom side was kept at 0 degrees Celsius to see the heat diffusion inside the model (Figures 2-7 and 2-8). The defects are of the same size as the defects in our experimental model and they are put in the same exact depths as well.

Figure 2- 7. Defects location in the software model

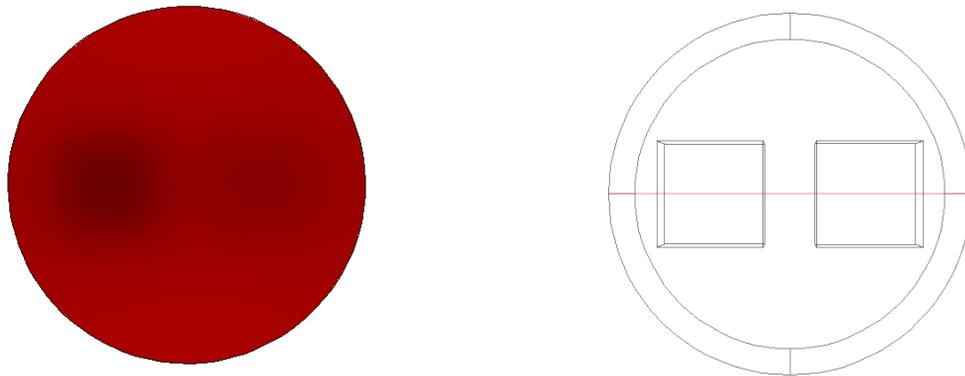
As it is shown in Figure 2-8, a guideline is put on top of the model that covers the surface on top of the defects and their surrounding sound areas. This line was used to extrapolate a temperature-distance graph from the model. This will help us to detect the defects underneath the model as we did in the actual experimental test and it helps us to learn about the depth difference between the two delaminations by using the data that is shown inside the graph.

Figure 2- 8. Line that is used to plot a temperature related graph of the surface of specimen

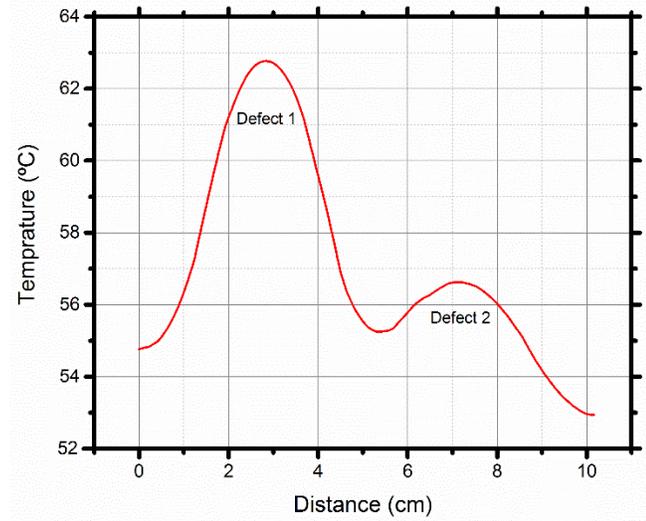
experimental test was not uniform, the heated areas are different in the software results from the actual experimental results especially on the deeper defected area.

Figure 2- 9. Temperature-length graph assigned to the line in Figure 2-8

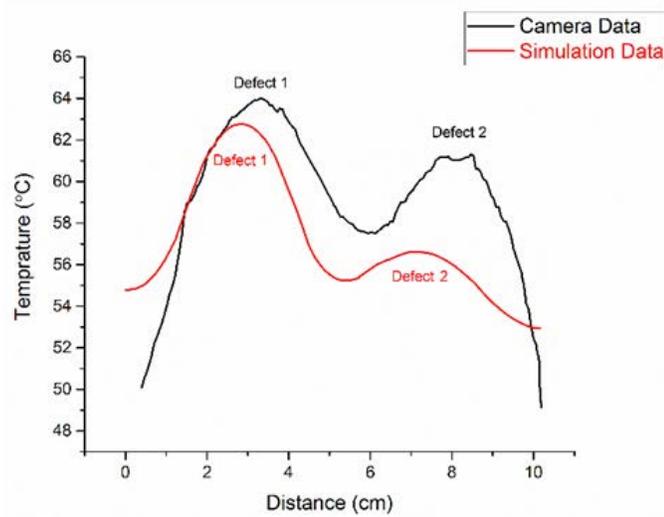
heating process, which was done using a heat blower, was not performed in a uniform manner.

Figure 2- 10. Comparison between the location of defects on both camera and software graphs

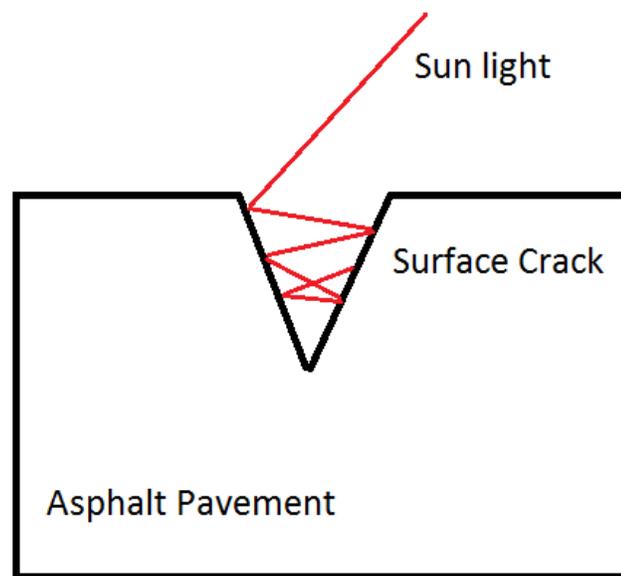
Both active and passive IRT processes rely on the temperature gradient of the surface of the target. This gradient is caused by the back and forth bouncing of the sunlight inside the crack, which eventually heats up the walls of the crack and makes the temperature elevate, as shown in Figure 3-1 (Sham et al. 2008).

Figure 3- 1. Surface delamination temperature gradient

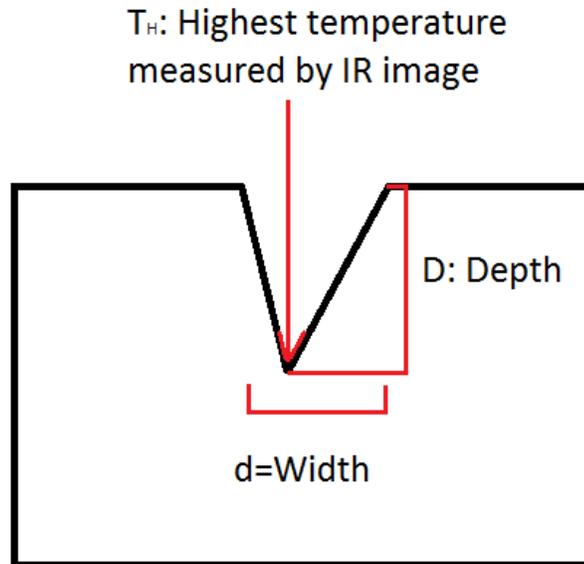
Width and depth, as two of the major components of crack profile, are two of the effective factors on the temperature gradient which is present within a pavement delaminated surface. Figure 2 illustrates how width and depth of the crack are measured in the field. The width is considered as the distance between the two edges of the opening mouth of the crack. The depth is the measurement of the distance between the top edges of the crack to the lowest section of it.

Figure 3- 2. Correlation between depth and width and temperature

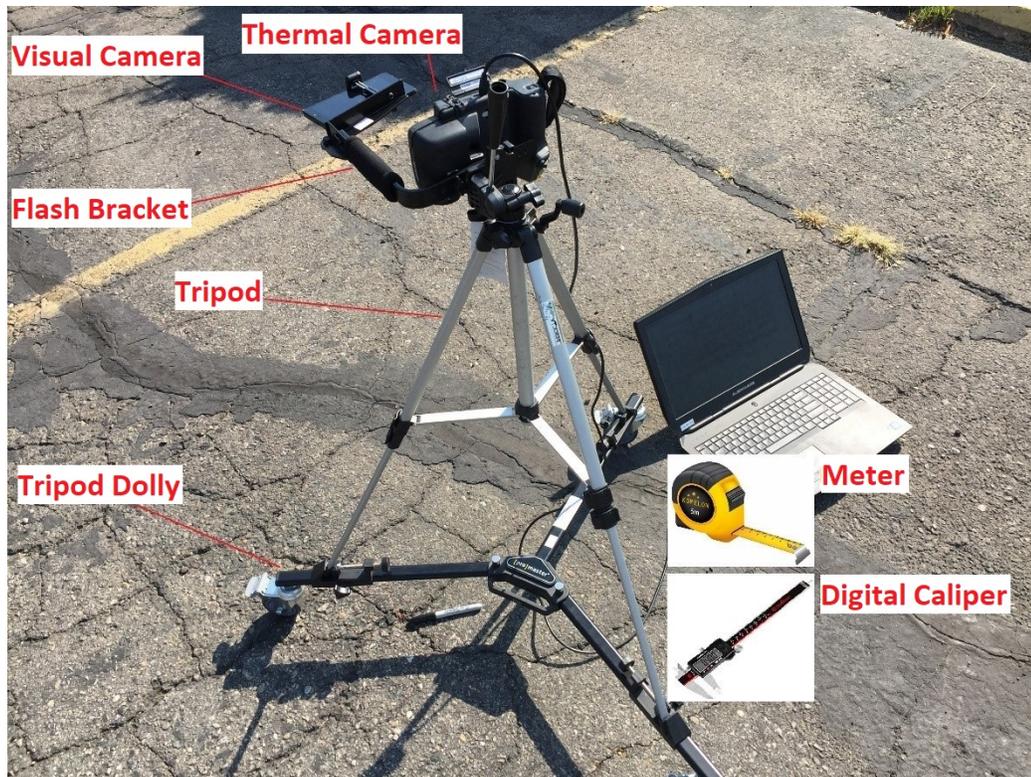
In order to locate the delaminated areas on top of the asphalt domain by capturing the temperature gradient on the surface, the raw collected image data must be processed using a processing algorithm which will be discussed in the next section of this paper. This processed image consists of a visual image and a thermal image which have been aligned on top of each other in the post-processing section of the research. The camera setup which can capture both thermal and visual images simultaneously is shown in Figure 3-3.

Figure 3-3. Mobile thermography testing setup

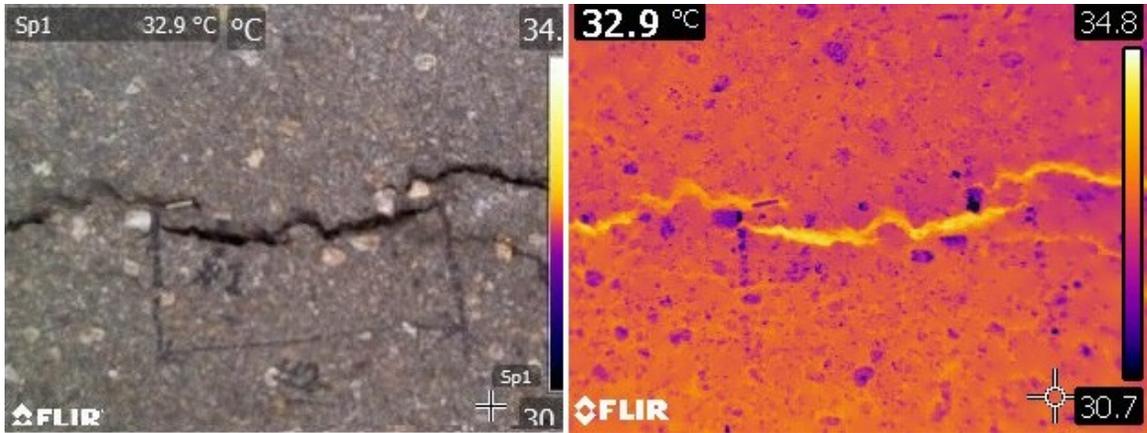
In the following, the premise of the processing algorithm will be discussed and the employment of the algorithm on each frame that was collected using the camera setup will be fully explained. In Figure 3-4, the visual and thermal frames that are collected from the surface of the road are shown. These images were taken on a relatively hot day from the surface of a sidewalk.

Figure 3- 4. Visual versus thermal images

The Luminosity Method is a transition between the raw thermal image (Figure 3-4) and the processed image (Figure 3-5). During this transition, colored images are converted into grayscale images. Later on, a number of thresholds, known as gray thresholds, will be assigned to these grayscale images. Each image is constructed of 255 different thresholds and each of these thresholds are assigned to a specific temperature. In this image, Figure 3-4, a gray threshold corresponding to 33 degrees Celsius, is used to get the best contrast between the delaminated area and the sound area (Lu et al. 2017). By choosing this threshold, all the pixels that have a measured temperature less than the indicated corresponding temperature will be eliminated from the image (Ibarra-Castanedo 2004). Therefore, this can clarify the area of the delaminated surface for further study inside the computer (Neal 2016). Figure 3-5 shows the processed image after employment of the threshold using our developed code.

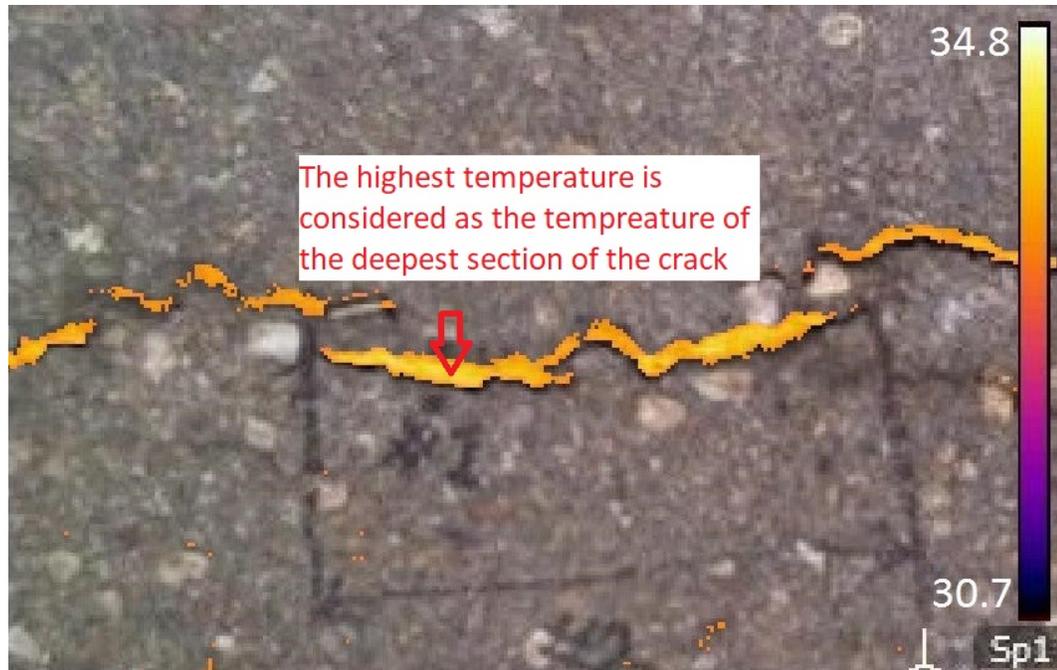
Figure 3- 5. Processed image

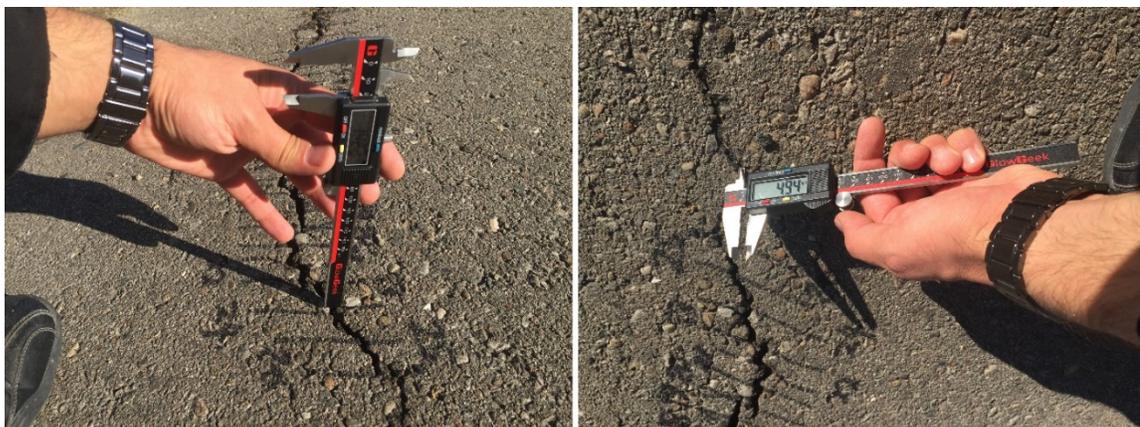
In this research, a number of data from roadways have been gathered to address different aspects of IRT. In order to construct the crack profile, depth and width of crack is measured using a digital caliper (Figure 3-6).

Figure 3- 6. Measuring depth and width of crack using digital caliper

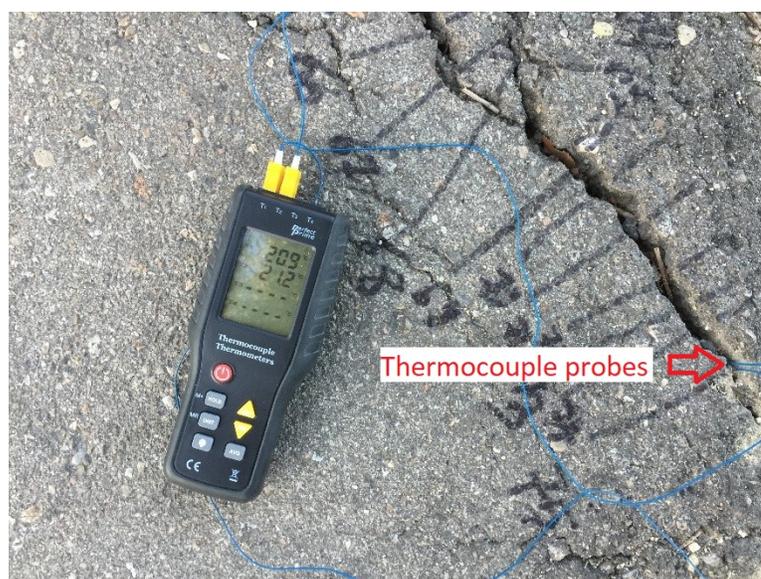
Different means have been used to calculate temperatures in the field. The ambient air temperature is collected from the weather information of the nearest weather station. A thermocouple is used to calculate the temperature of the bottom of the crack, as shown in Figure 3-7. This data is used to calibrate and confirm the temperature data that is collected from the thermal camera.

Figure 3- 7. Thermocouple is used for measuring the mean temperatures inside cracks

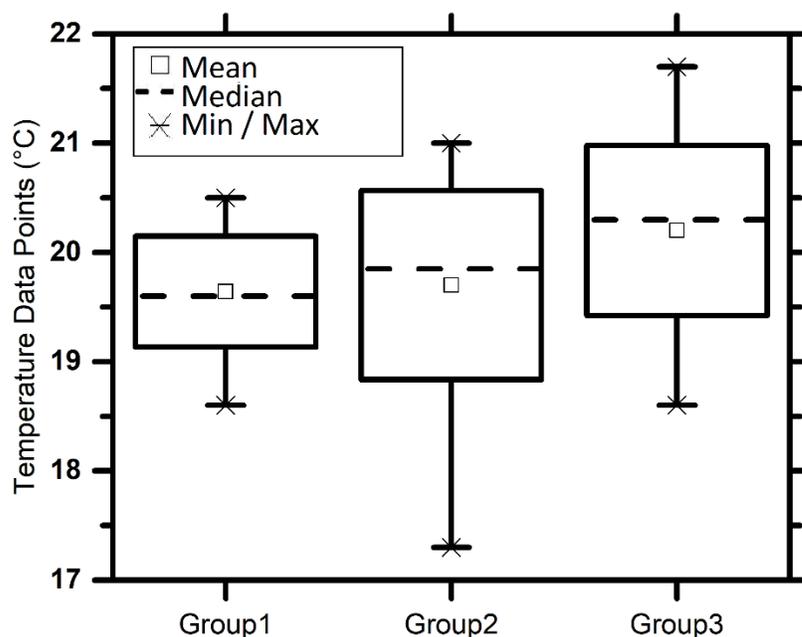
As mentioned in an earlier section, the ANOVA method has been used to study the relationship between the means of the temperatures that have been collected during different days and under different weather conditions. There are three groups of data available that contain temperature data points that were collected under similar circumstances during the span of two months. These circumstances include, but are not limited to, similar ambient air temperatures and weather conditions. The following box plot shows the result of the ANOVA study for these three groups.

Figure 3- 8. Boxplot of temperature data points which are separated into three groups with similar ambient air temperatures and weather conditions

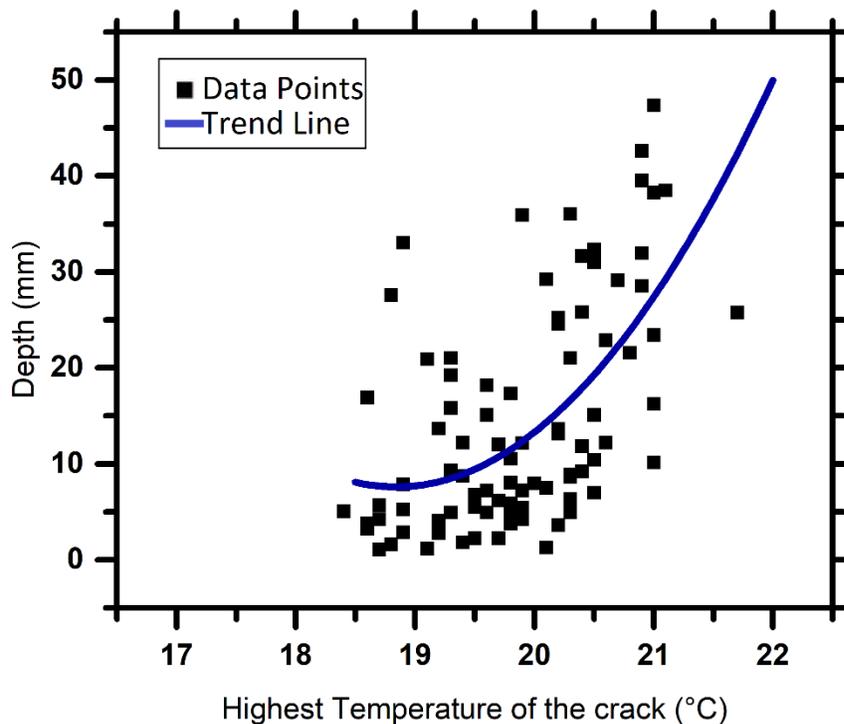
using a regression test. As is shown in this graph, the minimum temperature that is recorded from the field is 18.4 degrees Celsius and the maximum temperature is 21.7 degrees Celsius. The depth of cracks vary from 1.1 millimeters up to 47.4 millimeters and the majority of the depth measurements are between 1 to 10 millimeters. The adjusted R^2 for this line, which is a representation of the coefficient of determination, is close to 35%. This indicates that the trend line that is correlating the depths and temperatures of the cracks has a relatively low accuracy.

Figure 3- 9. Relationship between depth and the highest temperature that is recorded from the crack

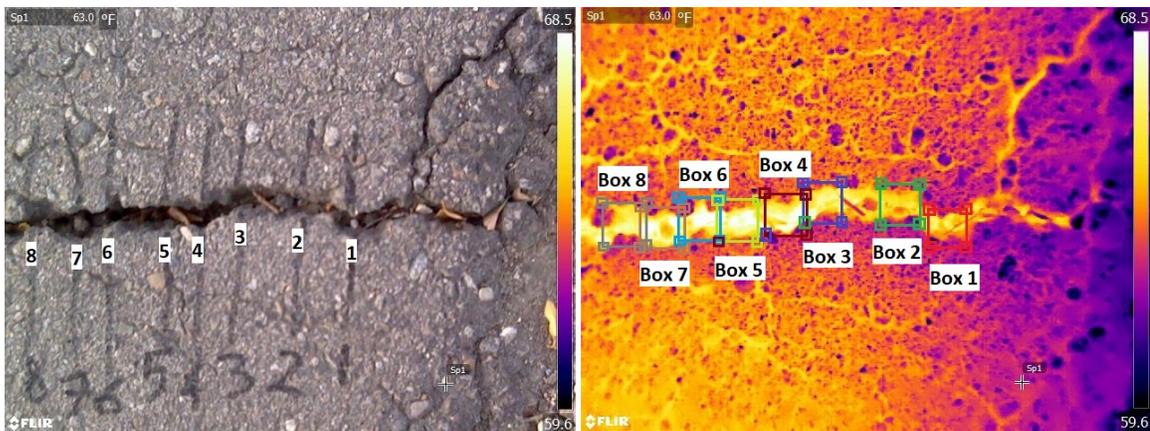
$$\text{Point-wise normalized temperature} = \frac{\text{Individual crack temperature}}{\text{Average of ambient surface temperature}} \quad (3-6)$$

Figure 3- 10. Calculation of the average ambient surface temperature

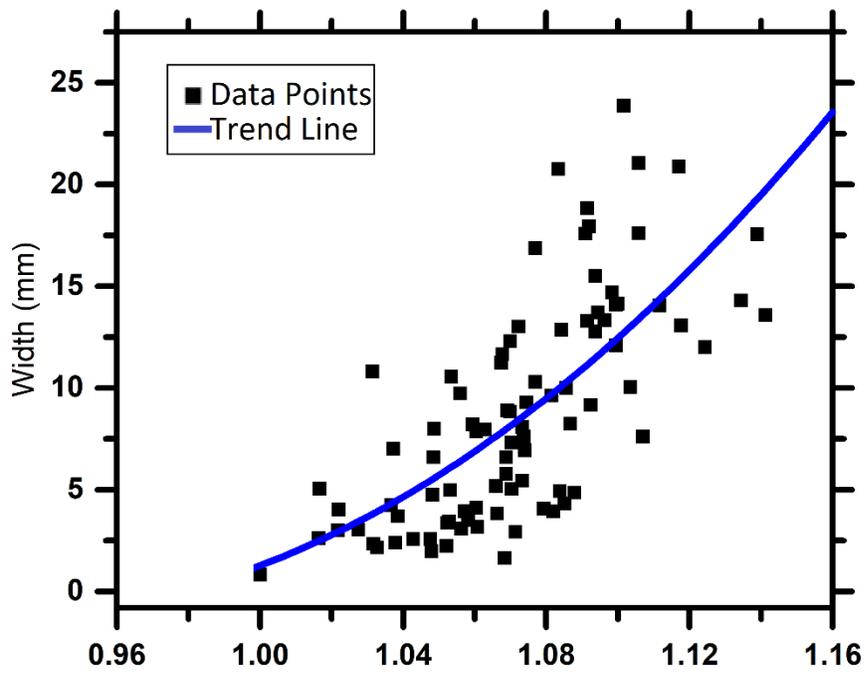
The point-wise normalized temperature was first compared with the measured width of each data point on cracks as shown in Figure 3-11. The correlation between the two entities is illustrated in this figure. The minimum point-wise normalized temperature is calculated to be 1 and the maximum point-wise normalized temperature is calculated to be 1.14. The minimum point-wise normalized temperature will never become less than 1 as it is clearly shown in the graph. This is because the temperature of the crack is equal or higher than the temperature of the surrounding sound area during the cooling cycle. The width of cracks varies from 0.85 millimeters up to 24 millimeters. A correlation can be observed between widths and point-wise normalized temperatures but the adjusted coefficient of determination (R^2) for this trend line, which is equivalent to its accuracy, is around 50 percent. This means that the data points are relatively scattered in this correlation study.

Point-wise normalized temperature based on ambient surface temperature

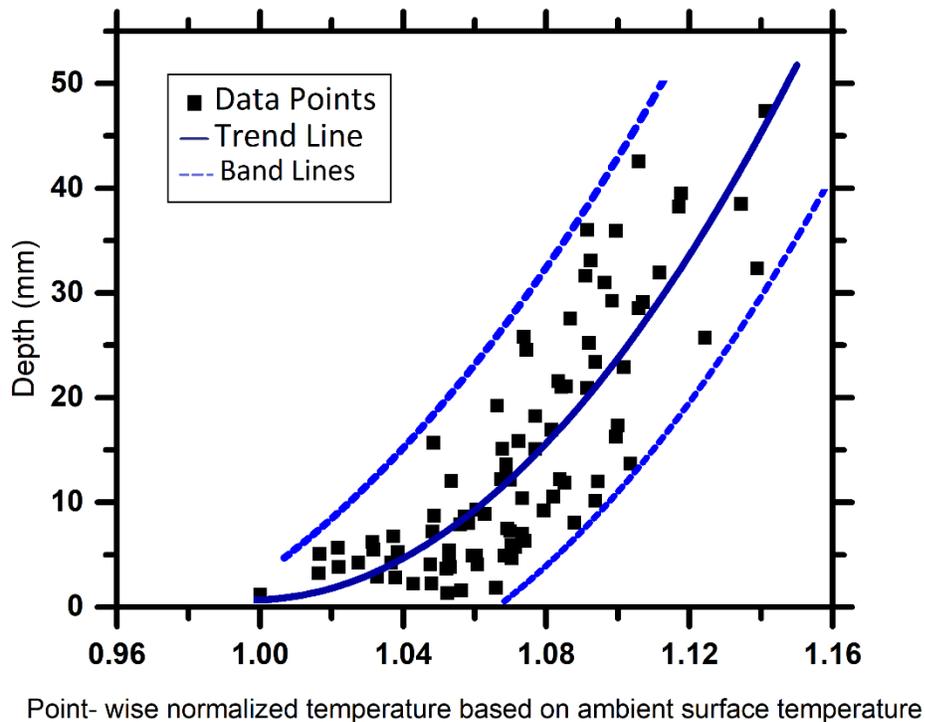
The corresponding equation for this trend line is $Y=2193X^2-4375X+2182$ and the adjusted coefficient of determination (R^2) for this trend line is 70.06%. In this equation Y represents the depth and X represents the point-wise normalized temperature of each data point on the crack. This trend line is a more accurate representation of the data and shows that as the temperature of the crack, with respect to the ambient surface temperature, increases then the depth of the crack also increases. After plotting the trend line, it is possible to calculate the original temperature by multiplying the point-wise normalized temperature with the mean ambient surface temperature. Therefore, it is reliable to connect each measured temperature of the crack to its corresponding depth data.

Figure 3- 12. Relationship between depth and normalized temperature based on average ambient surface temperature

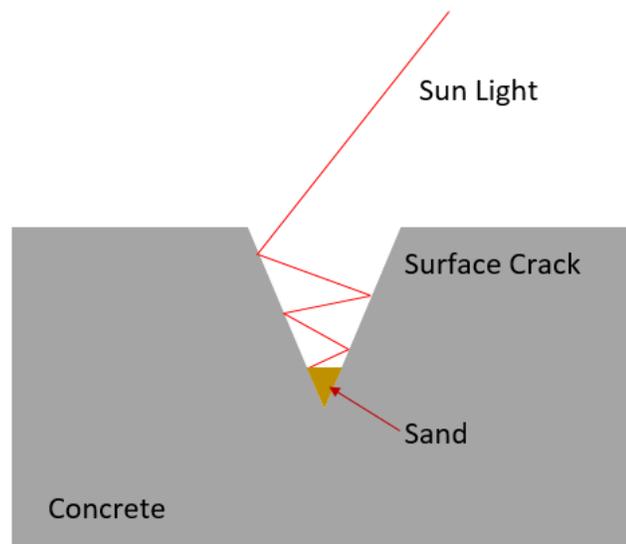
which heats up the walls of the crack and elevates the inner crack temperature (Sham et al. 2008). The other is the difference between the specific heat capacities of dry soil (fine sand) at the bottom of the crack and concrete, $800 \frac{J}{kg^{\circ}C}$ and $900 \frac{J}{kg^{\circ}C}$ respectively (Engineering ToolBox 2003). This shows that concrete has a higher specific heat capacity compared to dry soil, which means the temperature of the fine soil rises up faster than concrete when they are exposed to heat.

Figure 4- 1. Surface crack temperature gradient

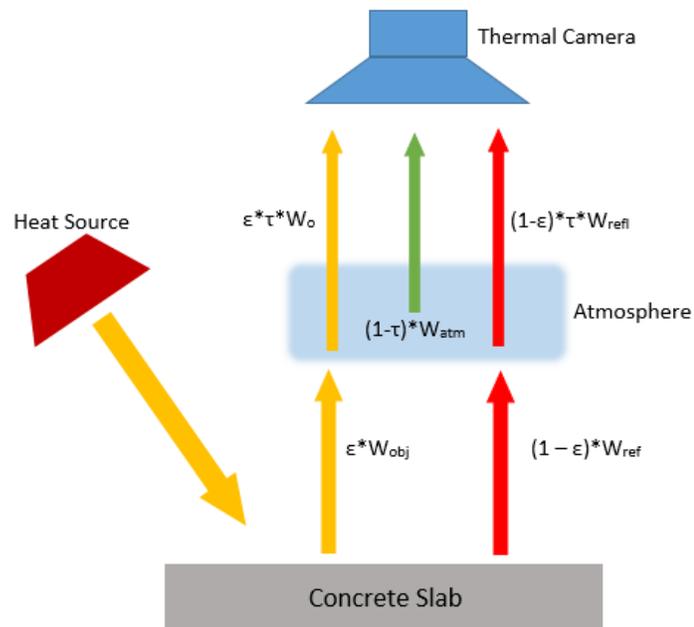
In which τ represents the transmittance of atmosphere. Figure 4-2 is a summary of all types of radiations that the camera is receiving during a heat recording process (Tran et al. 2017).

Figure 4- 2. The temperature reading process of thermal camera in experimental tests

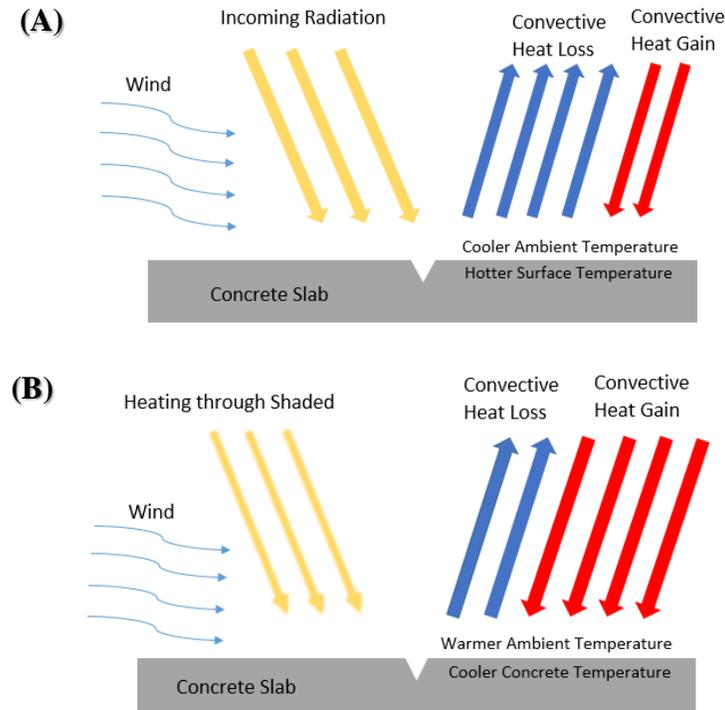
The rate of heat transfer is also affected by the wind. If the surface of the concrete slab has a higher temperature than the surrounding air, then the wind will increase the rate of convective heat transfer between the concrete and the ambient air. Therefore, the wind will decrease the temperature of the surface of the concrete and reduce the effect of radiant heating due to the cooling of the surface (Figure 4-3(A)). This phenomenon can have a reverse effect if the surface of the concrete is cooler than the ambient air, presumably in a shaded area such as the soffit of the bridge or underneath a tree. This means that the wind will expedite the heating up of the surface of the concrete by expediting the convective heat transfer from the hotter air to the cooler surface of the concrete slab (Figure 4-3(B)).

Figure 4- 3. The effect of wind on convective heat transfer on the surface of the concrete A) Under direct sun exposure B) Under indirect sun exposure (Shadow)

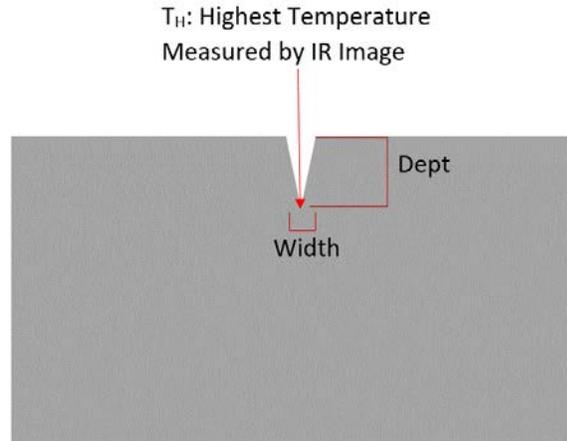
the crack with a very good precision. Figure 4-4 illustrates the measurement of width and depths and temperature of the crack on the surface of the concrete slab.

Figure 4- 4. Width, depth, and highest temperature measurements in surface cracks

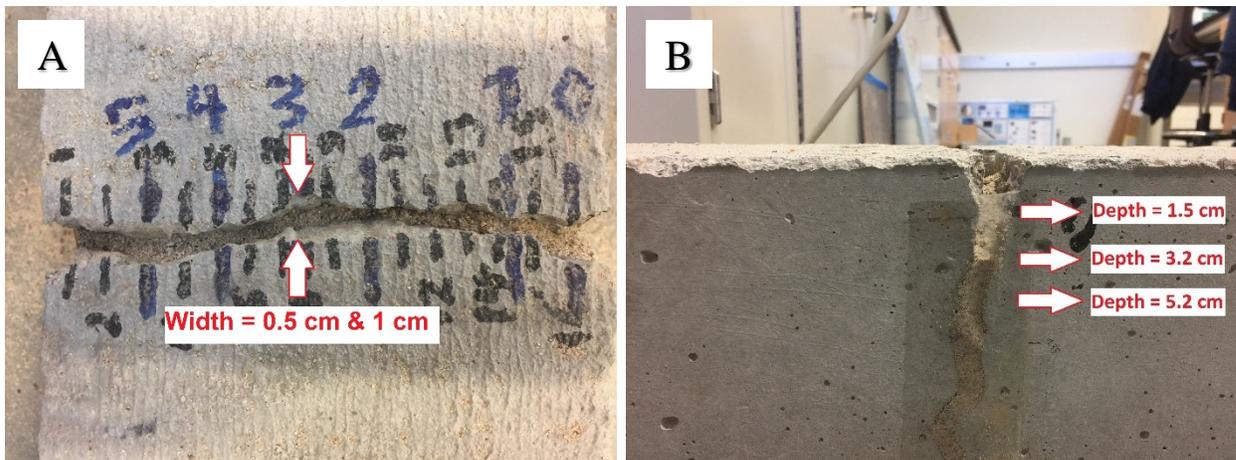
Figure 4- 5. Laboratory crack sample: A: Crack width, B: Crack depth

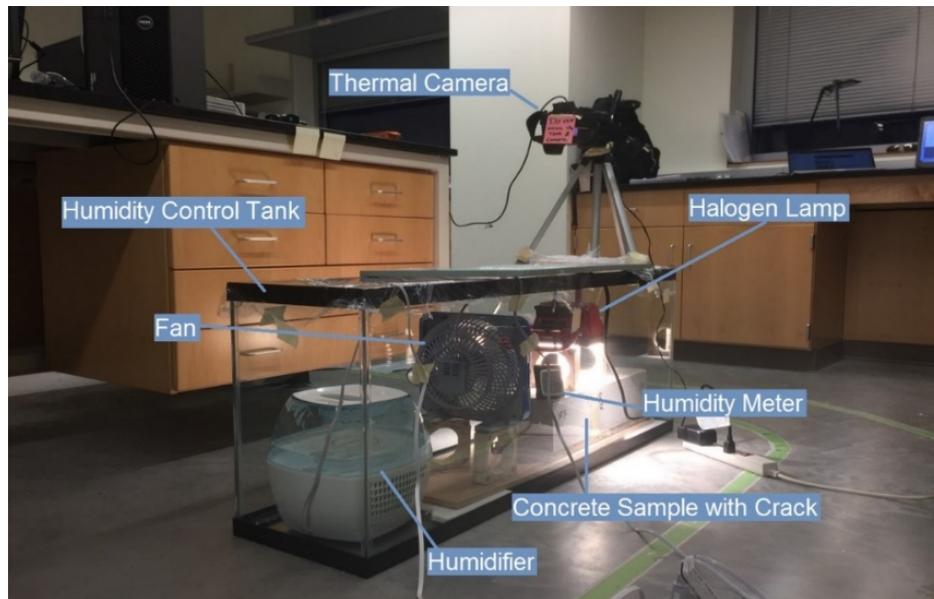
Humidifier and fan are also added to the system, in separate tests, in order to adjust the humidity level of the system and the wind speed respectfully.

Figure 4- 6. Controlled laboratory testing system

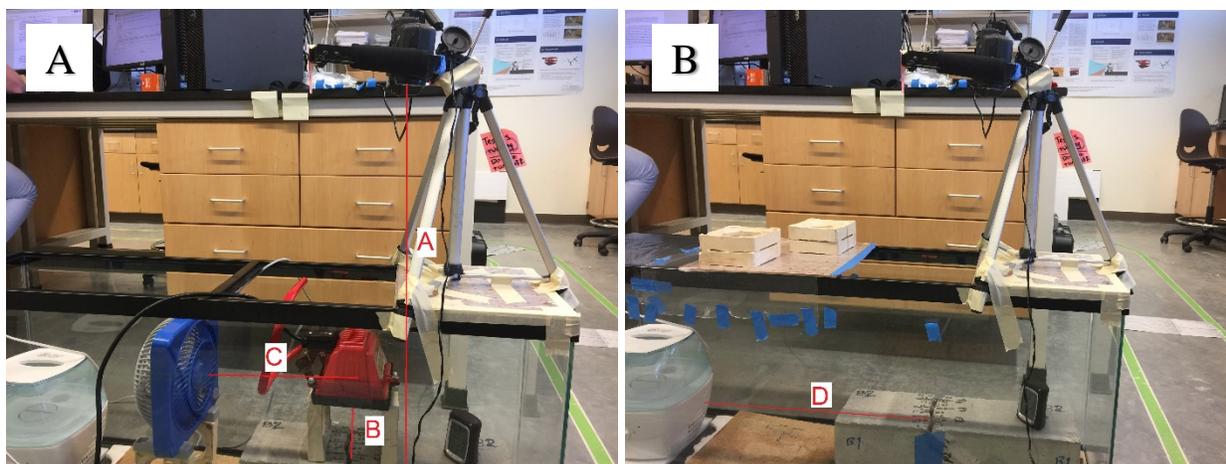
In most of the tests, the wind speed is chosen to be 3.54 m/s, with the distance of 12 inches (30.5 cm) between the fan and the cracked area on the surface of the concrete slab (Figure 4-7(A)). The humidifier is used to elevate the humidity level of the tank. The average speed of humidity addition to the air is 30% per hour when the tank is fully sealed using plastic wraps (Figure 4-7(B)).

Figure 4- 7. Distance between the test facilities and crack: A: Distance between Thermal camera and crack= 70 cm, B: Distance between halogen lamp and crack= 10 cm, C: Distance between fan and crack= 30. 5 cm, D: Distance between humidifier and crack= 55 cm

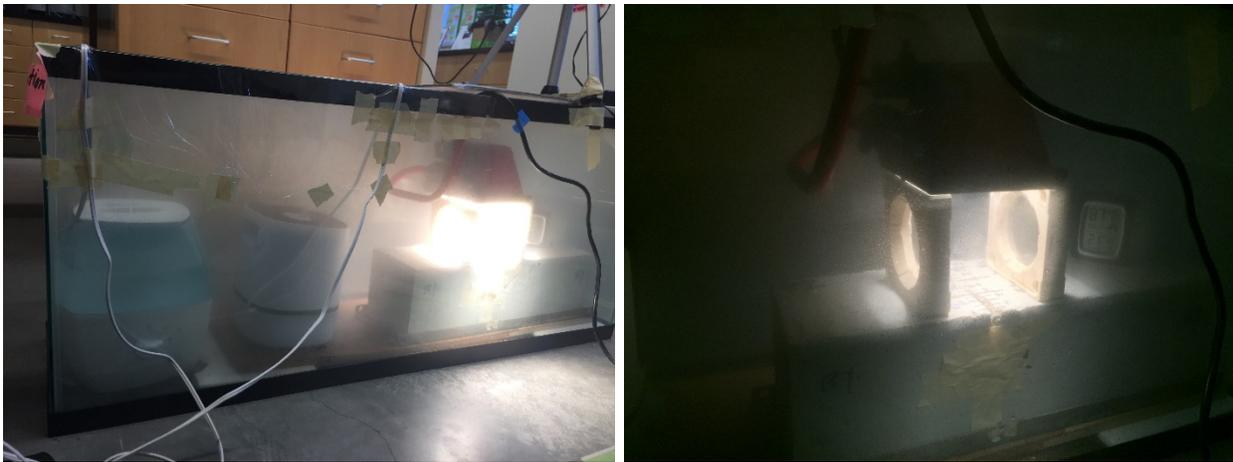
To imitate foggy weather, which represents the extreme amount of humidity, almost 100%, a different setup was utilized. In this test setup, two humidifiers were used which were constantly adding humidity to the air inside the tank throughout the whole procedure. The initial humidity before starting the heating process was 99%. Although the humidity decreased after 2 hours of heating, it was increased back to 99% after 20 minutes into the cooling process. Figures 4-8(A) and 4-8(B) show the special setup for the foggy weather.

Figure 4- 8. (A & B) Foggy weather test setup (Humidity= \sim 100%)

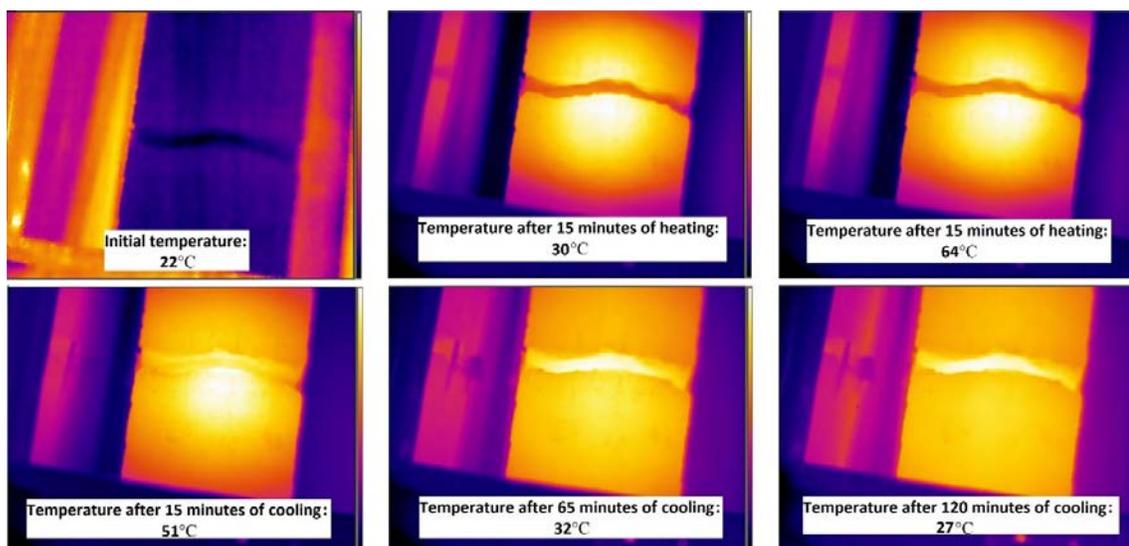
Figure 4-9 shows that the temperature gradient between the top and bottom side of the crack during the heating and the cooling cycles of the test in thermal images. The same pattern can be seen in these images with the top edge having a higher temperature during the heating cycle and vice versa during the cooling cycle.

Figure 4- 9. Temperature gradient captured by the infrared thermal camera during the heating and cooling cycles (Crack sizes: Width=1cm Depth=3.2cm) - Highest surface temperature is calculated in each image

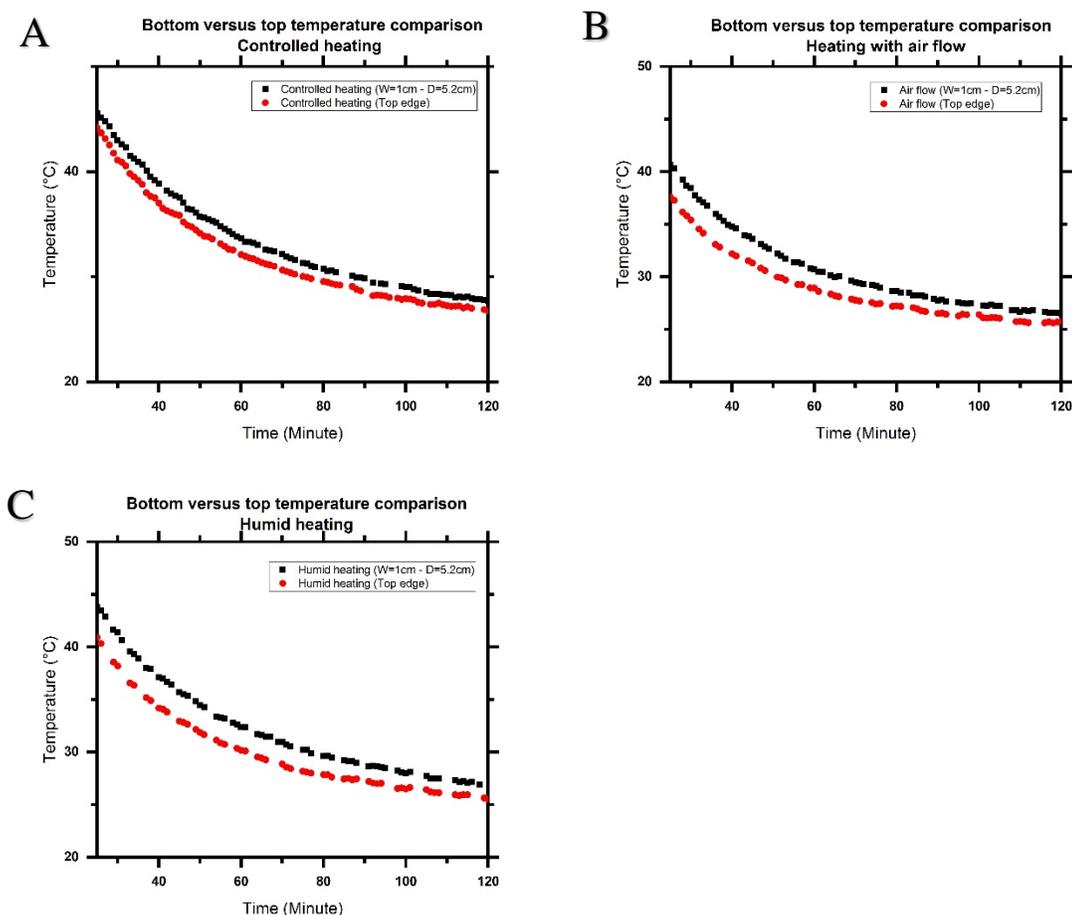
The same tests have been carried out on cracks with varying profiles and under different weather conditions (Figures 4-10(B) and 4-10(C)). The same trend was observed for cracks with varying crack ratios. However, the temperature gradient is more severe in heating with airflow inside the system and is about 3°C at a point in the middle of cooling cycle. Eventually, the temperature gradient resumes to 1°C for all three types of weather conditions at the end of cooling cycle.

Figure 4- 10. Temperature decay versus time for top edge and bottom of crack in 3 different test sets, A) Controlled heating, B) heating with airflow and C) moist heating

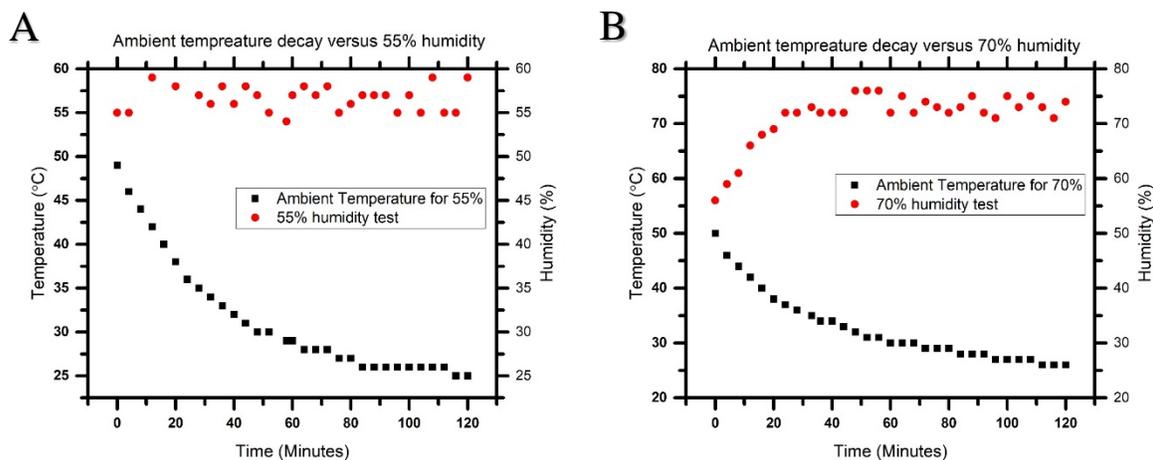
That is to have a higher temperature gradient and a better visualization of the temperature comparison.

Figure 4- 11. Relation between humidity and ambient air temperature decay: A: For 55% humidity, B: For 70% humidity

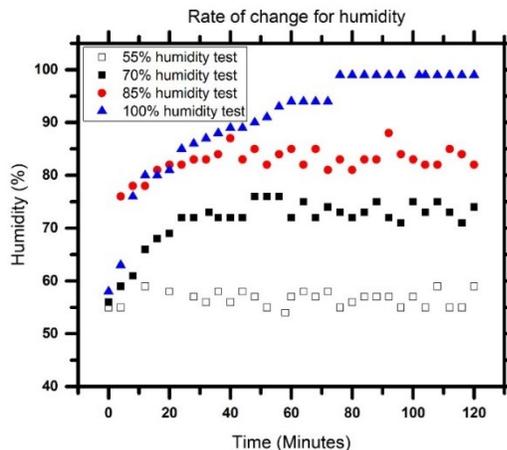
Figure 4-12 shows the rate of humidity change inside the system for different humidity tests.

Figure 4- 12. The change in humidity levels versus time

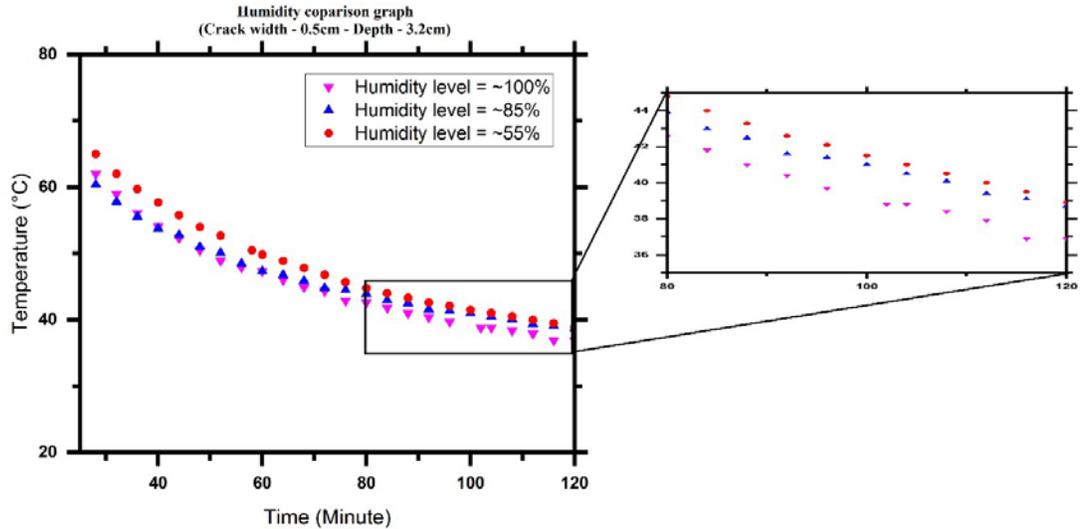
Prior the start of the heating process, humidity was raised up to 80%. However, as shown in Figure 4-13, the humidity decreases during the two hours of the heating process. In this graph, the rate of change for humidity during the cooling process is plotted for four different tests with different amount of humidity percentages. The humidity level never went below the target amount and it did not increase more than 5 percent above it. This helped to keep the humidity consistent throughout the testing period. However, the humidity in the foggy weather test reaches the highest amount, which is plus 99%, after 75 minutes into the cooling process.

Figure 4- 13. Time versus temperature decay graph for different humidity levels

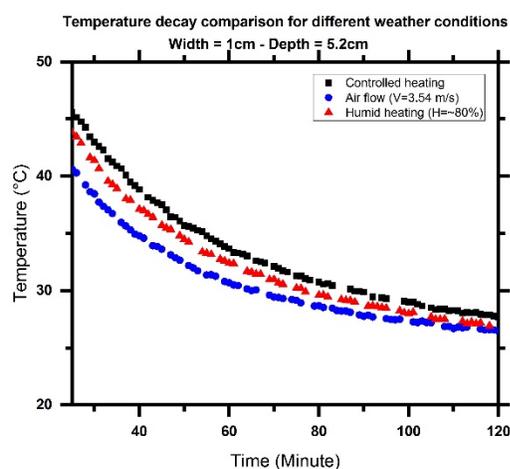
Figure 4- 14. The effect of different weather conditions on temperature reading of the thermal camera for a crack with 1 cm width and 5.2 cm depth

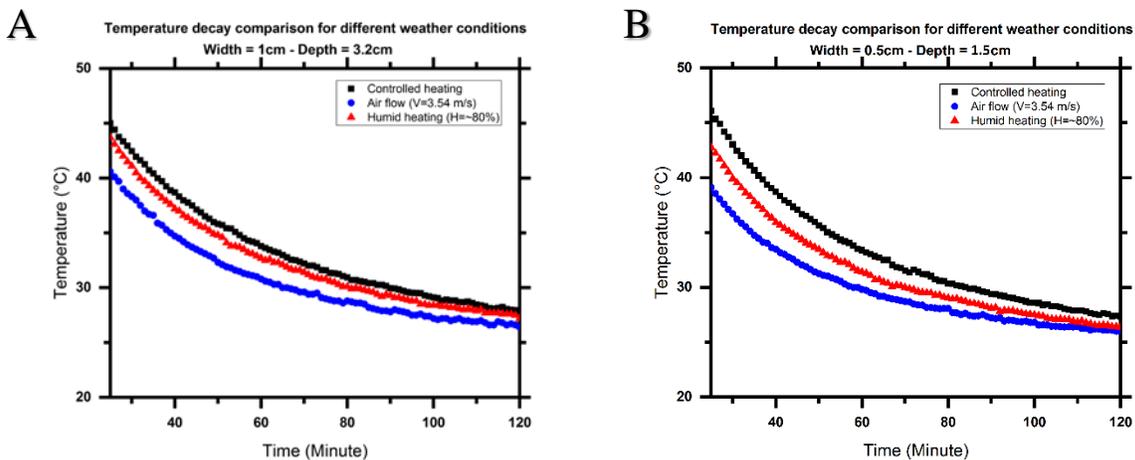
Figure 4- 15. Comparison of the effect of different weather conditions on temperature reading of the thermal camera for cracks with varying crack profiles: A: For width=1 cm and depth=3.2 cm, B: For width=0.5 cm and depth=1.5 cm
