FULL-SCALE STUDY OF INFRARED THERMOGRAPHY FOR ASSESSING
SURFACE AND SUBSURFACE DEFECTS IN PAVEMENTS AND OTHER CIVIL
INFRASTRUCTURE

Master of Science in Civil Engineering

Boise State University

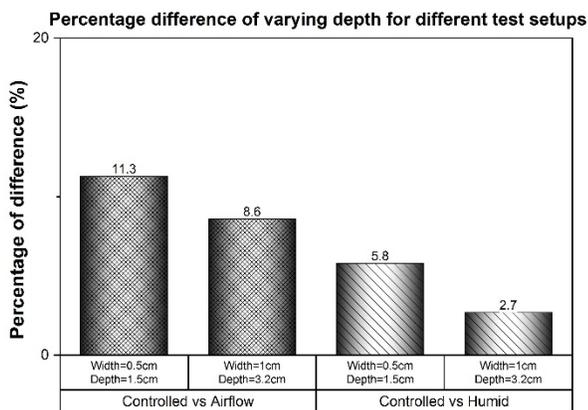
Figure 4- 16. Comparison of the percentage of difference for varying depths when exposed to different weather conditions

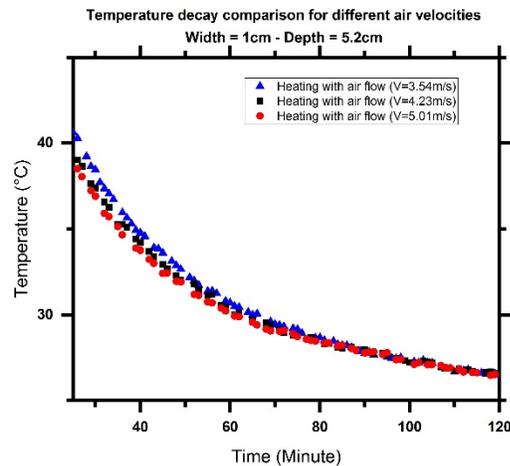
Figure 4-17. Temperature decay in different wind (air) speeds
