THE SIGNAL OF MODERN TO HOLOCENE DRIVERS OF COMPLEX CHANNEL
RESPONSE OF A SMALL ALLUVIAL STREAM

A thesis

Master of Science in Hydrologic Sciences

Boise State University

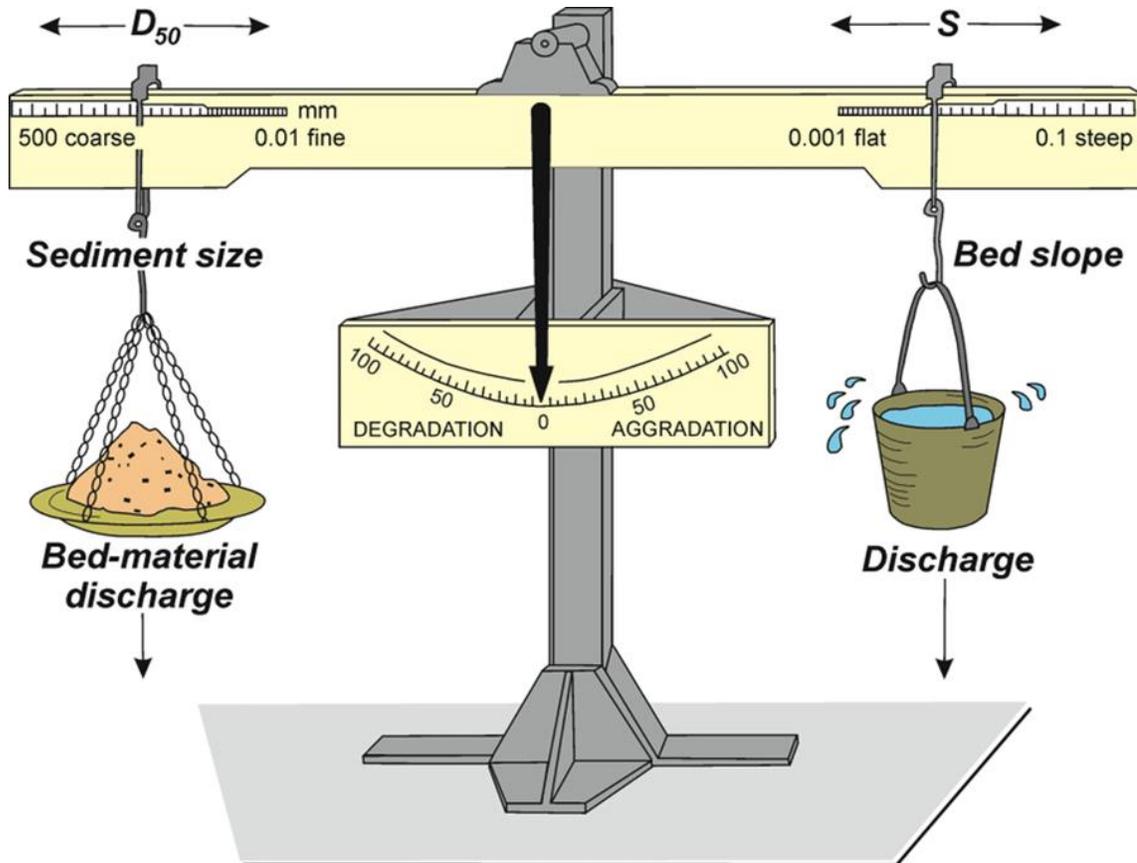
Figure 1 Conceptual schematic showing equilibrium conditions of stream channels as a balance of stream power and sediment discharge from Rinaldi et al. (2015, p. 90). The figure shows the qualitative expression $Q_w S \propto Q_s D_s$ which relates water discharge (Q_w), channel slope (S), sediment discharge or load (Q_s) and bed sediment size (D_s). A change in the relationship tilts the scale out of equilibrium towards either degradation or aggradation.

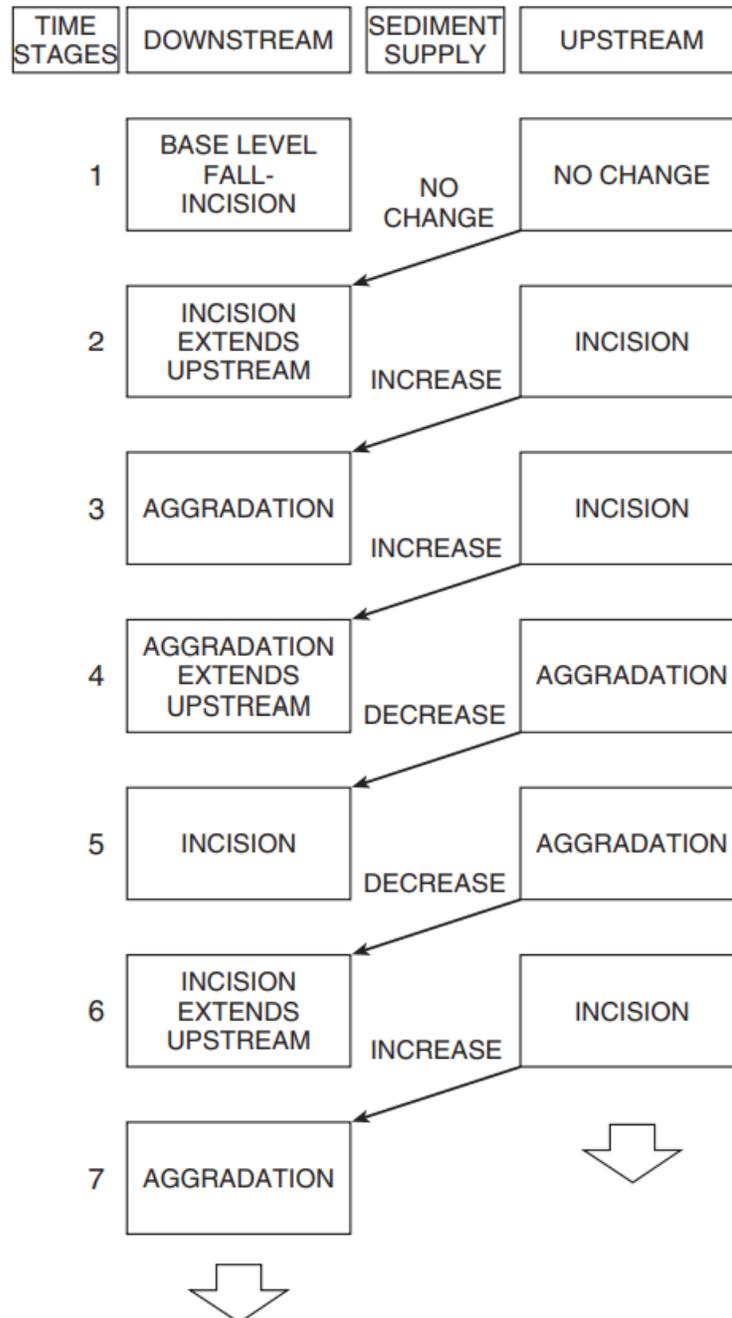
Figure 2 Schematic representation of a complex response as a result of a decline in base-level from Summerfield (1991, p. 227). The time stages are on the left from 1 to 7. The boxes describe the channel response during the time stage. The arrows show the change in sediment supply from upstream to downstream.

A complex response of the degradation and aggradation of streams was described by Schumm and Parker (1973) using an artificial basin. The study induced a base-level decline at the mouth of the basin, which caused downcutting of the stream and the formation of terraces. However, tributaries remained in their equilibrium state and didn't experience downcutting. As time progressed, the incision of the main channel migrated upstream, lowering the base level of tributaries and entrenchment of the tributaries began.

The incision of the tributaries provided an increased amount of sediment to the main channel. The increased sediment load caused aggradation at the mouth because the stream was incapable of transporting the increased load from the entrenched tributaries. The complex response from a base-level decline was expanded on by Summerfield (1991) who found several cycles of aggradation and incision. Figure 2 is a schematic diagram from the study that describes seven sequential time scales a stream can follow after base-level decline. Summerfield (1991) describes what is happening upstream, downstream, as well as changes to the sediment supply from upstream. In stage 1, a fall in base level causes a local steepening of the channel gradient. Erosion in the steepened section lowers the channel elevation and steepens the gradient upstream. The downstream reach incises, but upstream there is no change. Over time, in stage 2, incision propagates upstream and the amount of sediment from upstream increases. The increase in sediment supply results in a buildup of sediment downstream in stage 3. The aggradation results in a decrease in channel gradient downstream. Additionally in stage 3, incision continues upstream. In stage 4, aggradation propagates upstream as the channel gradient continues to decrease further upstream. The sediment supply from upstream decreases, due to the decrease in downcutting. The reduction in sediment supply means there is additional energy for erosion and incision starts downstream. In stage 6, incision propagates upstream causing an increase in sediment supply downstream. Finally in stage 7, the increased sediment supply leads to aggradation at the downstream end of the channel. Therefore, a downstream perturbation, base-level decline, caused changes which propagated upstream. Then the changes upstream caused changes downstream resulting

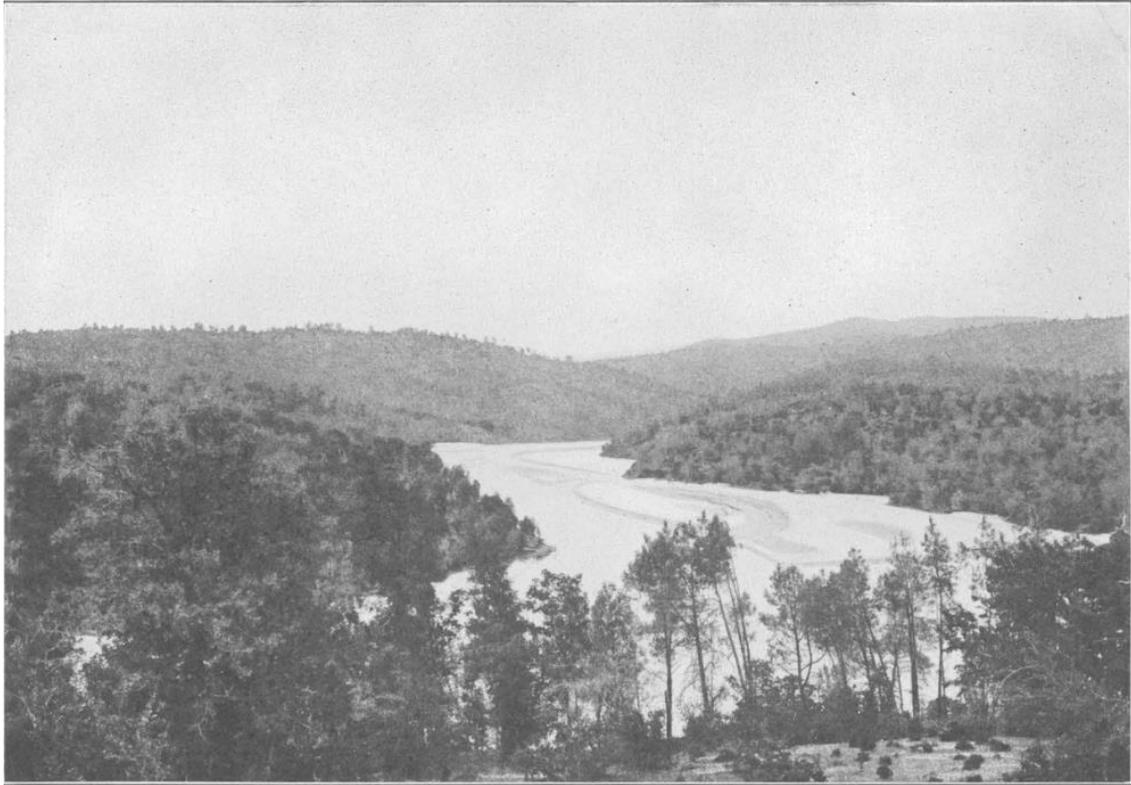
Figure 4 Photo of Sierra Canyon clogged by placer mining debris in 1908 from Gilbert (1917, p. 26).

aggradation in sections of the basin, covering downstream farm fields with packets of sediment from upstream mining (Figure 4). As segments of the river filled, the gradient increased at the downstream extent of aggradation allowing for the river to transport sediment further downstream. Gilbert (1917) found that channel segments stopped aggrading depending on the distance from the source of the sediment and the amount of sediment load. However, Gilbert also discovered that even when mining activity stopped, the downstream reaches continued to aggrade in some reaches. The rivers continue to aggrade because the upstream reaches were no longer receiving the large input of sediment from hydraulic mining and had excess energy to transport sediment that the river had established during mining activity. The upstream reaches incised and transported sediment to downstream reaches which aggraded as the gradient decreased. The remedial action exaggerated the initial aggradation when ceasing mining eliminated the source of the sediment load which resulted in another aggradational event, instead of a remedy to the problem. This second aggradational event is the result of environmental managers not understanding fluvial response and the time it takes for a stream system to reach equilibrium. This study illustrates a channel response caused by a land-use disturbance in which the stream system is aggrading in part and incising in others.

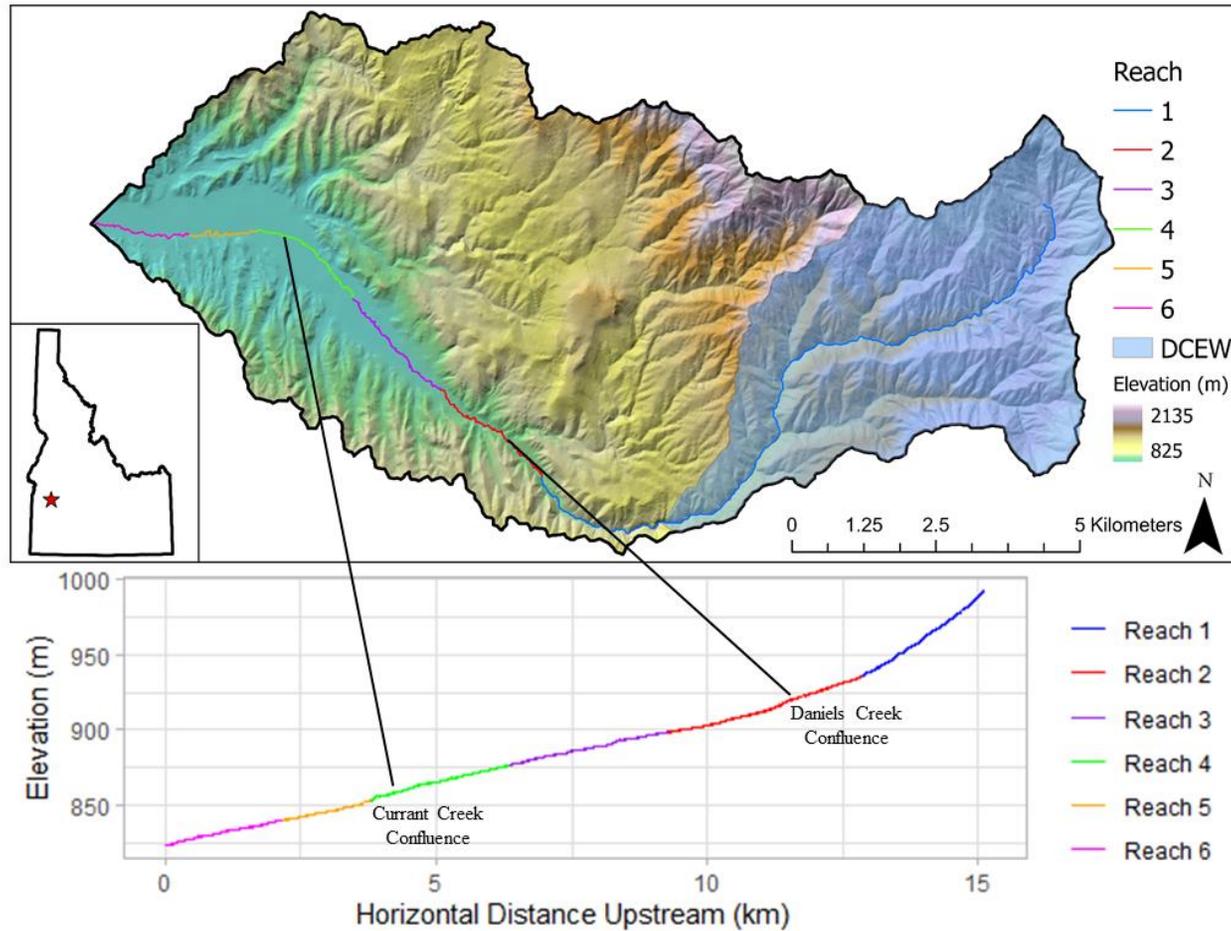
Figure 6 Map showing the Dry Creek watershed north of Boise Idaho and the six distinct reaches of the Lower Dry Creek study area downstream of Dry Creek Experimental Watershed (DCEW). The major tributaries in the study area are Daniels and Currant Creek. The longitudinal profile (bottom) of Lower Dry Creek is measured upstream of the confluence with Spring Valley Creek.

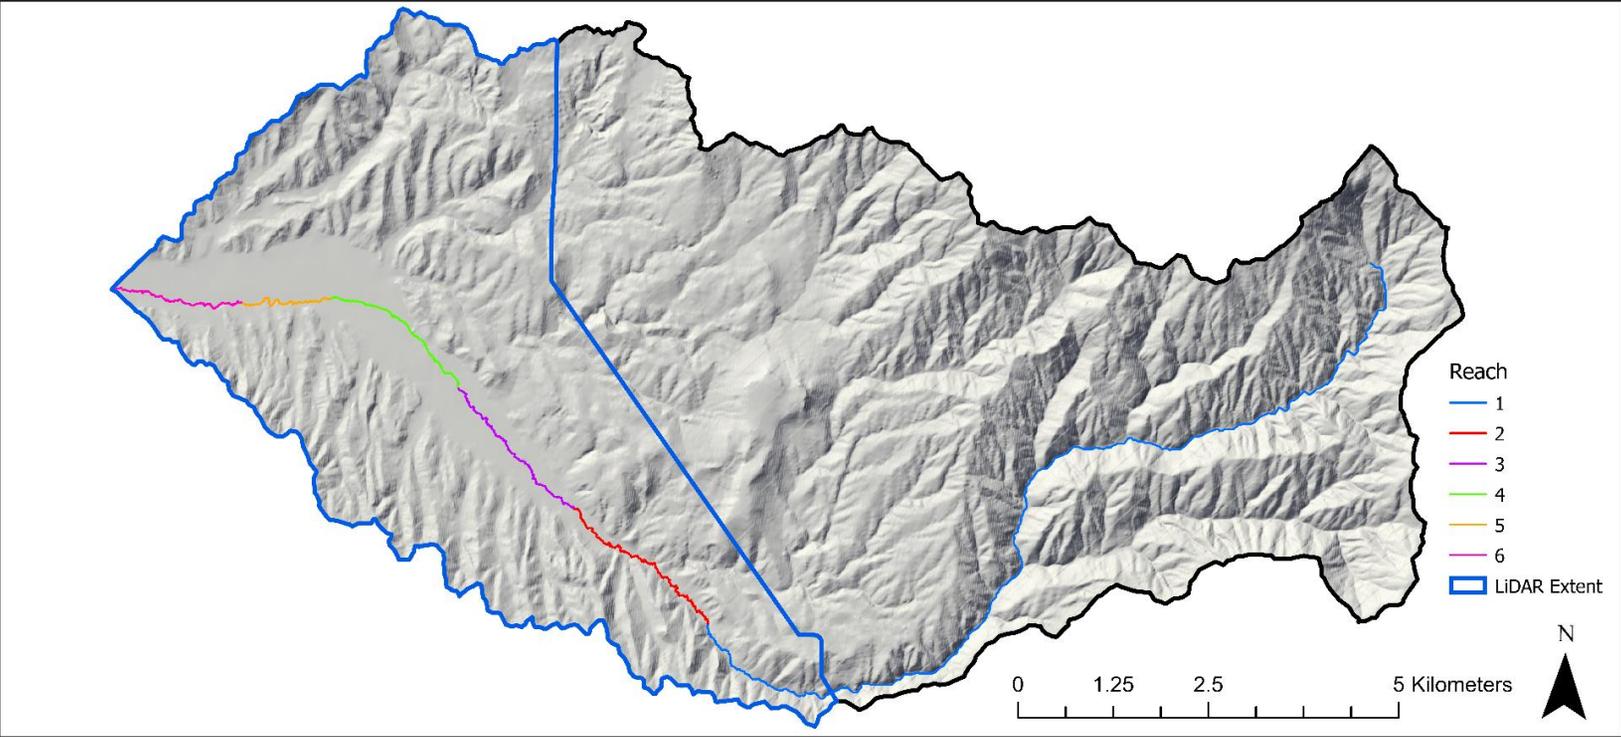
Figure 7 Map of Dry Creek watershed showing the extent of the 2015 LiDAR dataset.

The LiDAR dataset covers LDC and its tributaries as well as the surrounding topography from Bogus Basin Road to Highway 55 (Figure 7). We used the bare earth digital elevation model (DEM) for terrain analysis and creating a stream longitudinal profile in ESRI's ArcGIS Pro software. Additional technical details of the LiDAR data are found in the Ada Country Enhanced Wildfire Risk Map: LiDAR Technical Data Report (Quantum Spatial Inc., 2015).

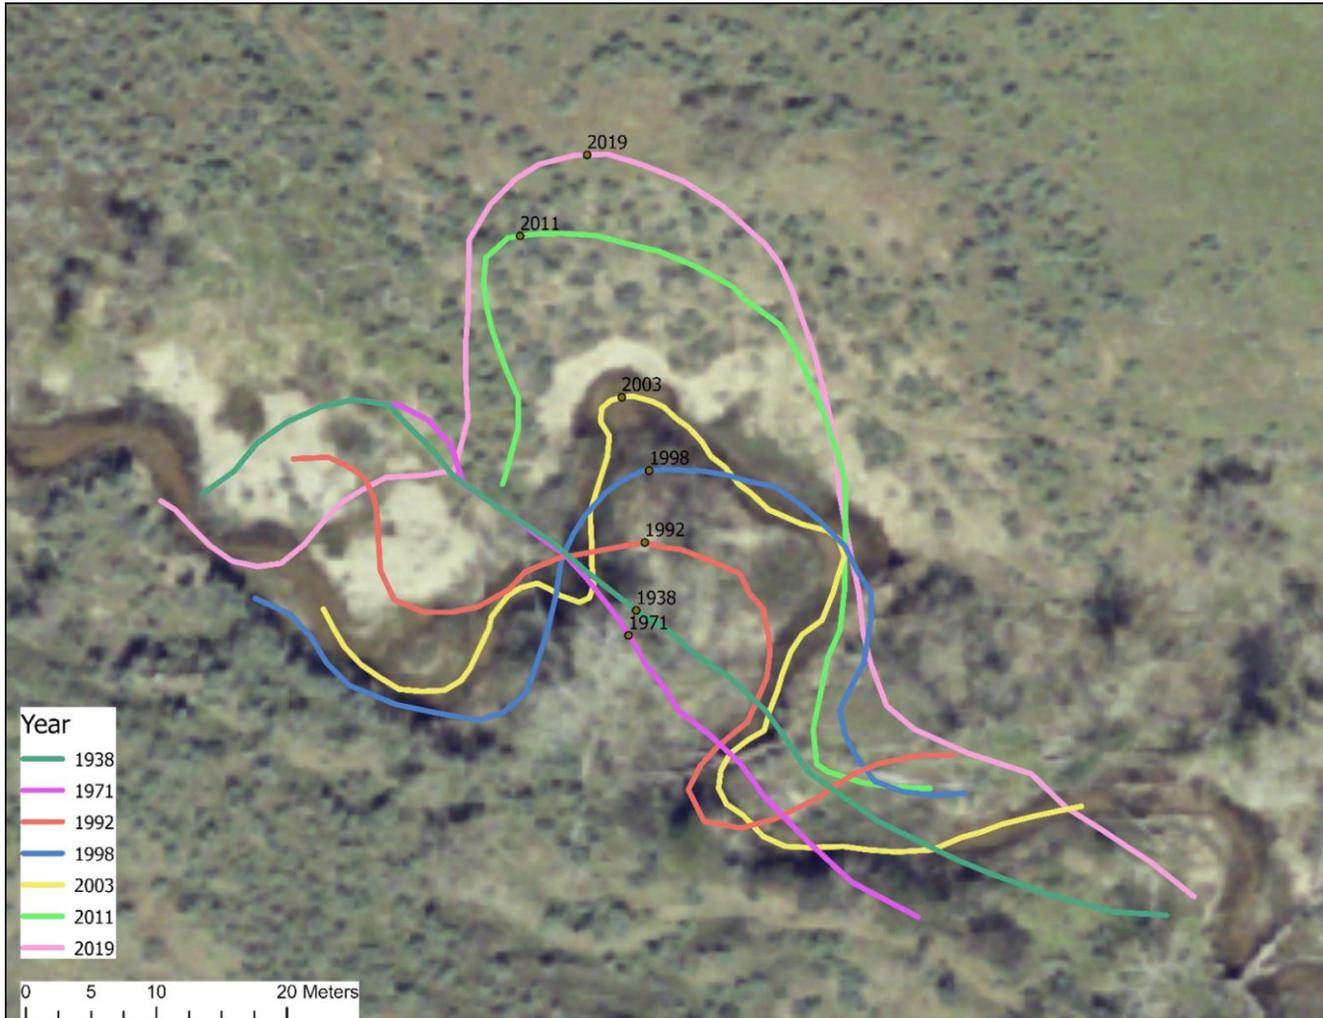
Figure 8 Aerial photo from 2003 showing meander number 2 channel delineation for each imagery year and the point at the crest of meander used to measure the meander movement.

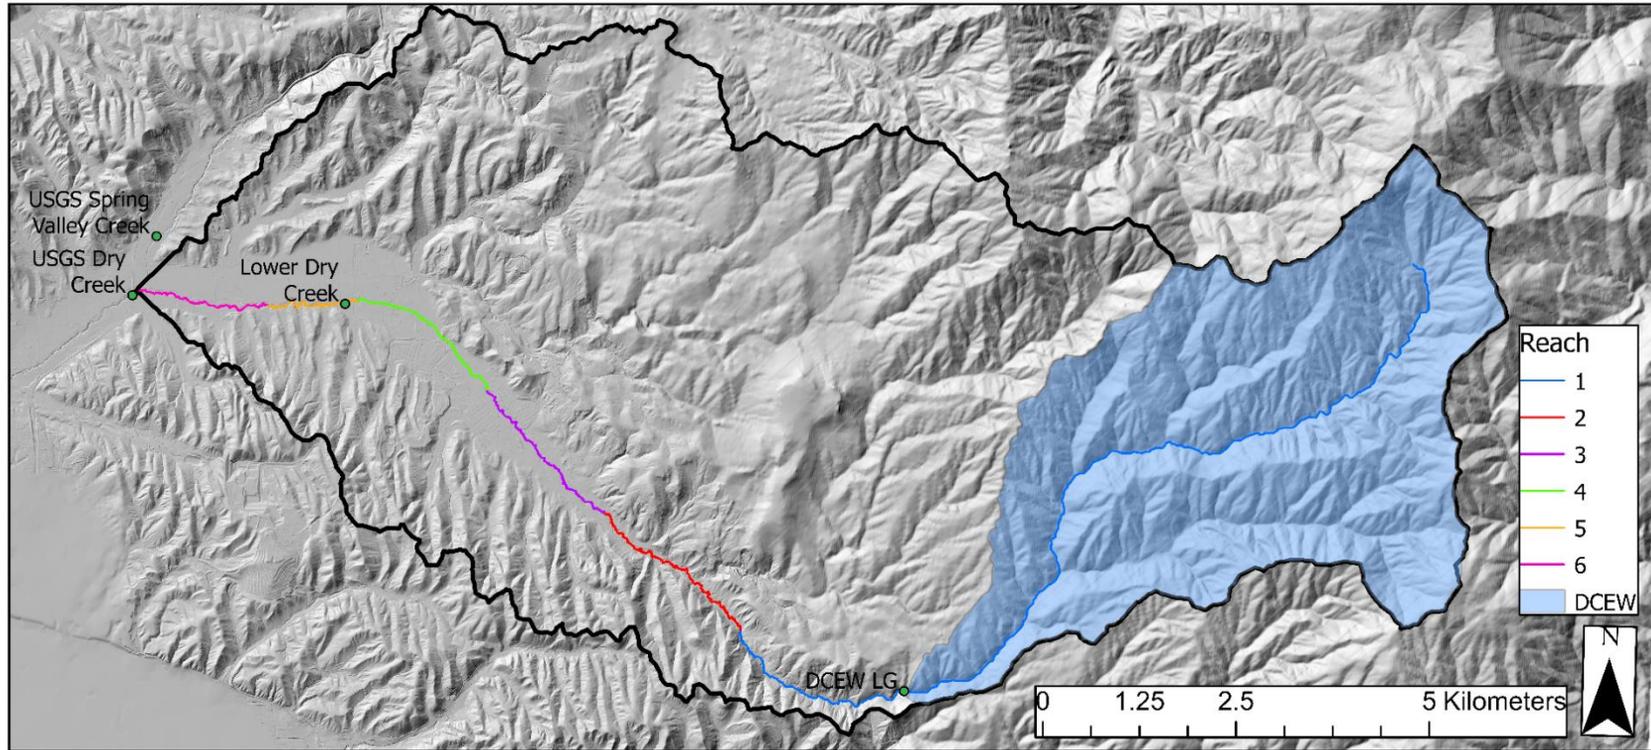
Figure 10 Map of Dry Creek watershed showing locations of stream gaging stations. Dry Creek Experimental Watershed Lower Gage (DCEW LG) is a long term monitoring site with record of discharge since 1999. For this project we installed the Lower Dry Creek gage and used stream discharge from spring of 2019. The USGS gage sites at Dry Creek and Spring Valley Creek both have records of discharge from 2010 to 2012, which allowed us to subtract the discharges to have comparable flows to this project’s Lower Dry Creek gage.

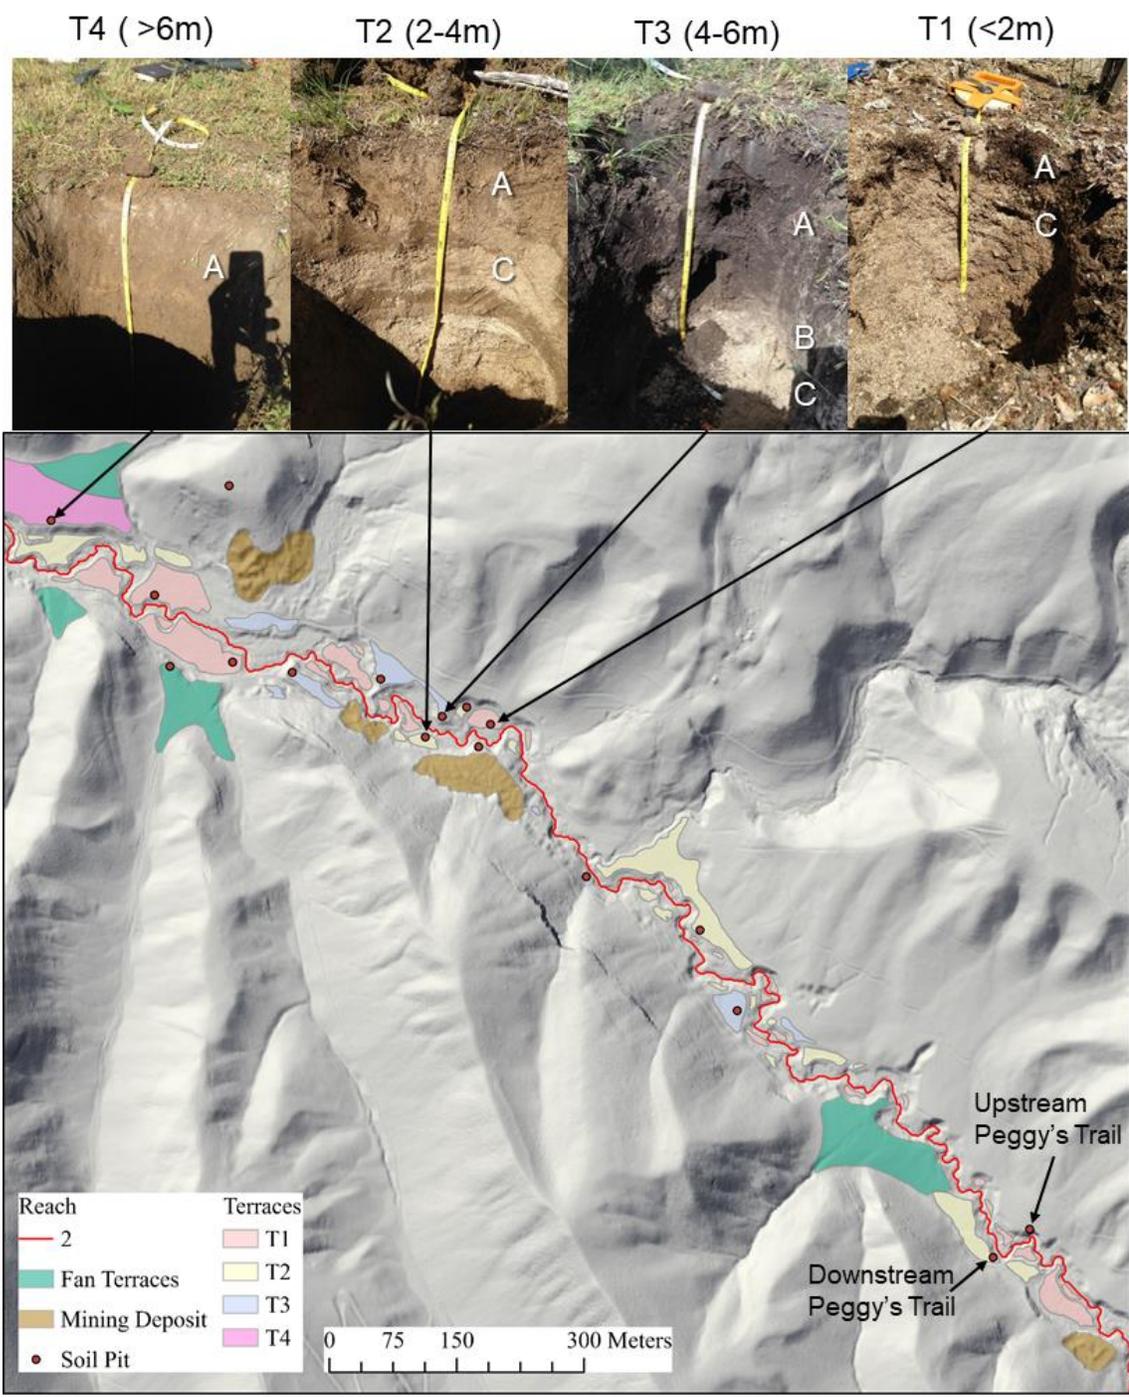
Figure 11 Geomorphic map of Reach 2 of Lower Dry Creek. Terraces are mapped and correlated based on height about the current stream. T1 is the lowest terrace and T4 is the highest terrace surface mapped. Representative photos of soil pits from terrace height show younger soils on the lower terraces. A, B, and C soil horizons are labeled where visible. The map shows the location of the upstream and downstream sample locations of the Peggy's Trail site (Figure 15).

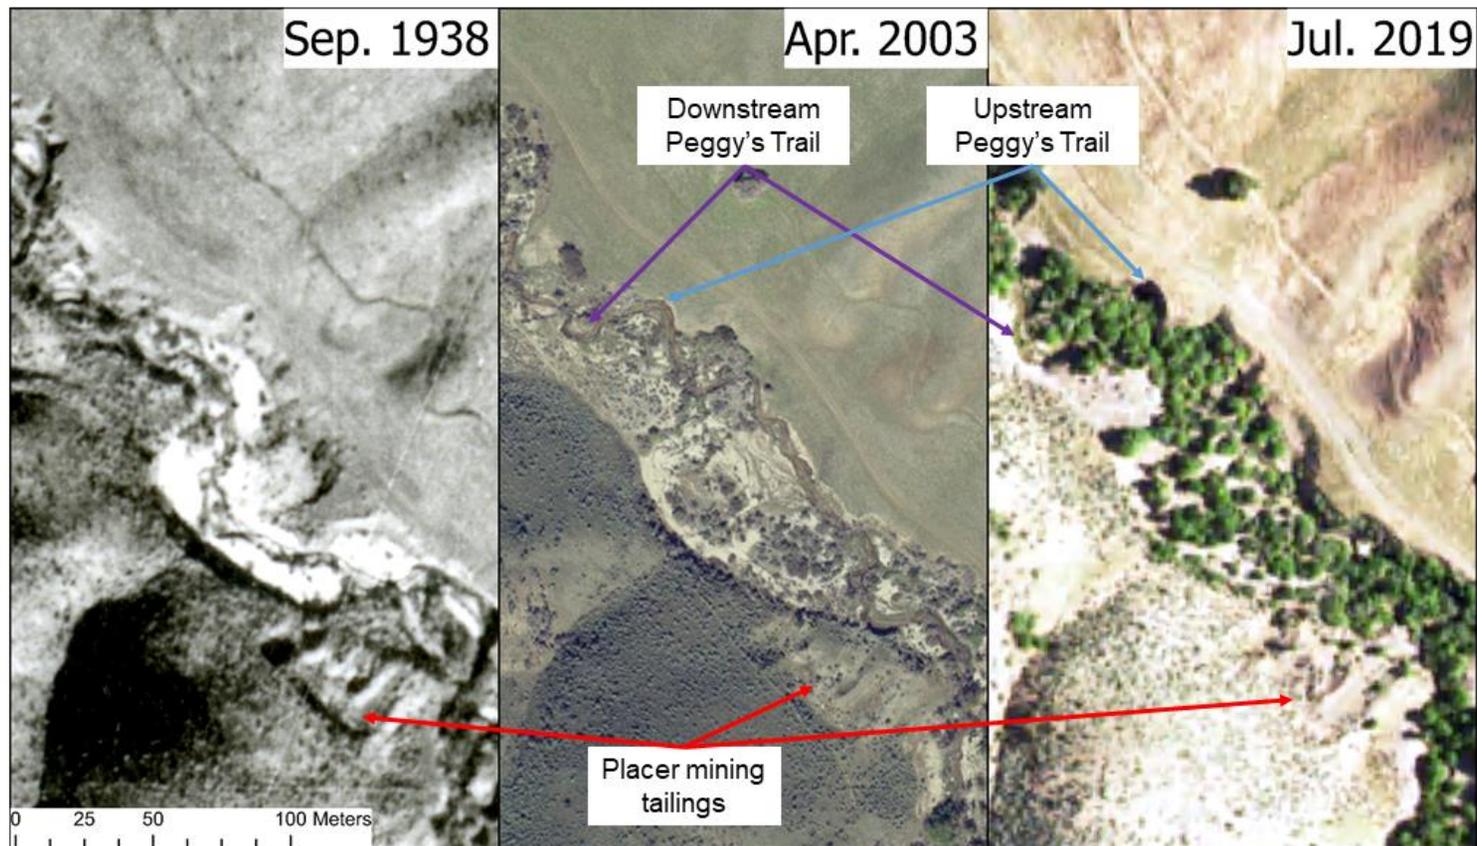
Figure 12 Aerial photos from September 1938, April 2003, and July of 2019 showing a placer mining tailings deposit and the location of the Peggy's Trail stratigraphy site. The red arrows show the location of one of the four placer mining deposits mapped. Observe the channels used for diverting water and cuts into the hillside where material was removed. Fine-grained material was removed from the piles during mining and left large granitic and basalt cobbles. The blue arrows show the location of the upstream bank of the Peggy's Trail site described and dated (Figure 15). The purple arrows show the location of the downstream bank. Observe the amount of meander movement which cut into the T2 terrace between 1938 and 2019, exposing the stratigraphy.

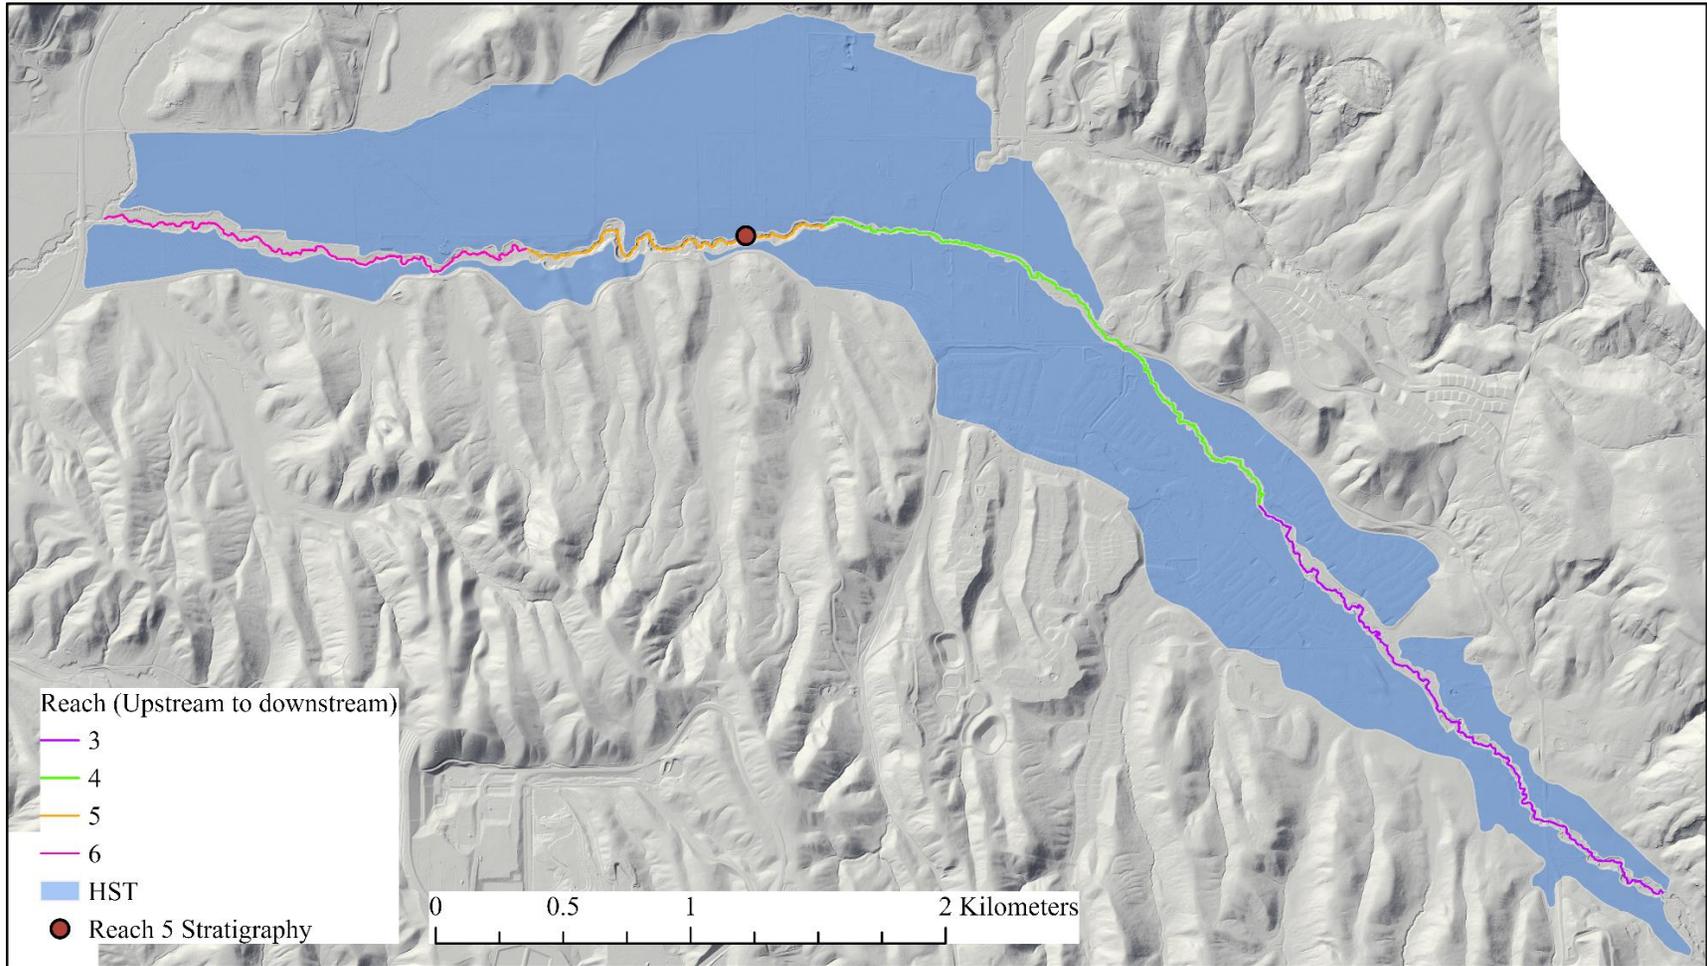
Figure 13 Geomorphologic map of Reach 3 to 6 of Lower Dry Creek. The map shows the extent of the Hidden Springs Terrace surface and the location of the Reach 5 stratigraphy site which shows the aggradational sequence of the Hidden Springs Terrace (Figure 14).

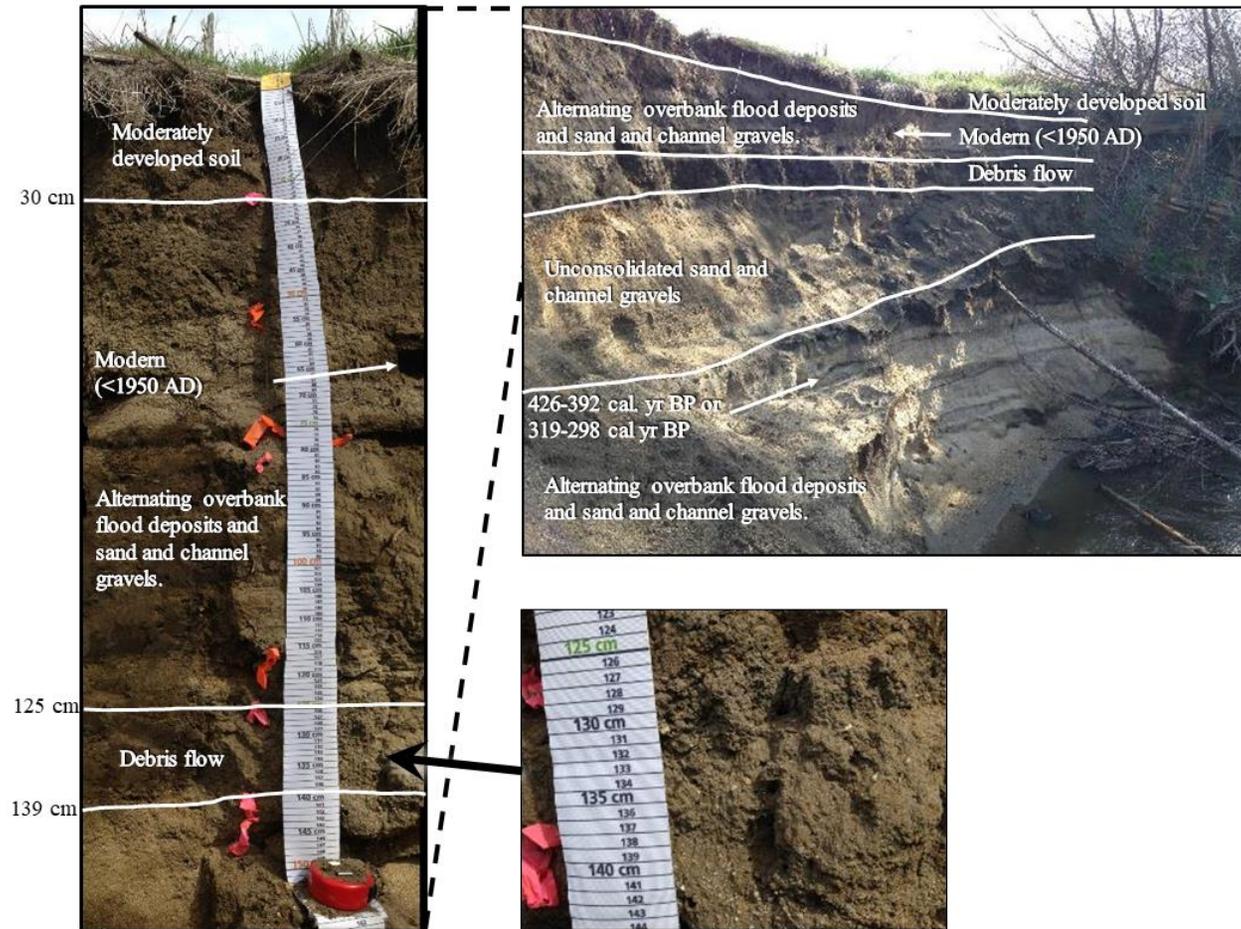
Figure 14 Annotated photos of the stratigraphy of the Hidden Springs Terrace at Reach 5. The photos show the complex sequence of fine-grained overbank flood deposits, channel gravels, and debris flow. Two charcoal samples are dated and calibrated from the site. The minimum aggradation rate between these samples is 0.75 cm/year. Minimum incision rate since deposition of the upper charcoal sample is 5.7 cm/year.

We selected a well-exposed streambank in incised Reach 5 of LDC for radiocarbon dating. Dating the exposure provided an aggradation rate of the Hidden Springs Terrace and a maximum age of incision. We measured and described the exposure's bedding. We collected sediment samples from each layer. Where charcoal is found, we measured the depth from the bank's surface. The charcoal samples were collected wearing nitrile gloves and placed in a plastic bag for transport.

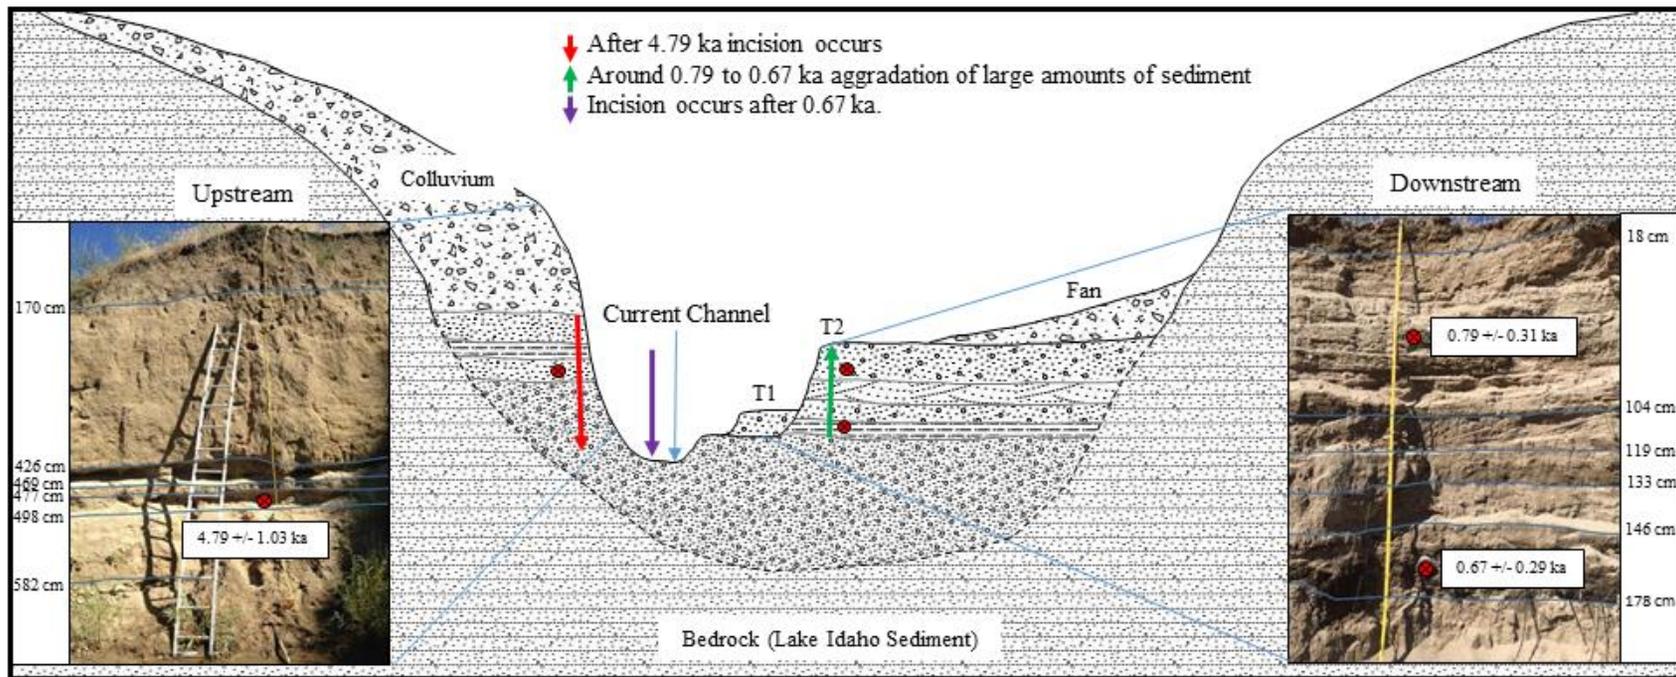
Figure 15 Conceptual drawing of the stratigraphy of Lower Dry Creek Reach 2 at the Peggy's Trail site. The upstream bank shows colluvial material deposits over a fluvial terrace. The terrace dated at 4.79 ± 1.03 ka. After the aggradation of the terrace, Lower Dry Creek incised. Around 0.79 to 0.67 ka the T2 terrace of the downstream bank aggraded. The stratigraphy shows sheet flood and crossed bedded sands. Timing of this aggradation correlates to a period of large amount of alluvial fan deposition in Dry Creek Experimental Watershed related to increased fire activity (Poulos and Pierce, 2018). After aggradation of the T2 terrace, Lower Dry Creek incised. Lower terraces (T1) are present between the T2 and current floodplain indicating episodic incision. Today, the stream is laterally migrating which exposed the upstream and downstream bank.

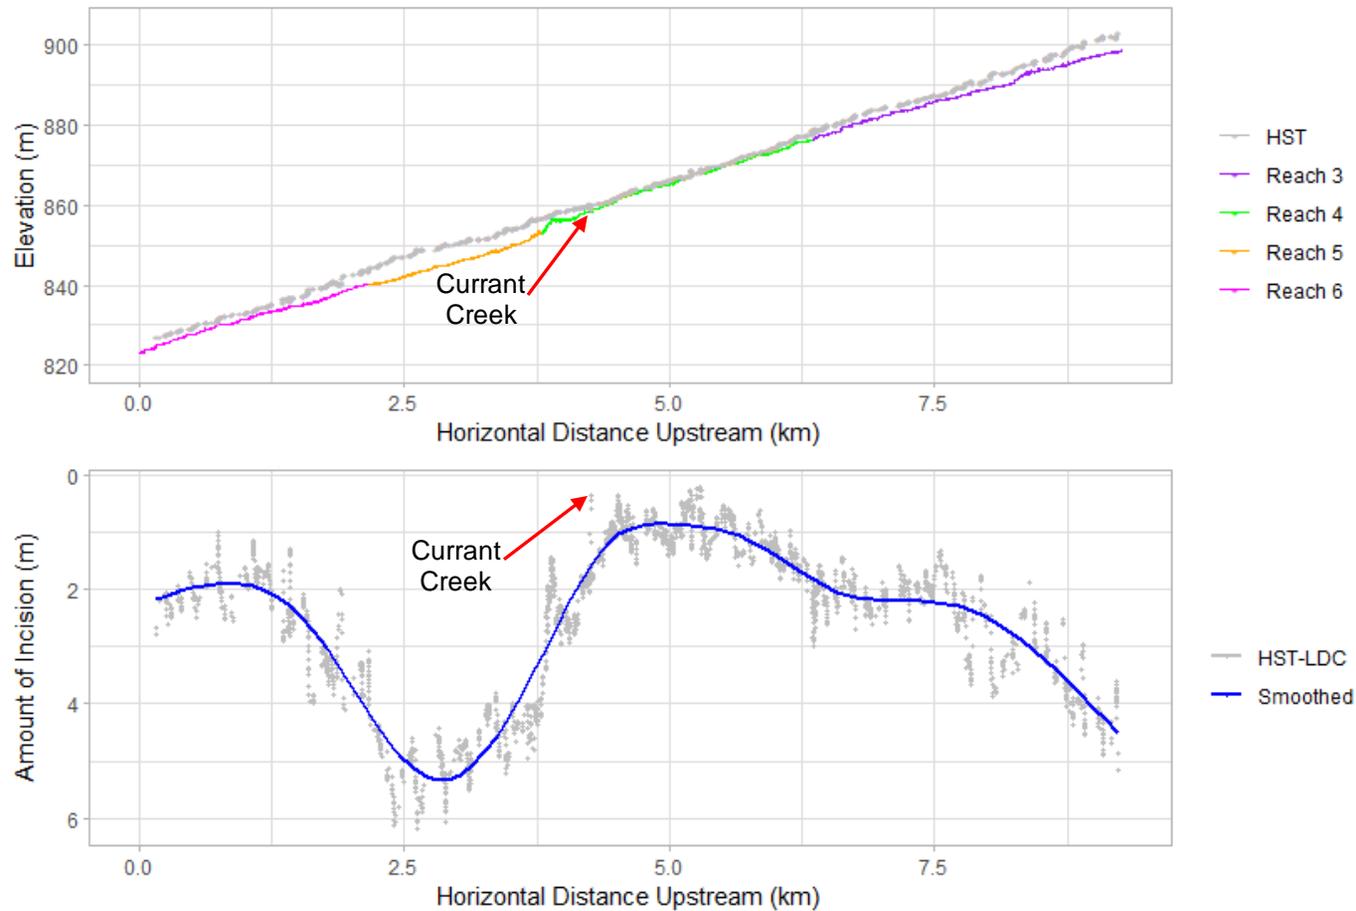
Figure 16 The upper plot is the longitudinal profile from Reach 3 to 6 of Lower Dry Creek (LDC) and the Hidden Spring Terrace (HST) surface. The bottom plot shows the amount of incision in meters between Lower Dry Creek and Hidden Springs Terrace (HST-LDC) and a generalized additive model smoothing line of the data. Observe that the profile is overall a well-behaved concave stream profile. However, the profile is convex through Reach 4 which has a lower amount of incision. Reach 5 has the highest amount of incision, which begins directly downstream of the confluence with Currant Creek.

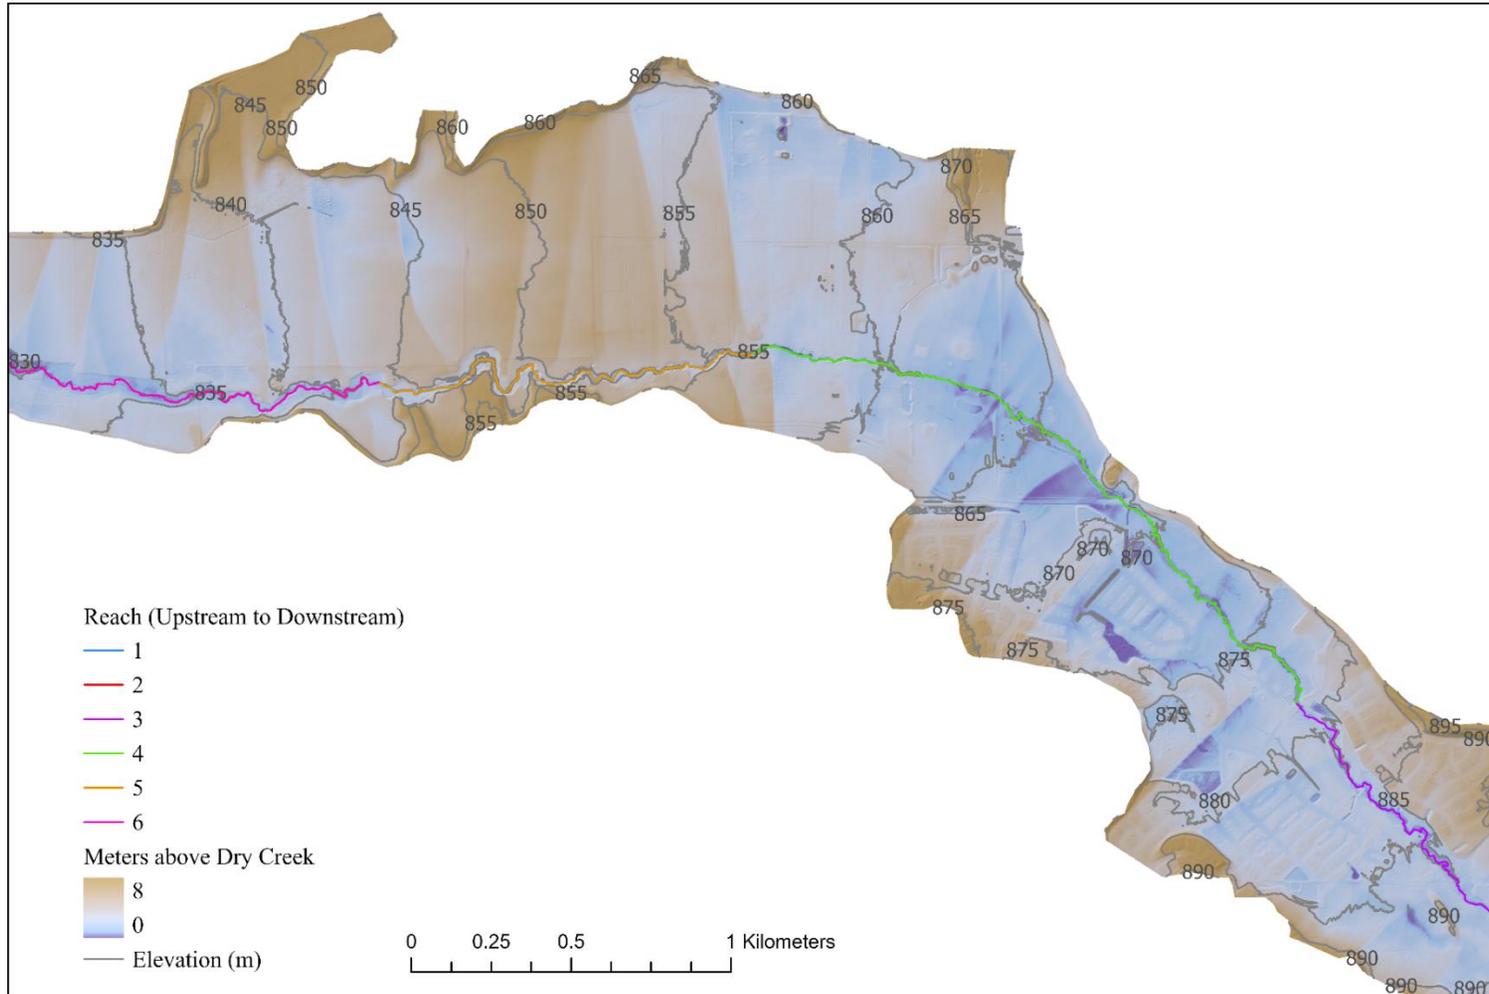
Figure 17 Relative elevation map showing the height the Lower Dry Creek Valley is above the current stream bottom from Reach 3 to 6. Notice the areas in Reach 3 and 4 that are connected to the Hidden Springs Terrace. We observed flooding on the Hidden Spring Terrace in Reach 4. Reach 5 is not connected to the Hidden Springs Terrace due to recent incision. Relative elevation maps of each reach is in Appendix D.

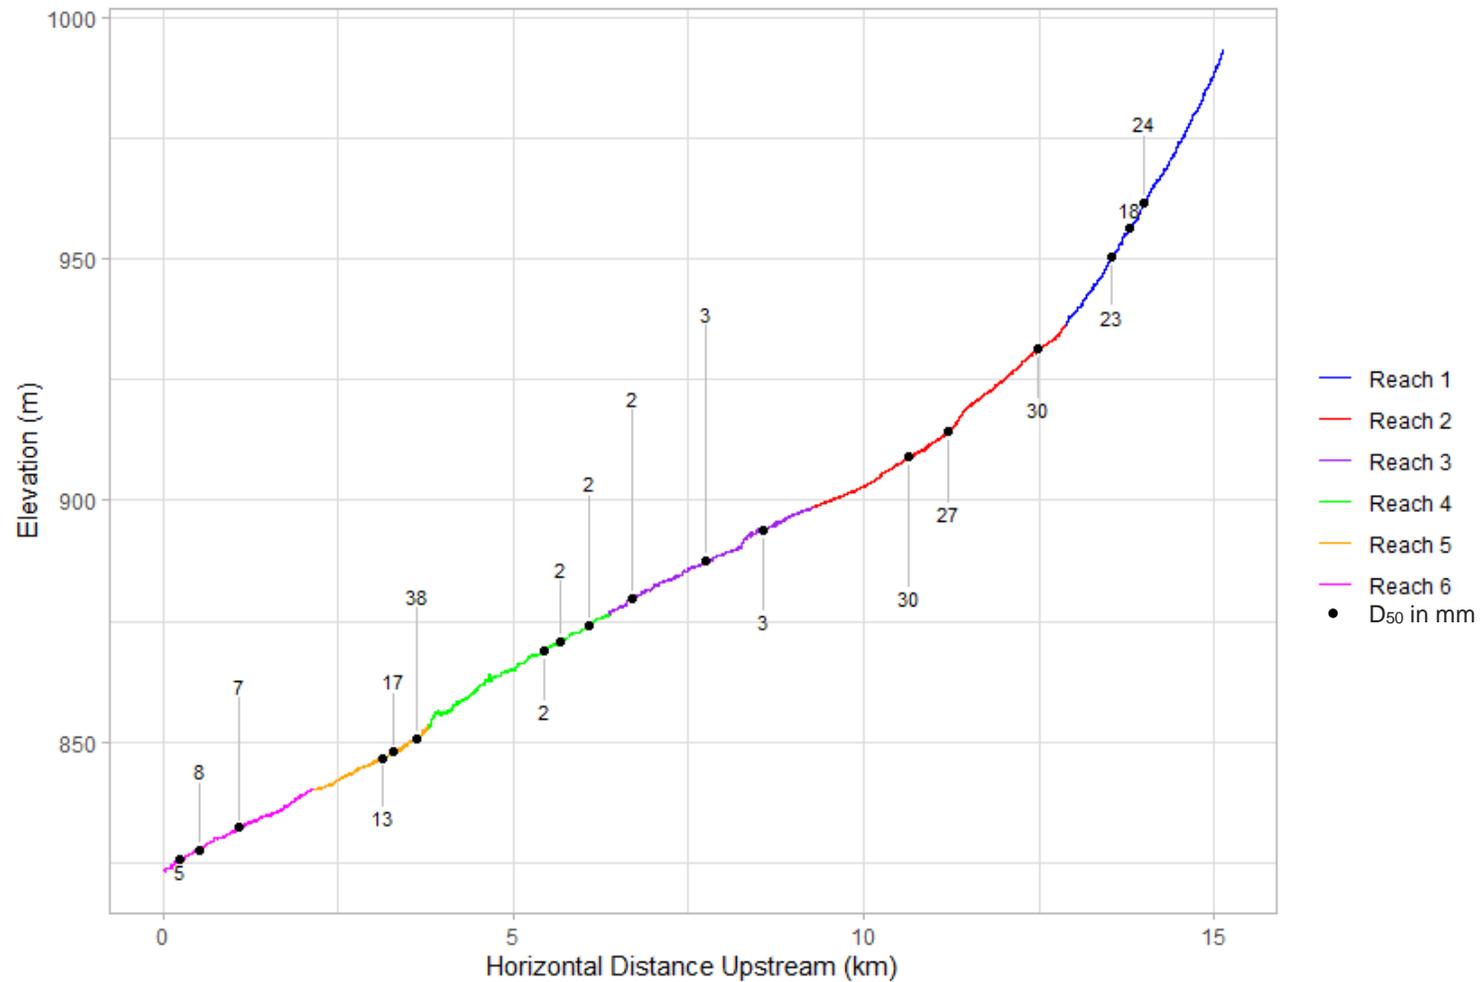
Figure 18 Longitudinal profile of Lower Dry Creek showing locations of grain size samples and the measured median grain size (D_{50}) in mm. The bed sediment fines between Reach 2 and 3 as the profile of Lower Dry Creek switches from concave to convex.
