THE SIGNAL OF MODERN TO HOLOCENE DRIVERS OF COMPLEX CHANNEL
RESPONSE OF A SMALL ALLUVIAL STREAM

A thesis

Master of Science in Hydrologic Sciences

Boise State University

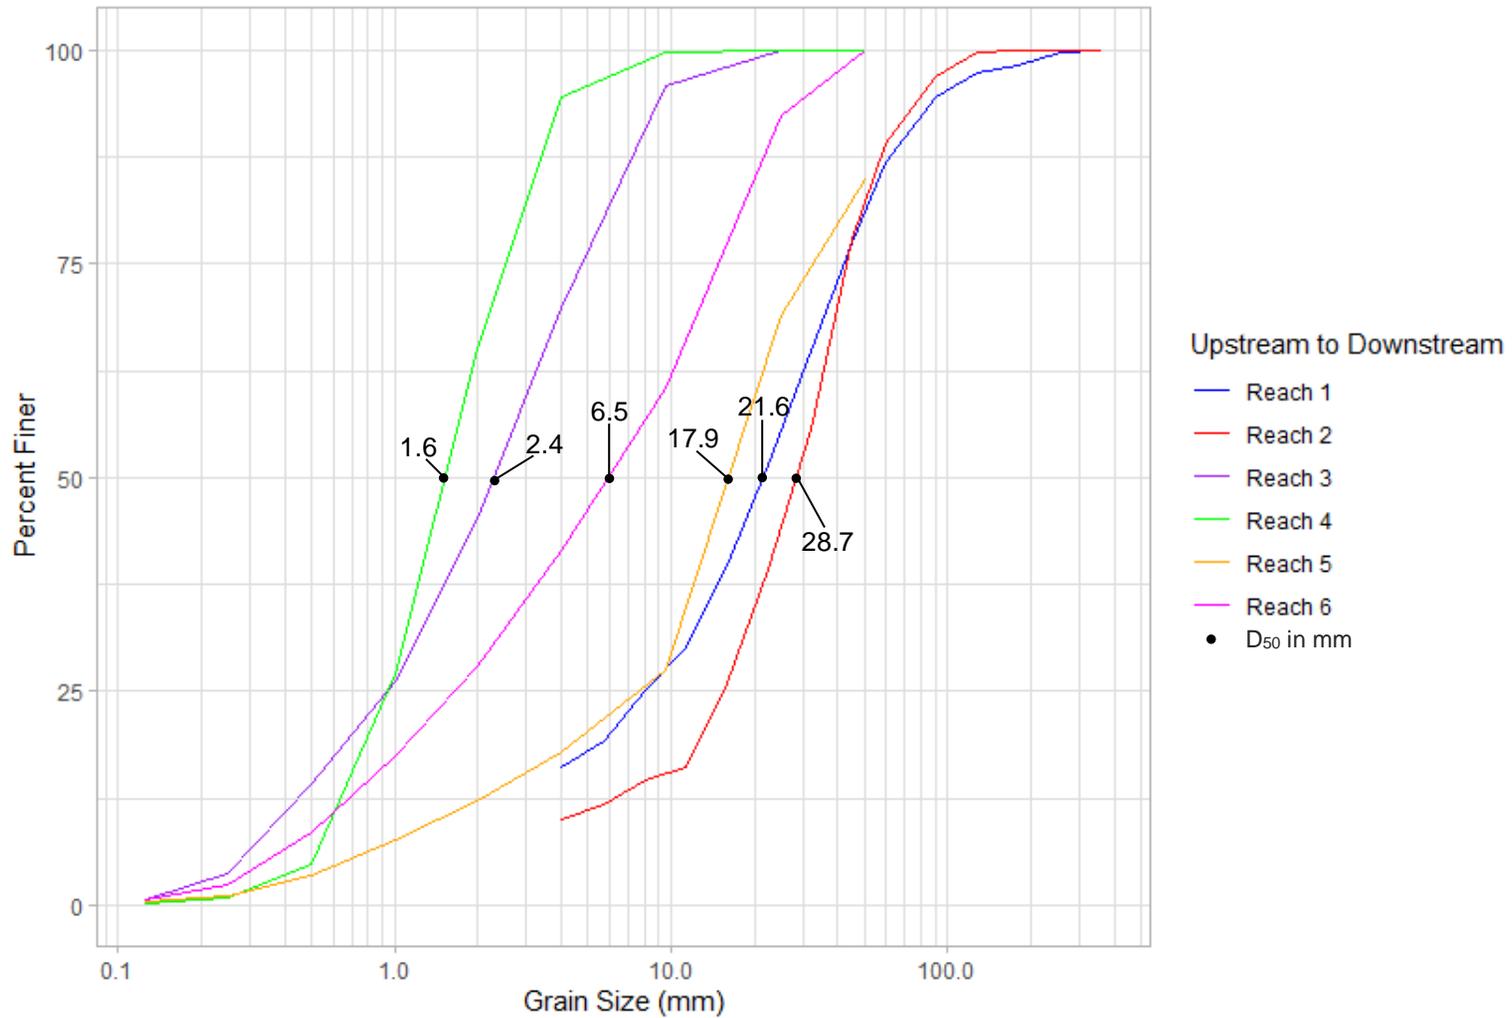
Figure 19 Grain size distribution plot of the average of three stream bed sediment samples from each reach of Lower Dry Creek. The median grain size (D_{50}) in mm is annotated on the plot. The grain size substantially fines between Reach 2 and 3. The grain size coarsens in the incised Reach 5.

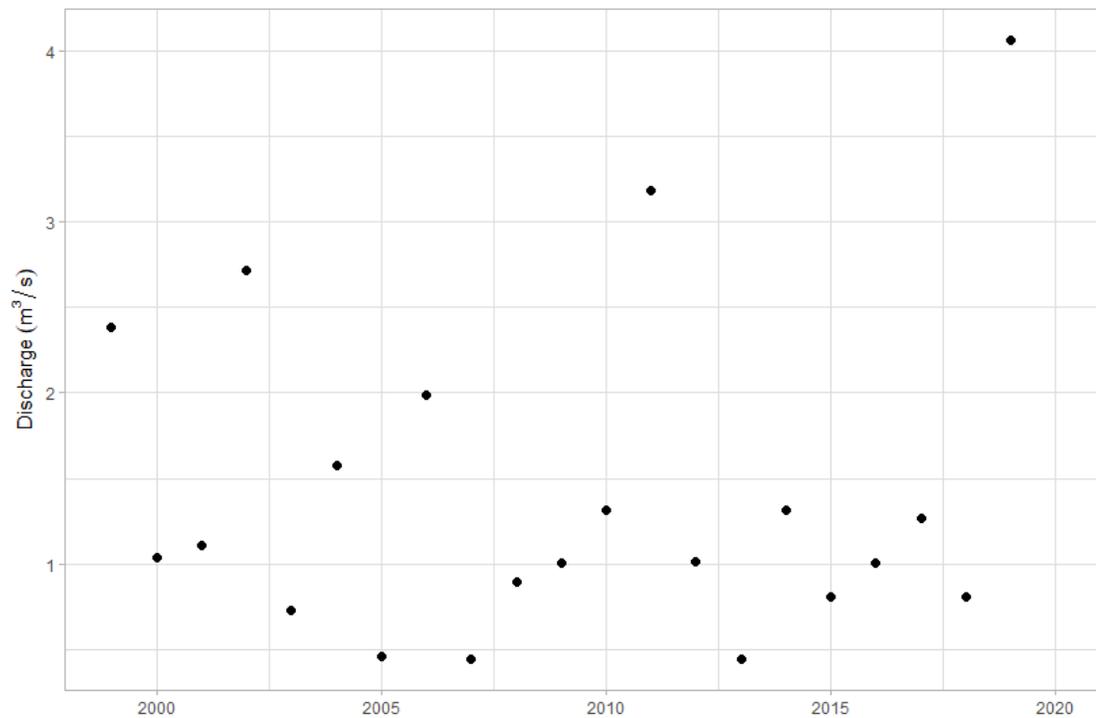
Figure 20 Plot showing Dry Creek Experimental Watershed Lower Gage annual peak discharge from 1999 to 2019. Estimated 2-year return internal bankfull flow is $1.13 \text{ m}^3/\text{s}$. All sampling for this project was completed after the highest discharge on record in the spring of 2019.

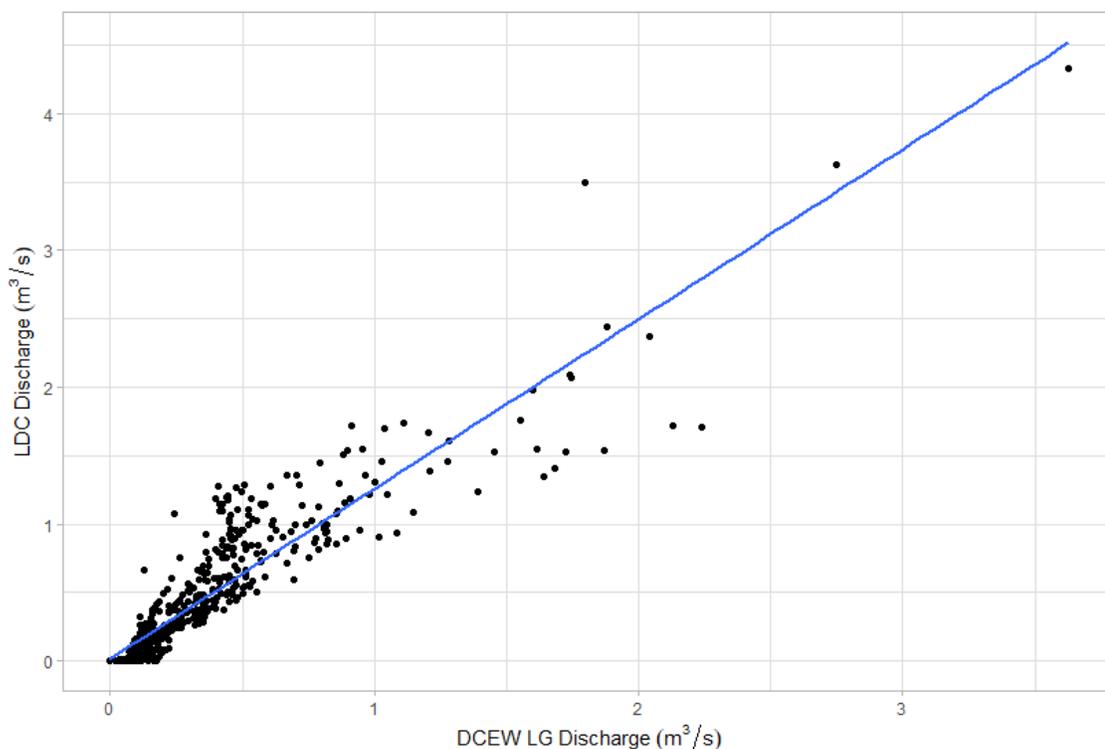
Figure 21 Dry Creek Experimental Watershed Lower Gage (DCEW LG) discharge plotted against Lower Dry Creek (LDC) discharge. The linear relationship is $y=1.24x+16.78$ with an $R^2=0.84$. The 2-year estimated bankfull flow at Dry Creek Experimental Watershed Lower Gage is $1.13 \text{ m}^3/\text{s}$ and using the linear relationship, the 2-year bankfull flow at Lower Dry Creek is $1.42 \text{ m}^3/\text{s}$.

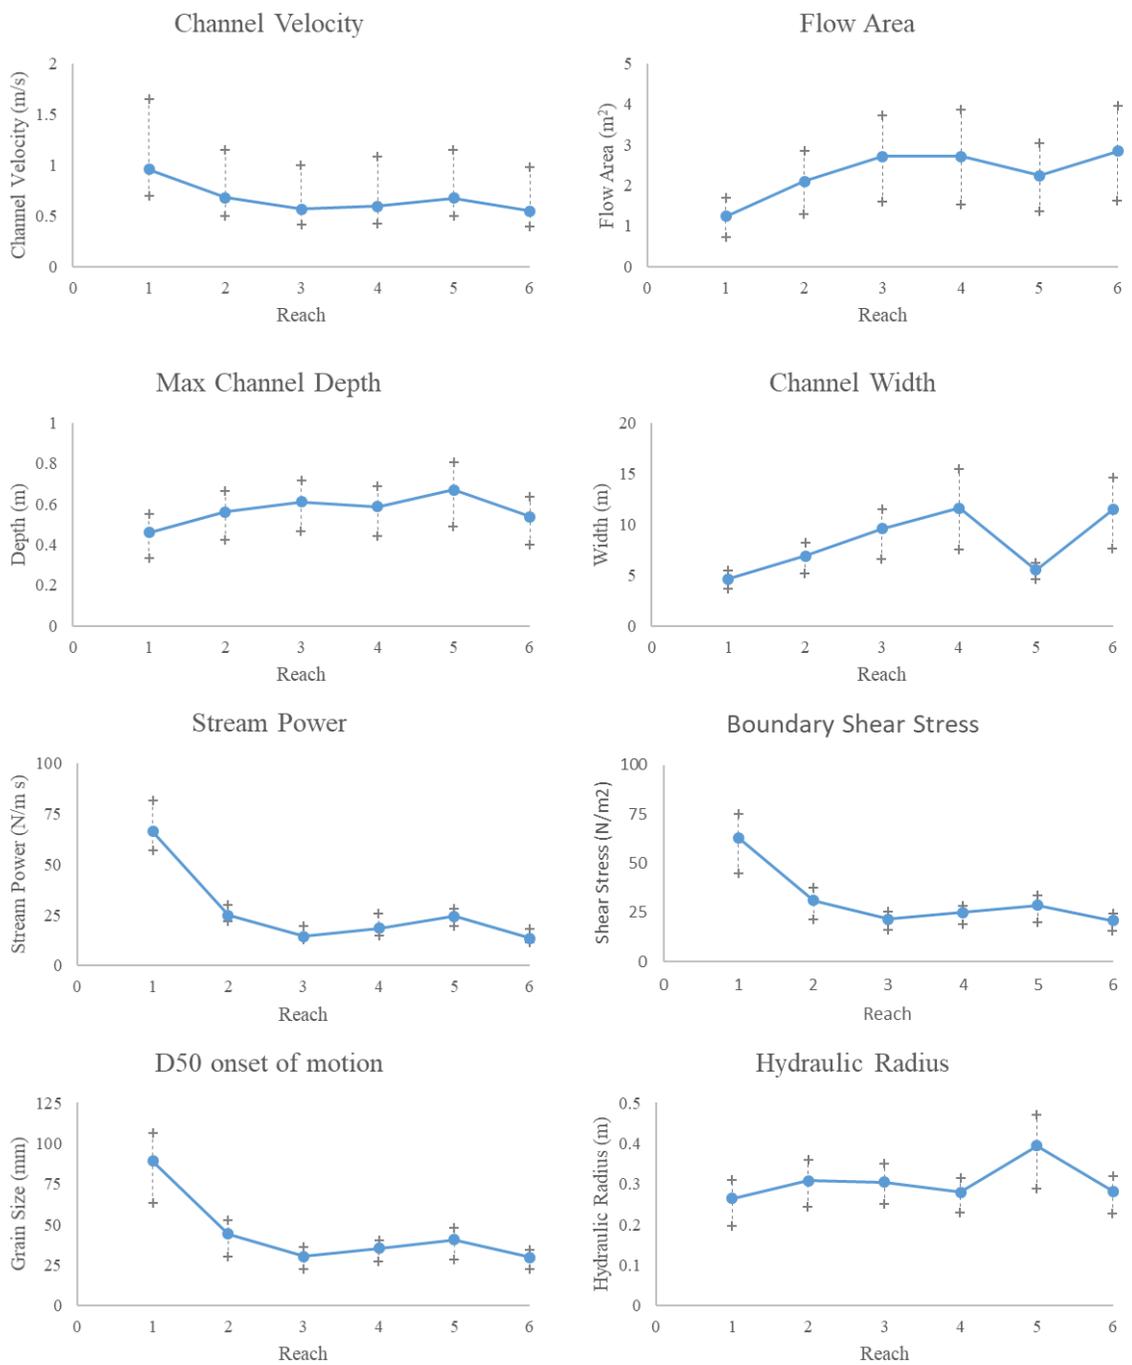
Figure 22 Plots of the results of HEC-RAS modeling divided by reach. Manning's n roughness of 0.065 is the blue dots and upper and lower limits are n=0.03 and 0.1 shown by the gray +. Reach 5 in all plots deviates from the trend due to incision.

By keeping Manning's n and discharge constant throughout LDC, we were able to analyze how width and depth change in each reach. It also allows for comparison of stream power and shear stress under the same conditions. Additional field data are needed to calibrate and validate the model; however, we believe the 1-meter resolution DEM is appropriate for HEC-RAS modeling of a stream of LDC size. Maps of water depth and velocity from the model are available for each reach in Appendix G.

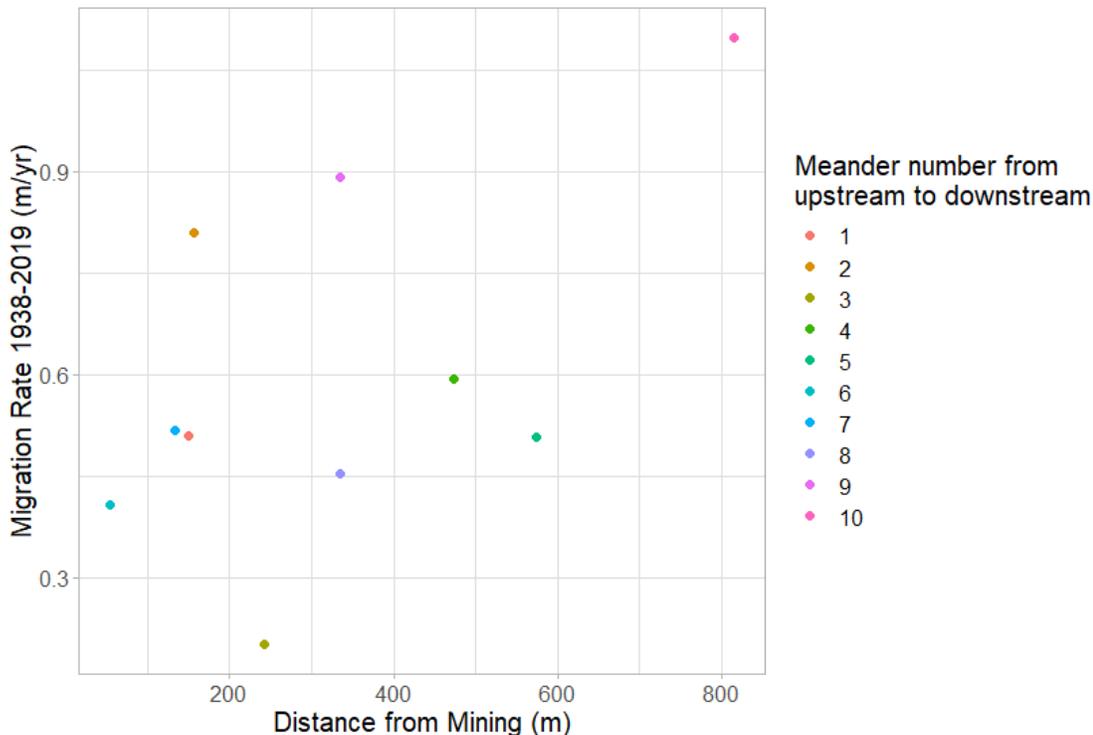
Figure 23 Plot of meander migration rate from 1938 to 2019 (m/yr) by distance from mining in meters from upstream (1) to downstream (10).

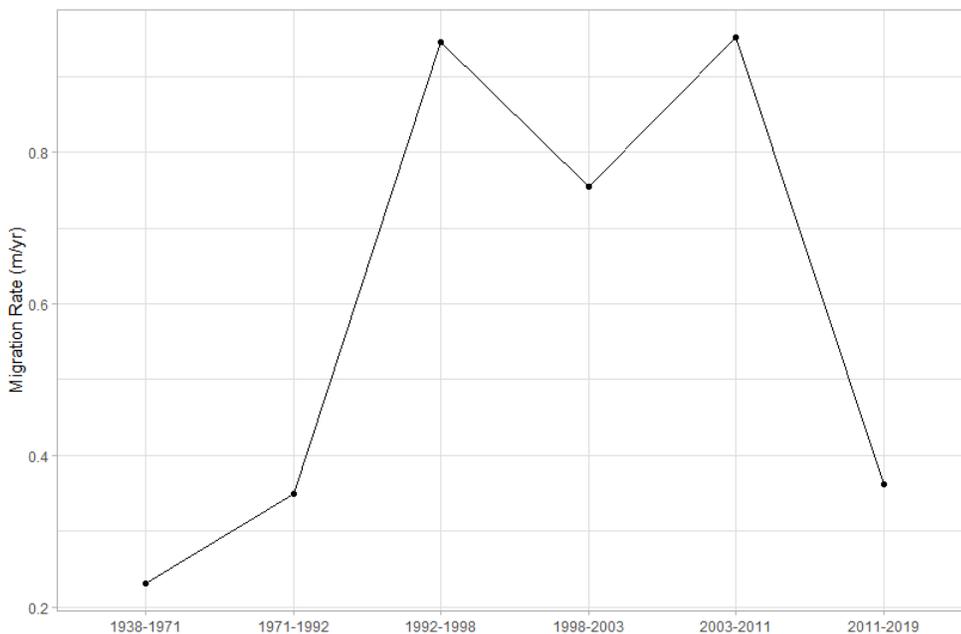
Figure 24 Plot of meander migration rate (m/yr) averaged for all 10 meanders between imagery years. Observe the rate increase between 1992 and 1998, which corresponds temporally to disturbances of the riparian vegetation potentially from a large rain on snow event. The rate stays high until 2011-2019 when the riparian vegetation reestablishes and stabilizes the channel.

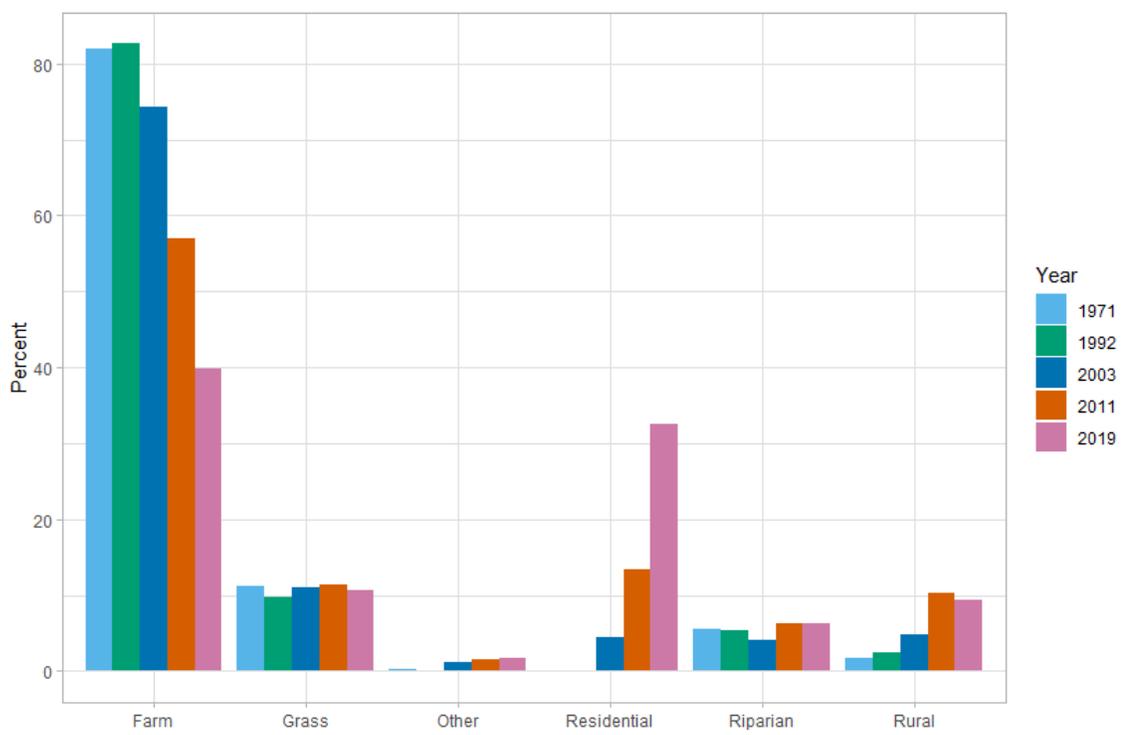
Figure 25 Plot of land-use for the entire Lower Dry Creek Valley through time. The valley has lost 42% of the farmland between 1971 and 2019. The lost farmland is today rural and residential development.

Year	Grass	Farm	Rural	Residential	Riparian	Other
1971	11.2	81.9	1.7	0.0	5.6	0.2
1992	9.8	82.6	2.4	0.0	5.3	0.0
2003	11.1	74.4	4.8	4.5	4.1	1.2
2011	11.3	57.1	10.3	13.4	6.3	1.6
2019	10.6	39.7	9.4	32.5	6.2	1.6

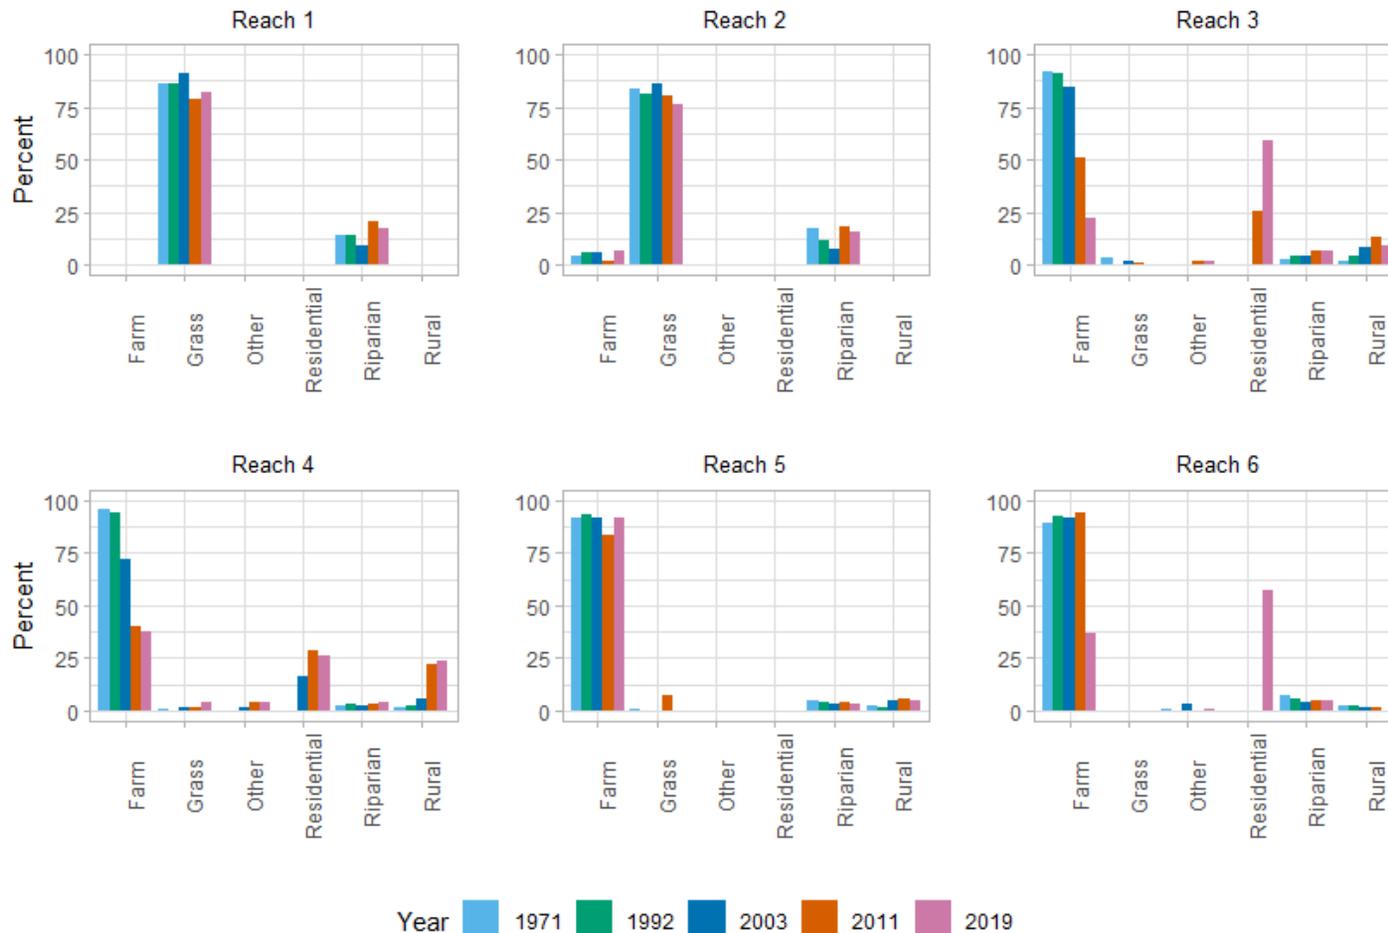
Figure 26 Plot of land-use delineation divided by reach in Lower Dry Creek Valley through time. Reach 1, 2 and 5 land-use has stayed constant through time. Reach 3 and 4 has seen a large amount of farmland converted to rural and residential development. Reach 6 is the site of ongoing development and will continue to see farmland converted to residential development.

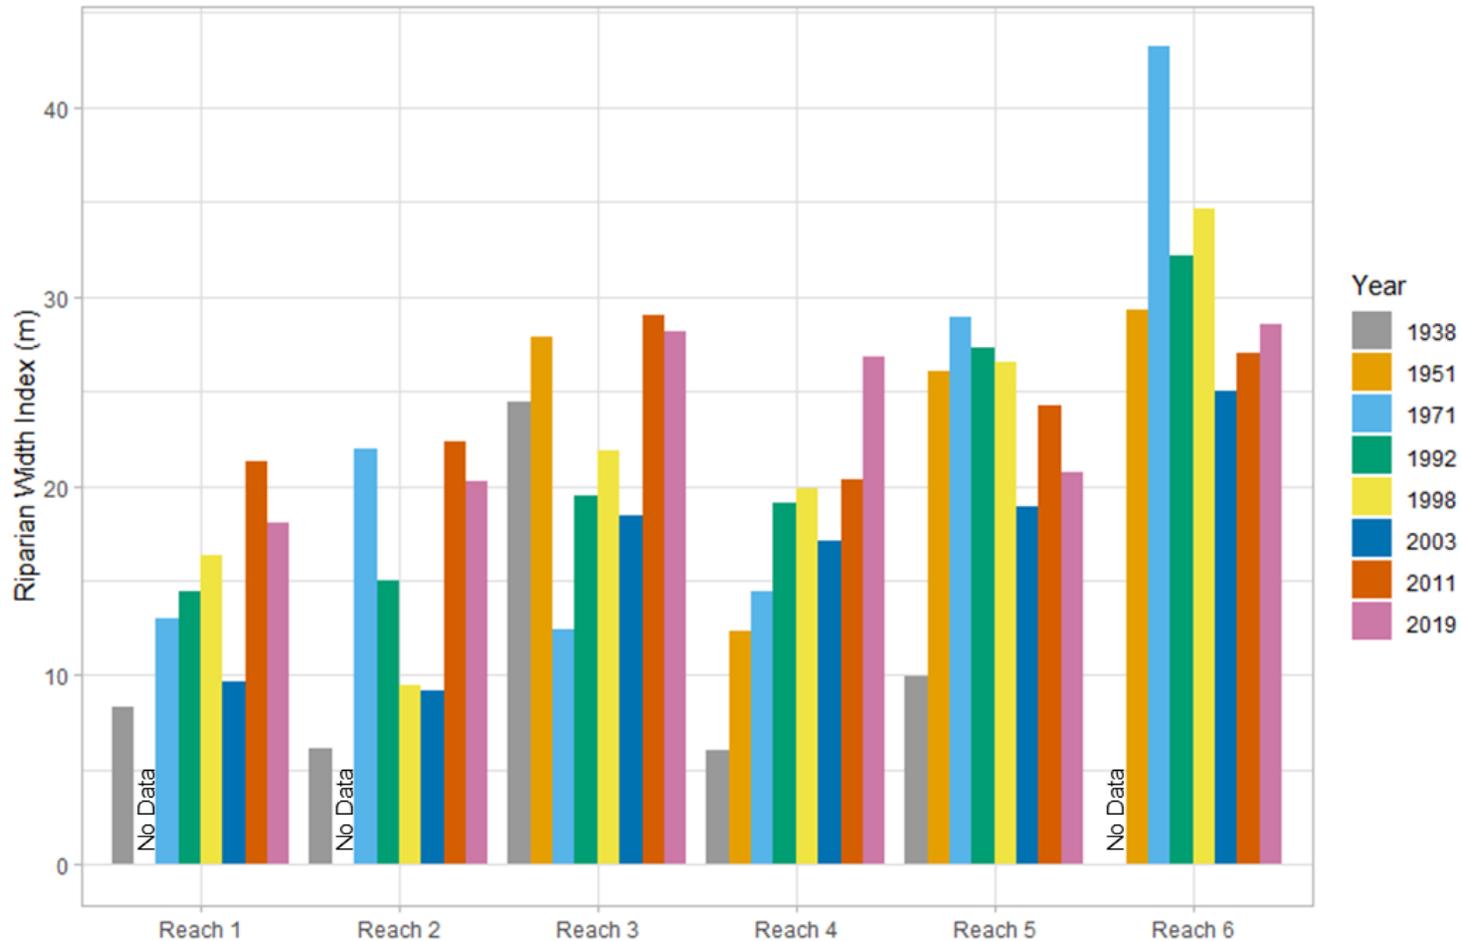
Figure 27 Plot of riparian width index (riparian area divided by stream length) for each reach through time. Reach 2 had a large loss of riparian vegetation after 1992 which corresponds temporally with a 100-year storm in December 1996 to January 1997 and an increase in meander migration rate (Figure 24). Reach 5 has lost riparian vegetation since 1992, which may relate to incision limiting the space for vegetation. Imagery from 2003 is from April, which is before full foliage of riparian vegetation and may have resulted in lower riparian vegetation delineation.

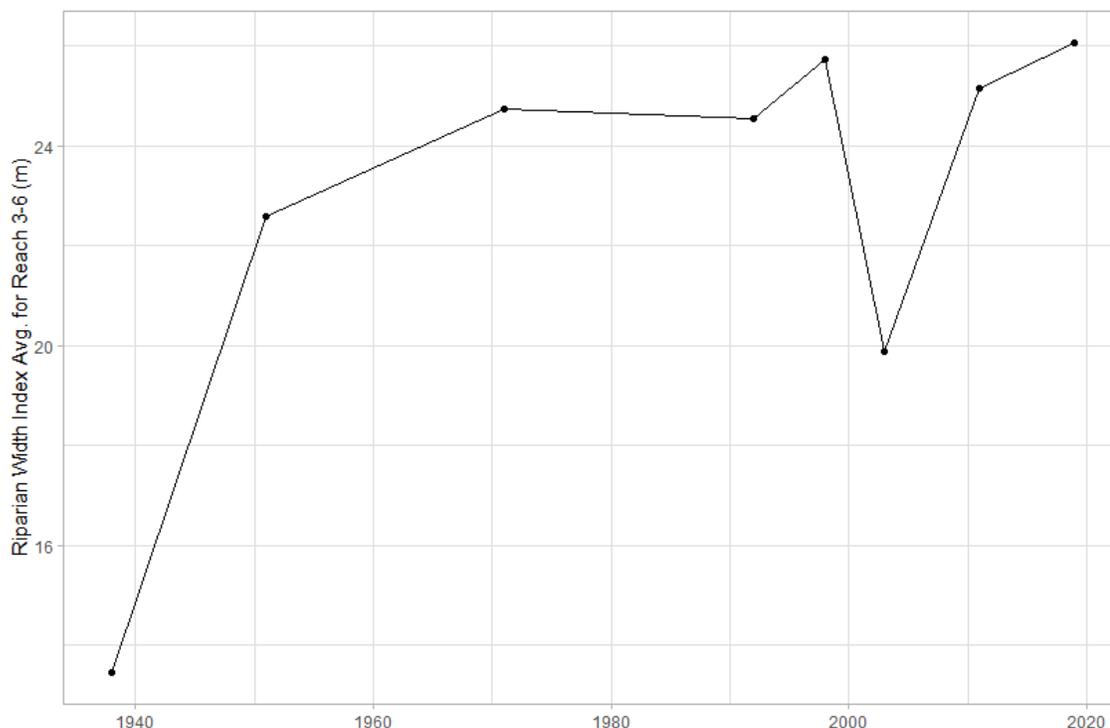
Figure 28 Plot of riparian width index (riparian area divided by stream length) averaged for Reach 3 to 6 though time. Disregarding 2003, riparian width is approximately constant since 1971 in Reach 3 to 6 despite the conversion of farmland to development. Imagery from 2003 is from April, which is before full foliage of riparian vegetation and may have resulted in lower riparian vegetation delineation.

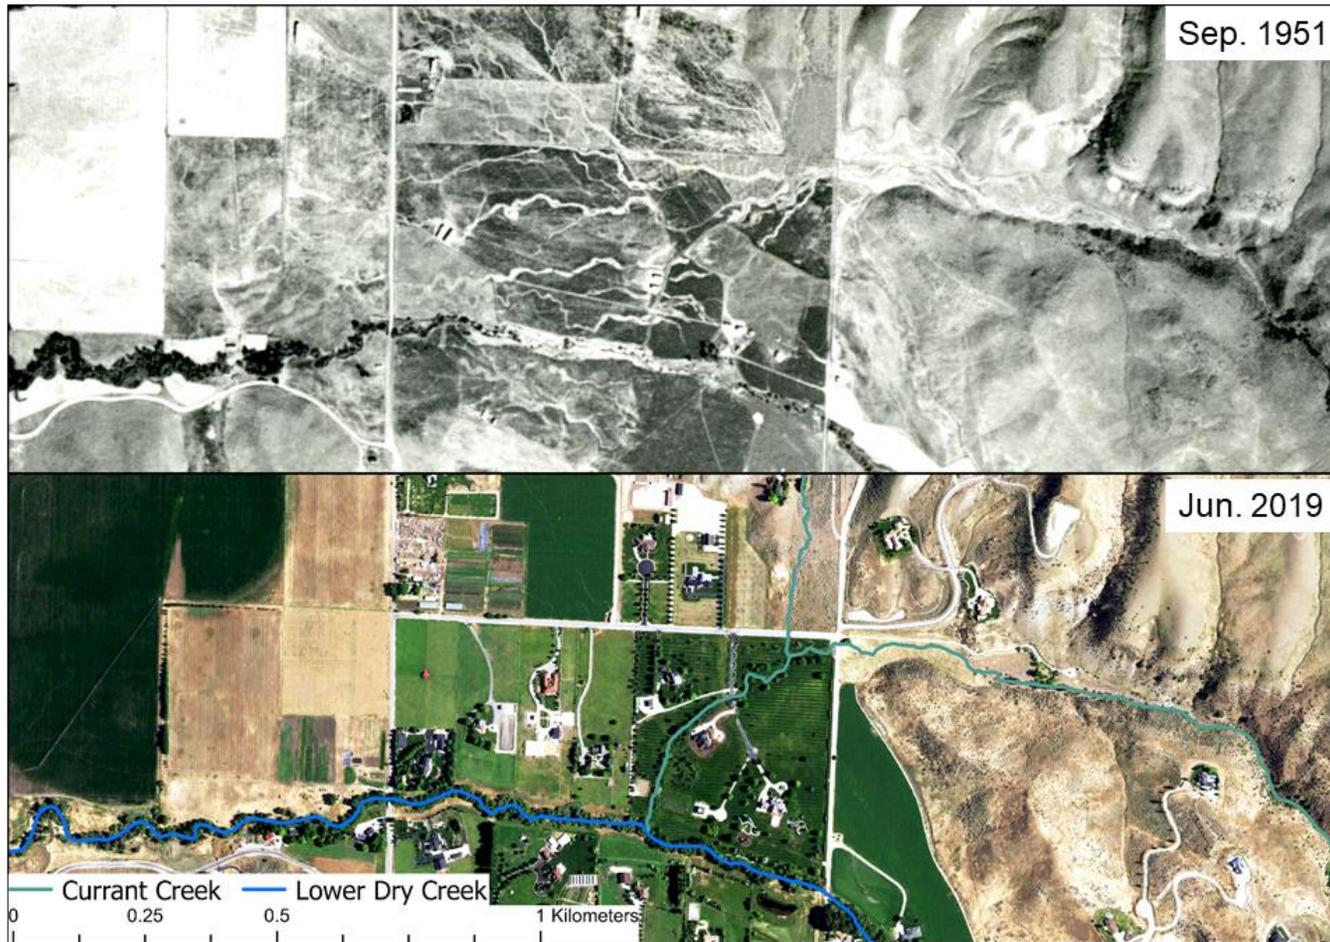
Figure 29 Imagery showing Currant Creek confluence with Lower Dry Creek in 1951 and 2019. In 1951 Currant Creek transitioned to a series of distributaries across the Hidden Springs Terrace. Observe the amount of sediment deposition on the floodplain in 1951. In 2019, Currant Creek is channelized to prevent flooding of rural housing. Flow paths of Currant and Lower Dry Creek are delineated in 2019 imagery.

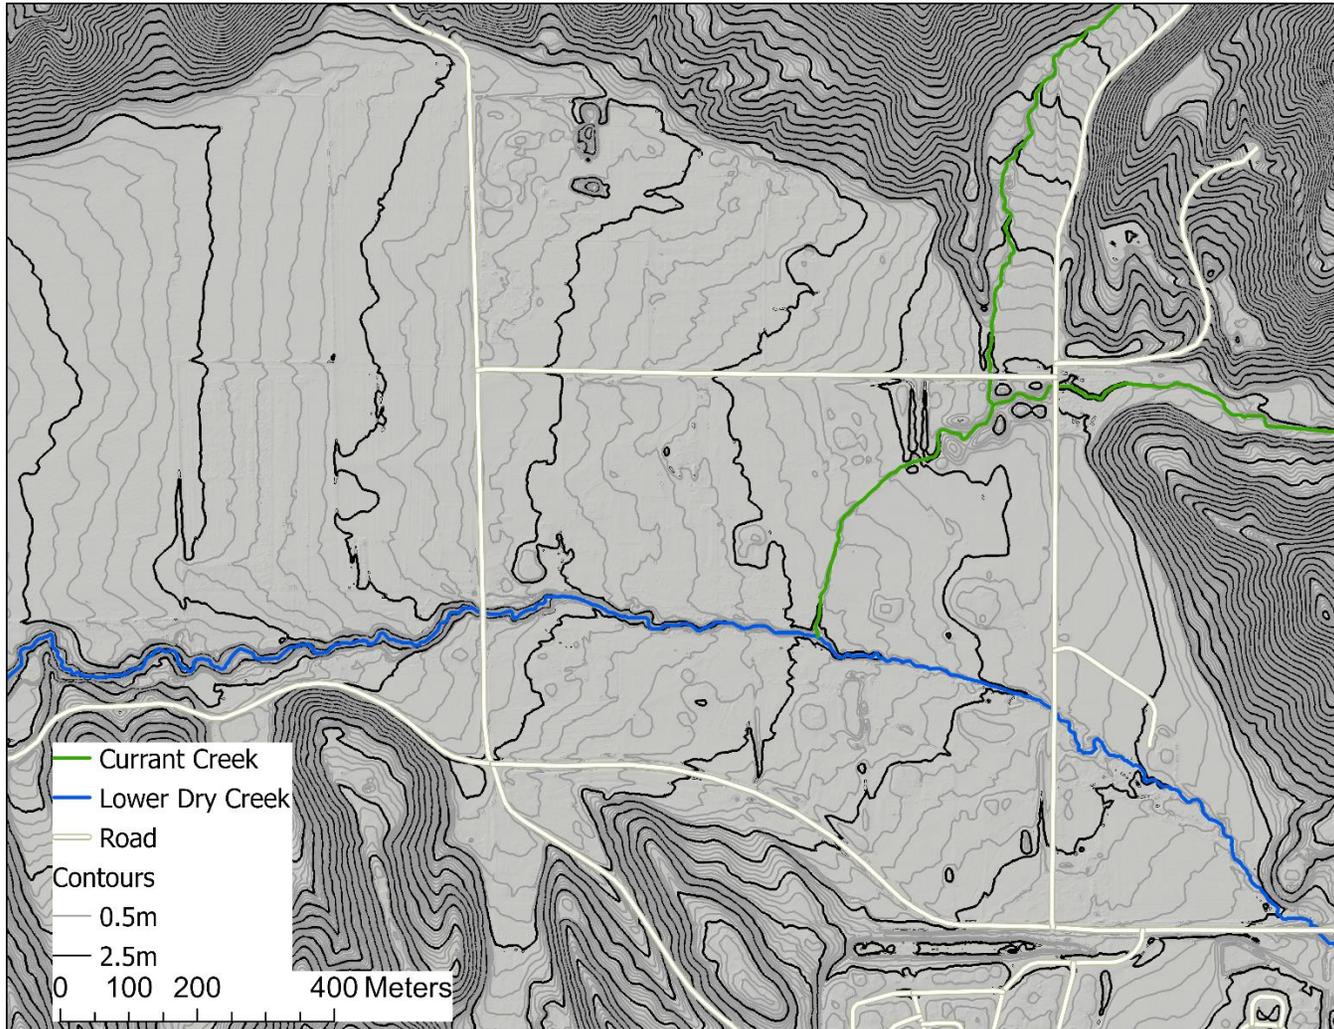
Figure 30 Hillshade map showing the confluence of Currant Creek with Lower Dry Creek. Contour lines at an interval 0.5 meters show a fan shape at the location of distributaries of Currant Creek visible in the 1951 imagery in figure 29.

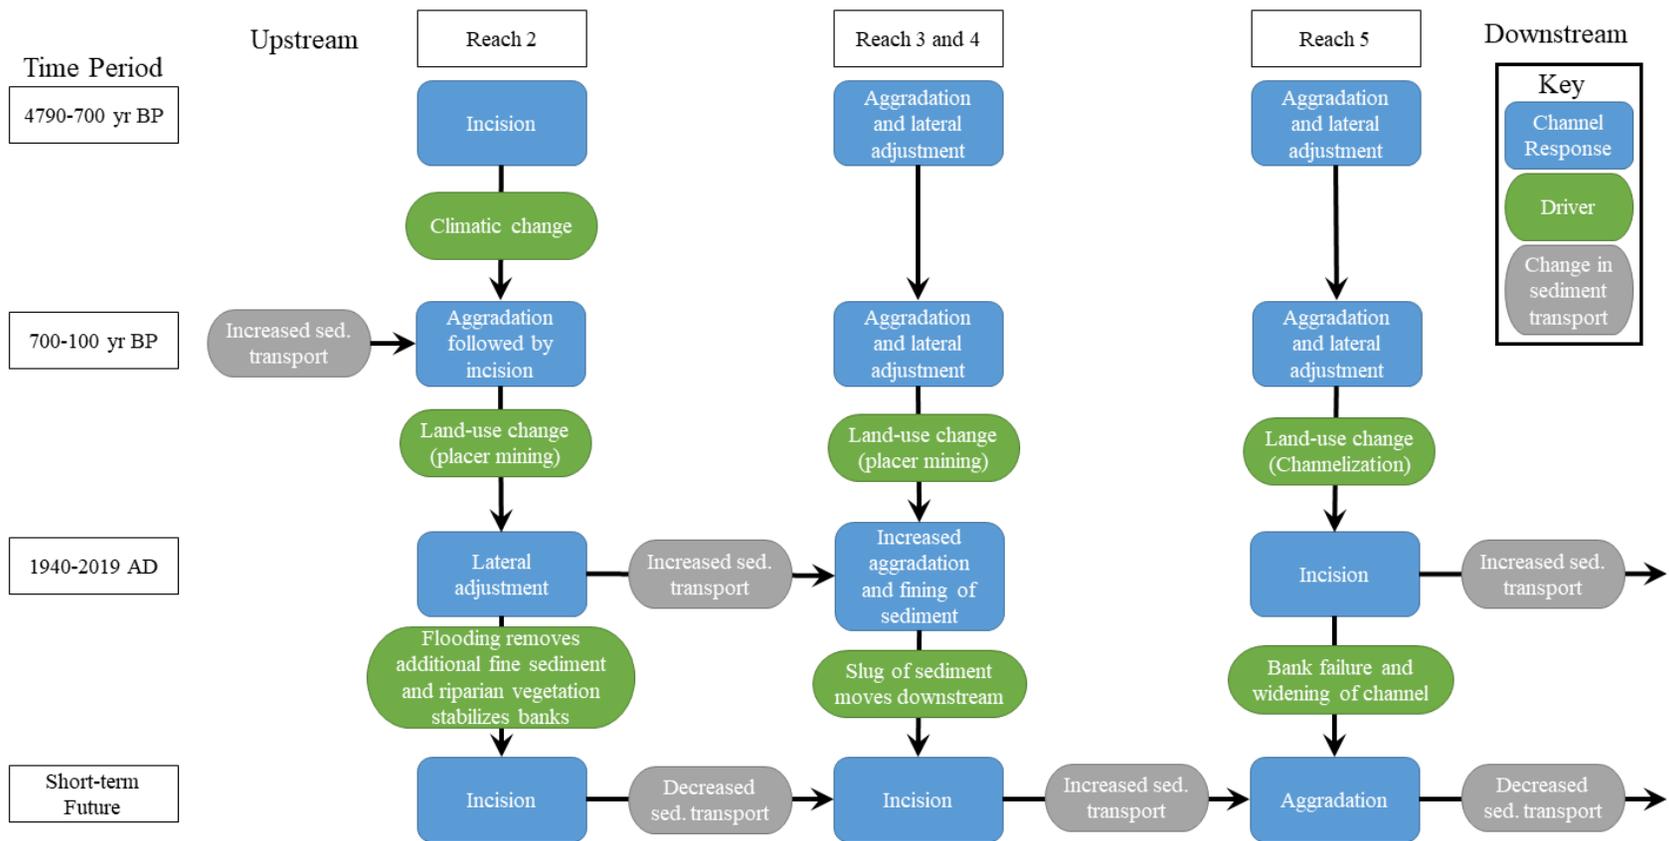
Figure 31 Flow chart of channel responses, drivers, and sediment transport changes of Lower Dry Creek. Time periods are from the earliest Quaternary date from this study to modern time. We hypothesize channel response Lower Dry Creek may experience in the short-term future. Blue boxes are channel responses we interpreted or observed during the time period. Green boxes are interpreted drivers which caused the channel response. Gray boxes are interpreted changes of sediment transport between reaches. Where there is no green or gray box we were unable to interpret a driver or change in sediment transport.

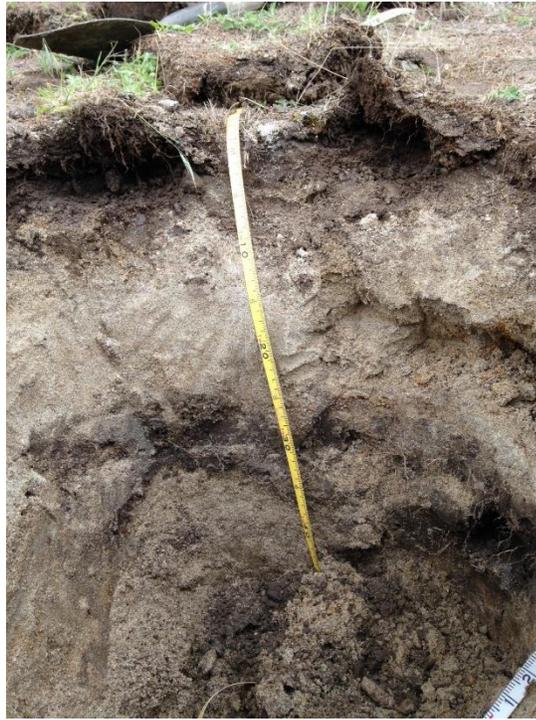
Figure B1 Photo of DC-Terrace 1 soil pit on terrace 0.6m above current Lower Dry Creek bankfull.

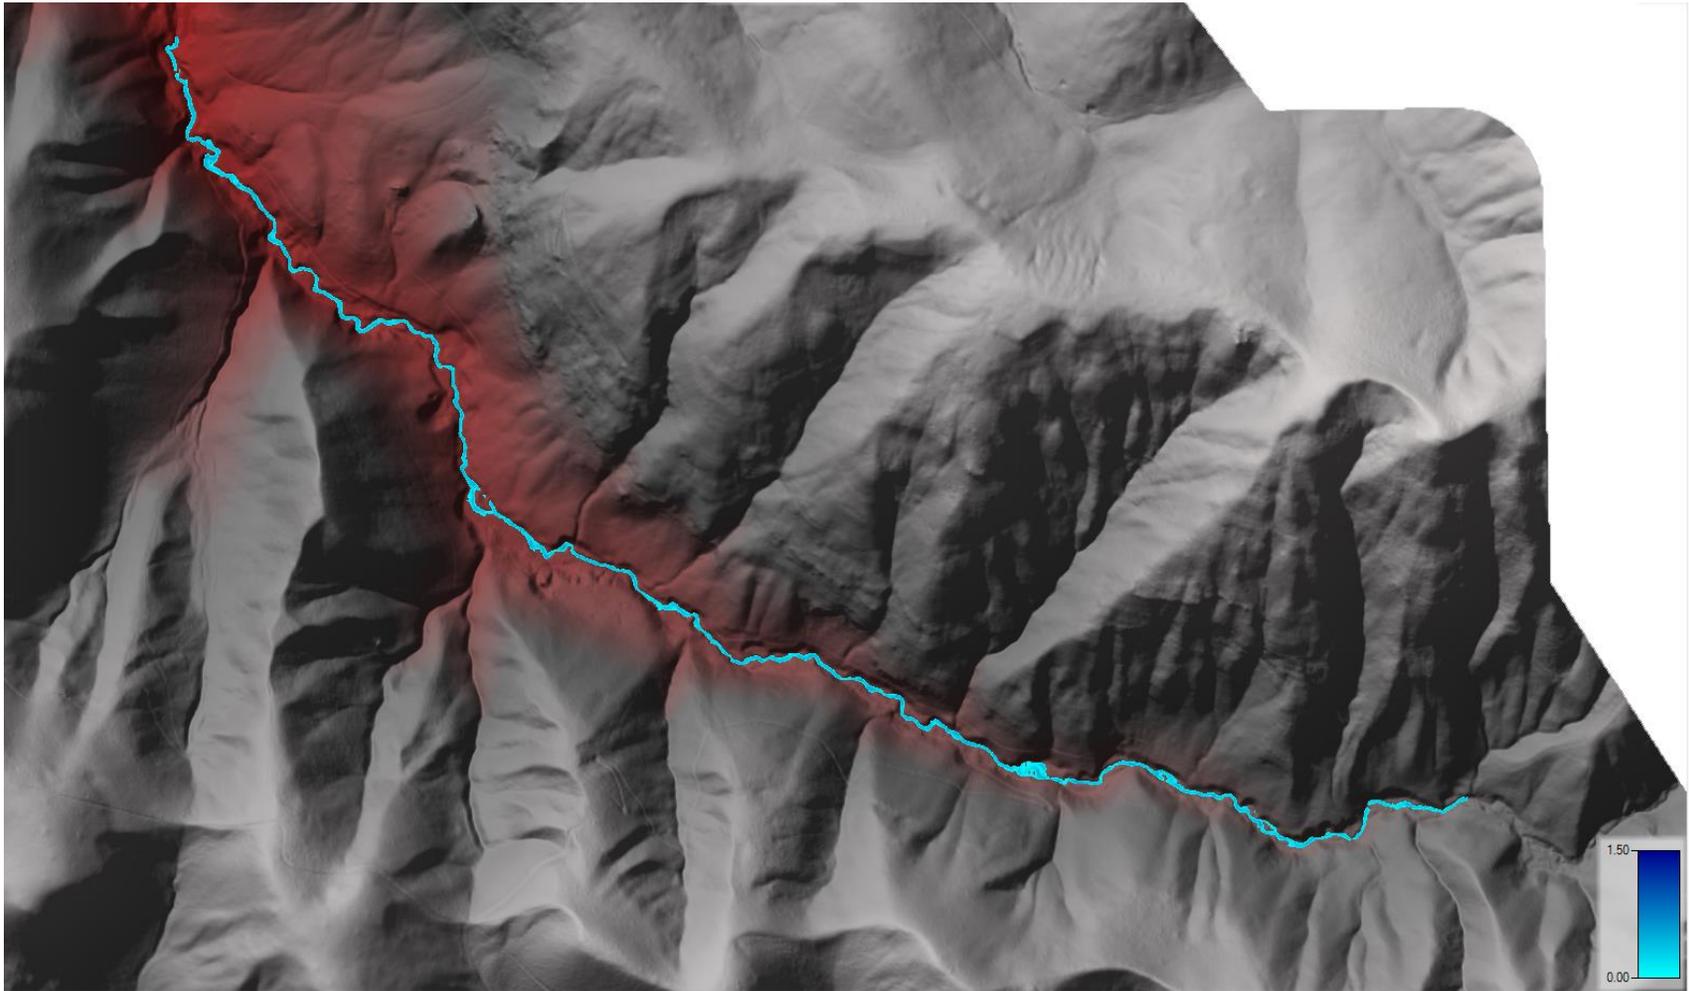
Figure G1 Model results of Reach 1 water depth with a discharge of $1.13 \text{ m}^3/\text{s}$ and a Manning n 0.065.

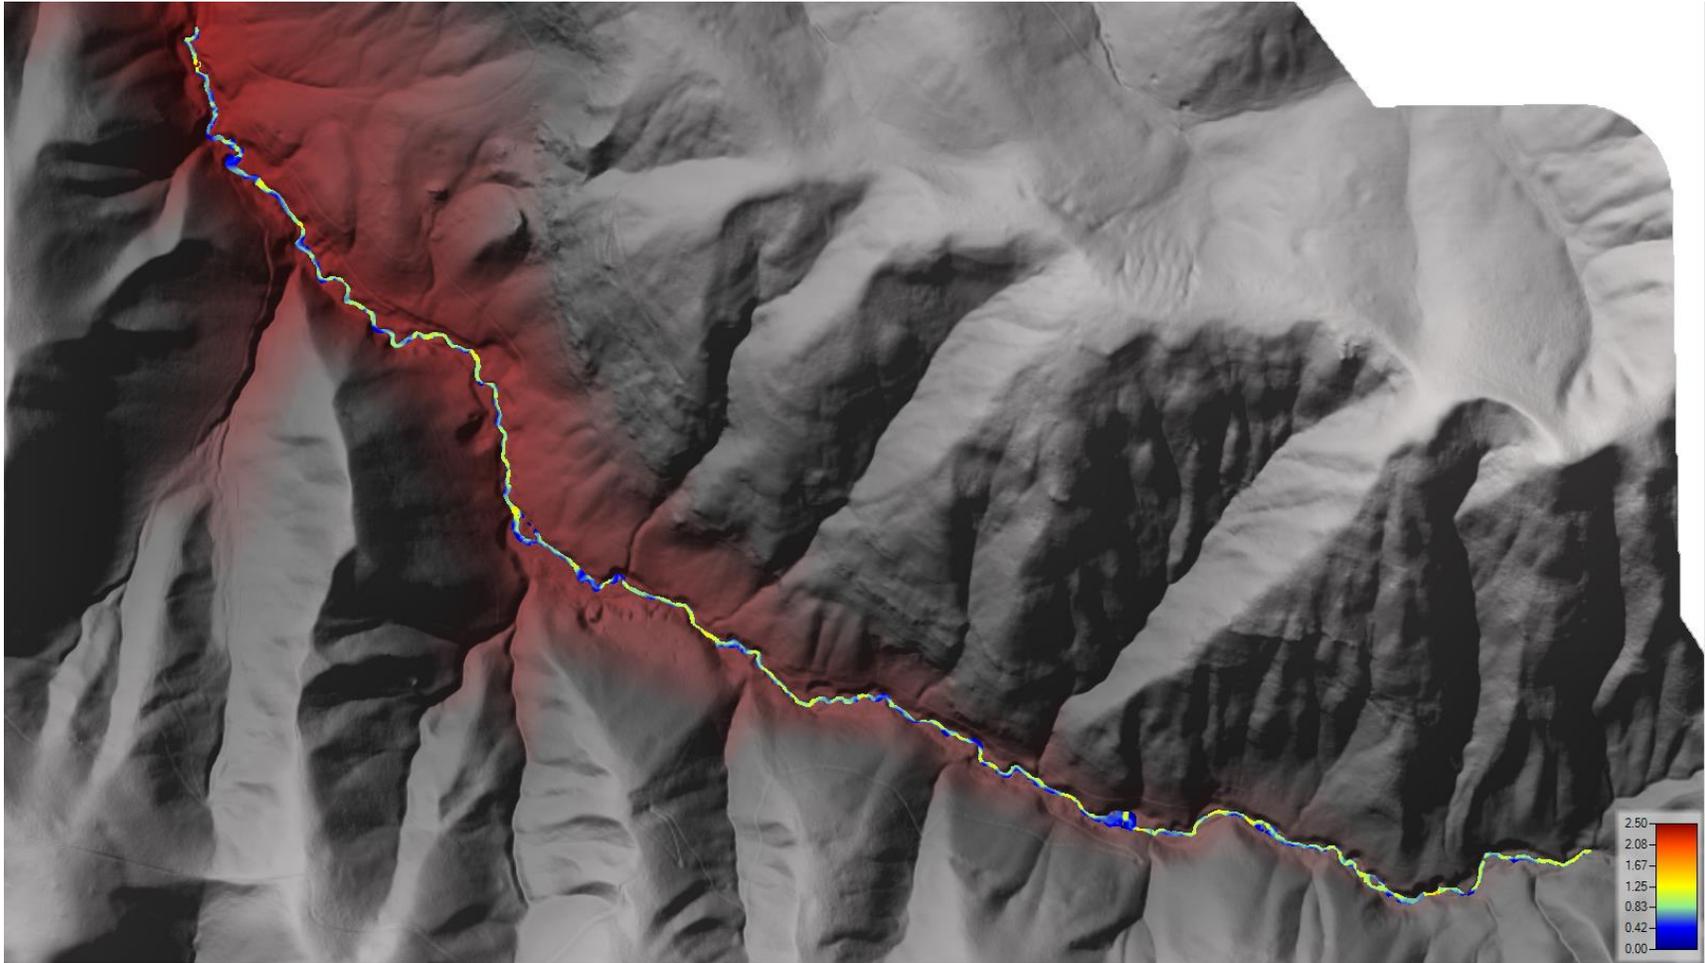
Figure G2 Model results of Reach 1 water velocity with a discharge of $1.13\text{m}^3/\text{s}$ and a Manning n 0.065.

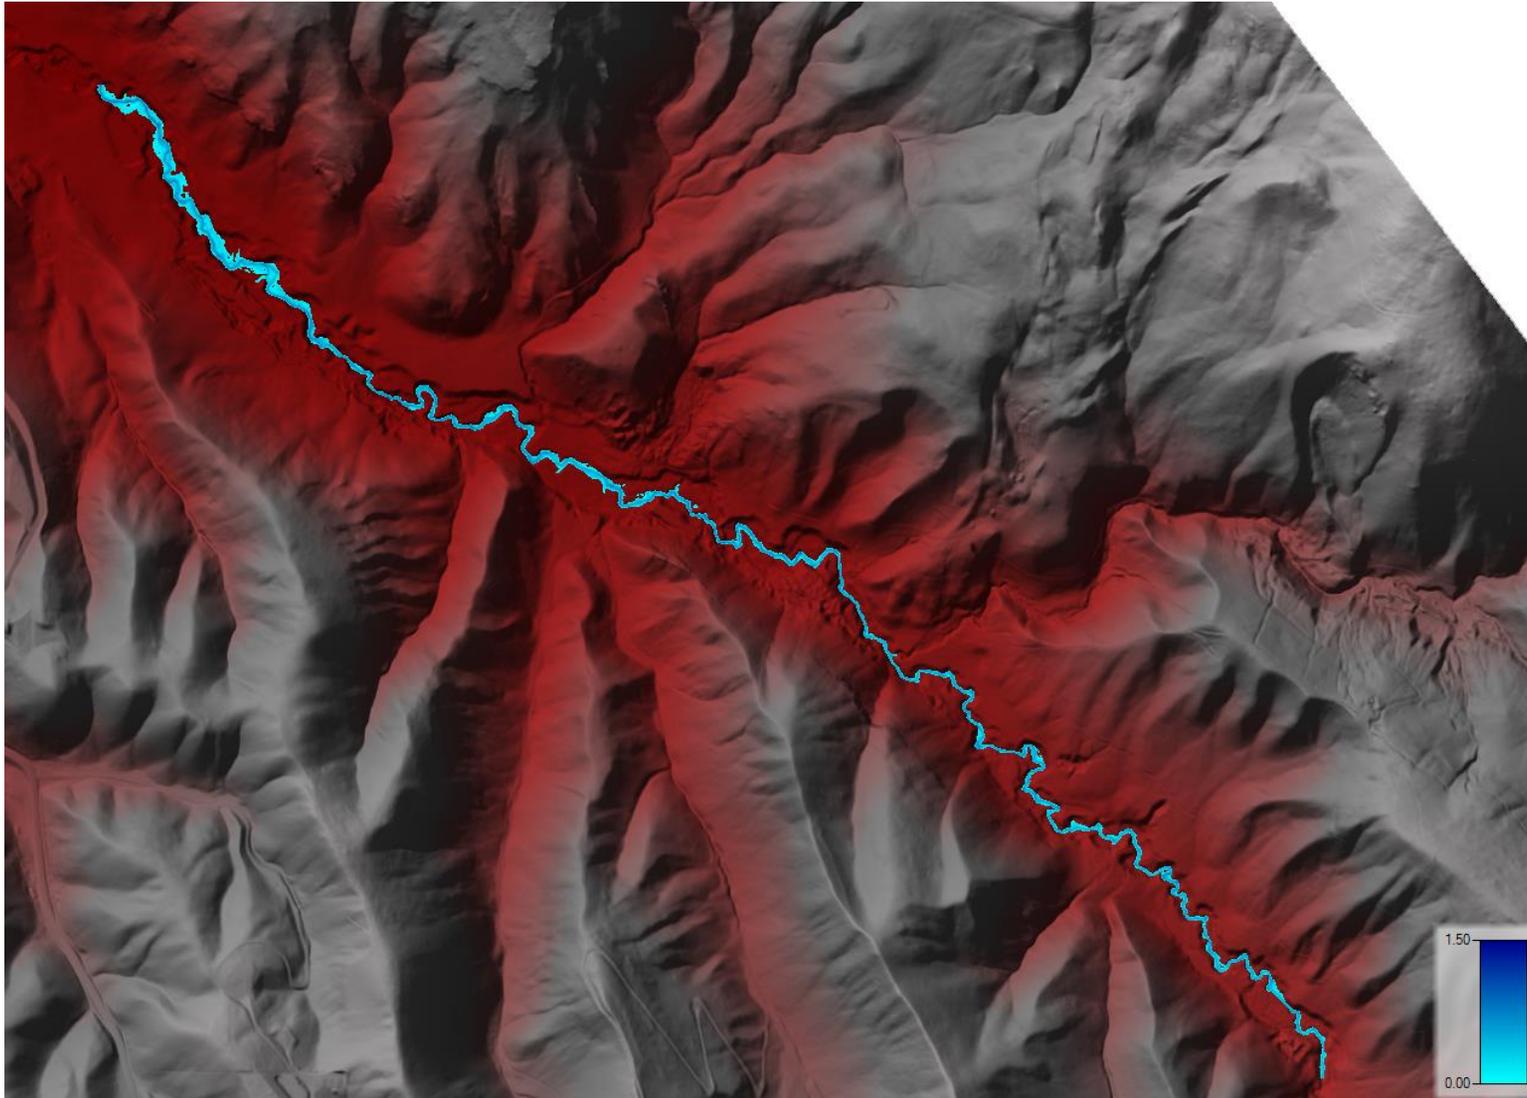
Figure G3 Model results of Reach 2 water depth with a discharge of $1.42\text{m}^3/\text{s}$ and a Manning n 0.065.
