THE SIGNAL OF MODERN TO HOLOCENE DRIVERS OF COMPLEX CHANNEL
RESPONSE OF A SMALL ALLUVIAL STREAM

A thesis

Master of Science in Hydrologic Sciences

Boise State University

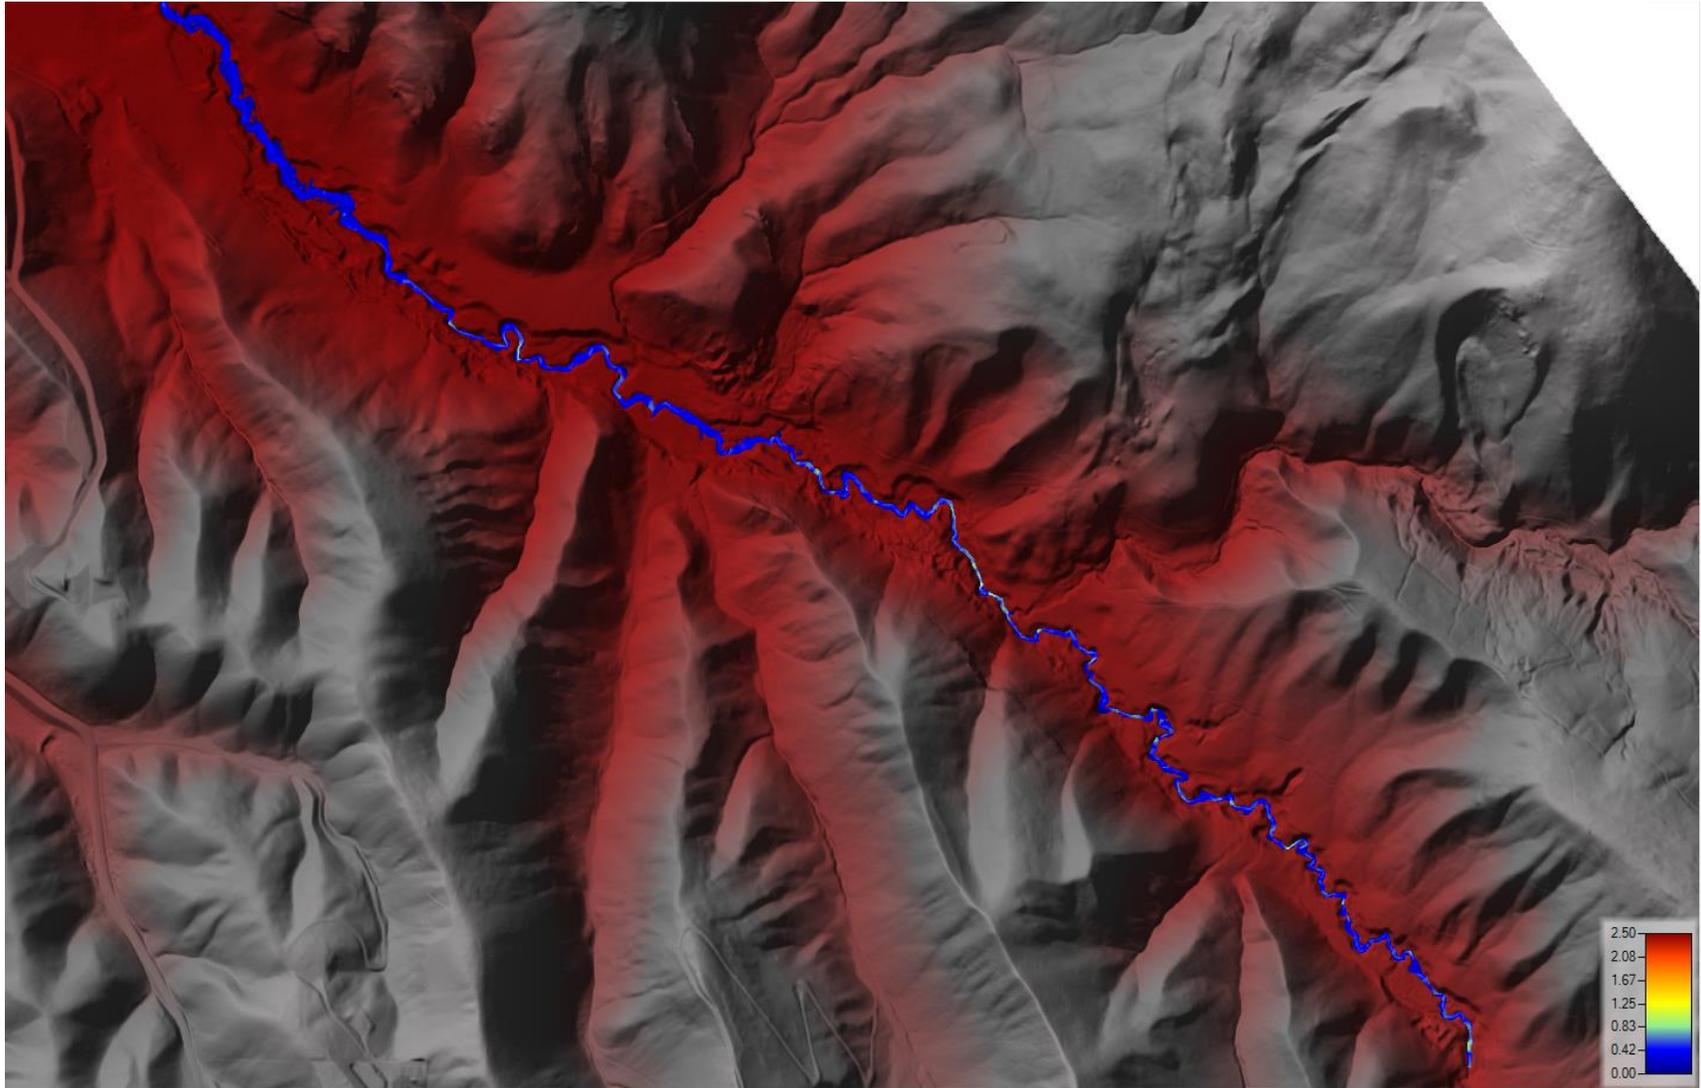
Figure G4 Model results of Reach 2 water velocity with a discharge of $1.42\text{m}^3/\text{s}$ and a Manning n 0.065.

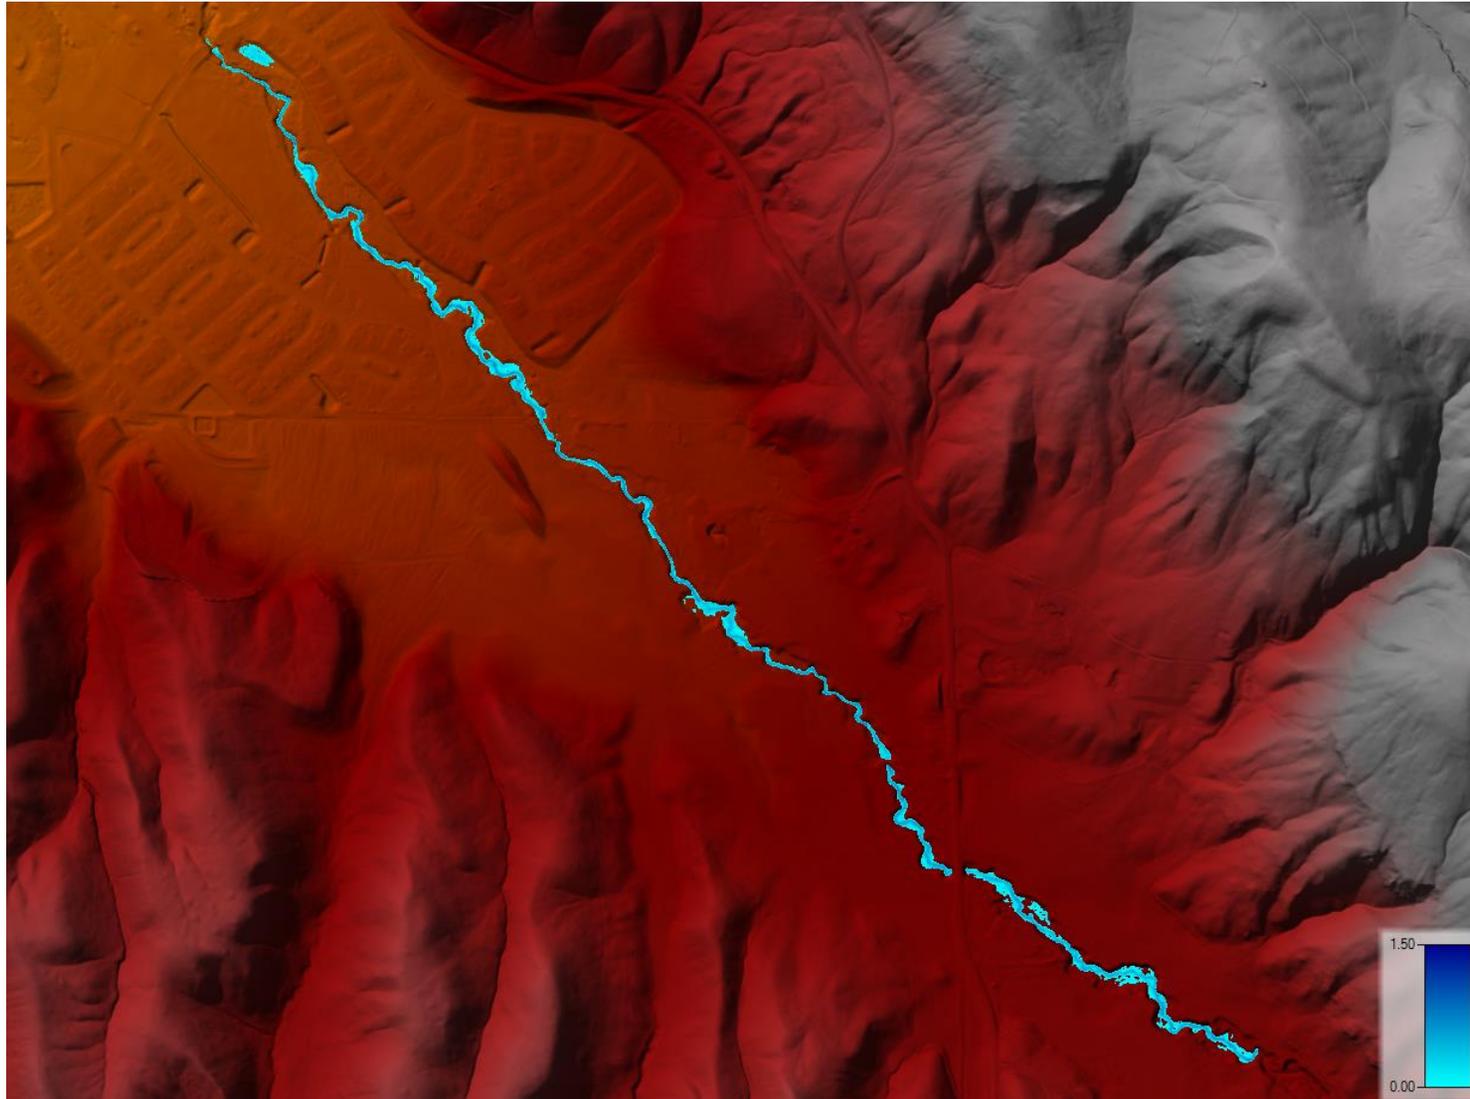
Figure G5 Model results of Reach 3 water depth with a discharge of $1.42\text{m}^3/\text{s}$ and a Manning n 0.065.

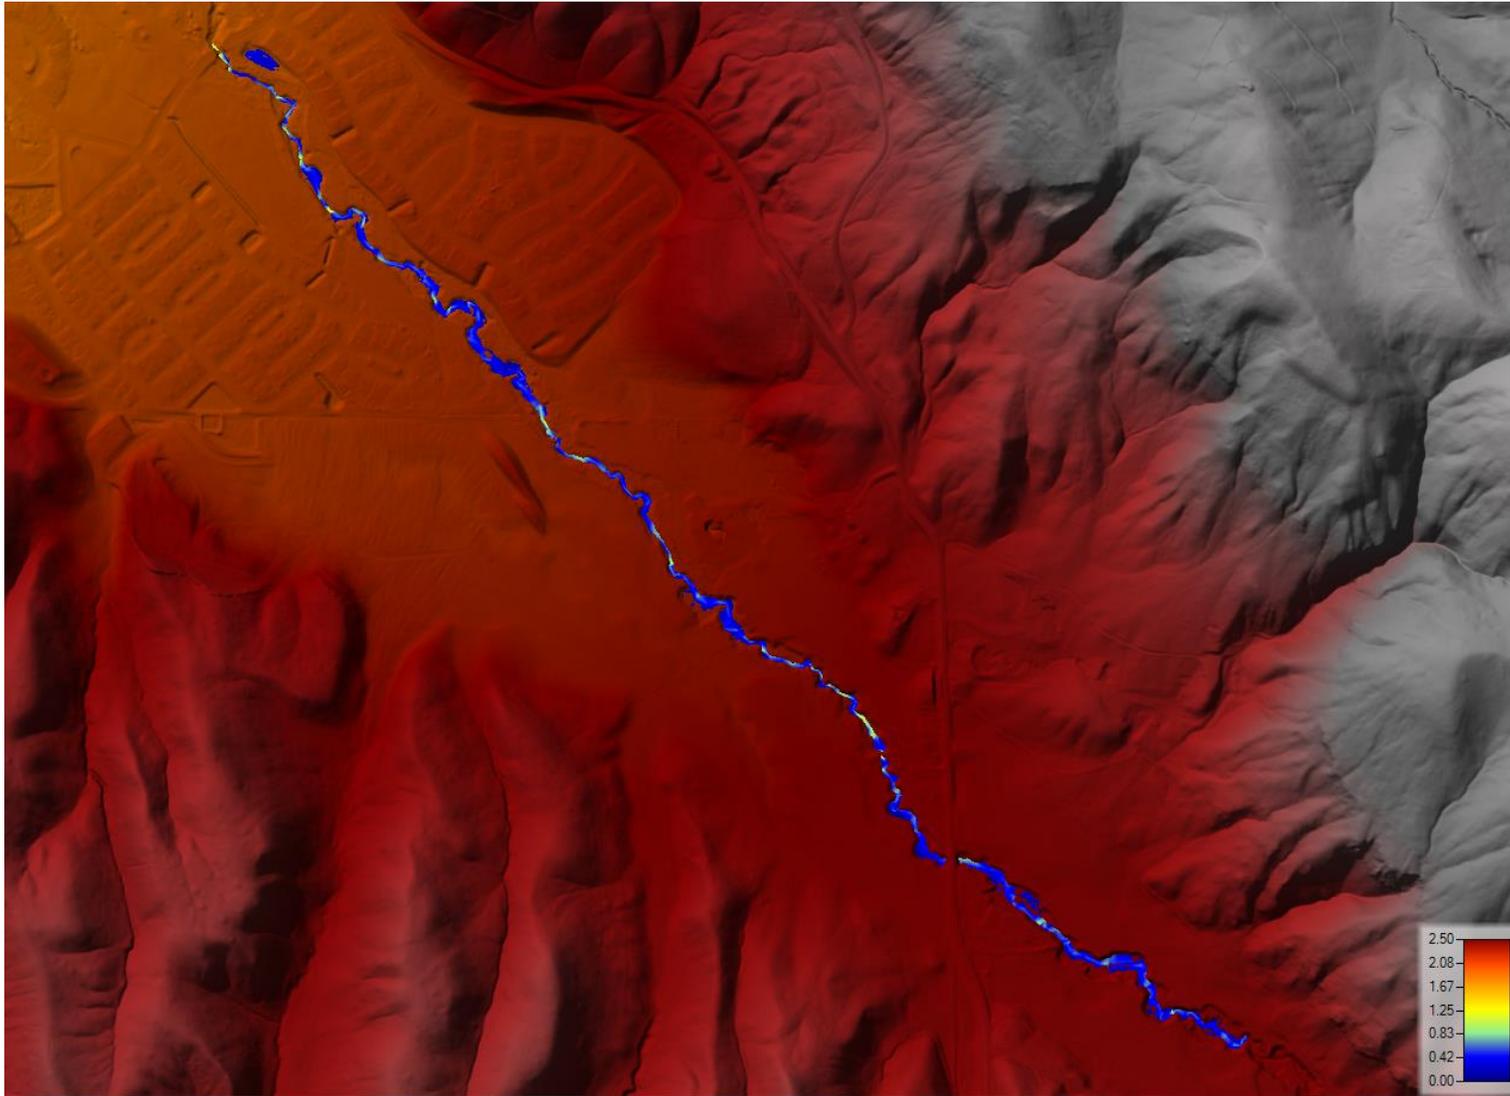
Figure G6 Model results of Reach 3 water velocity with a discharge of $1.42\text{m}^3/\text{s}$ and a Manning n 0.065.

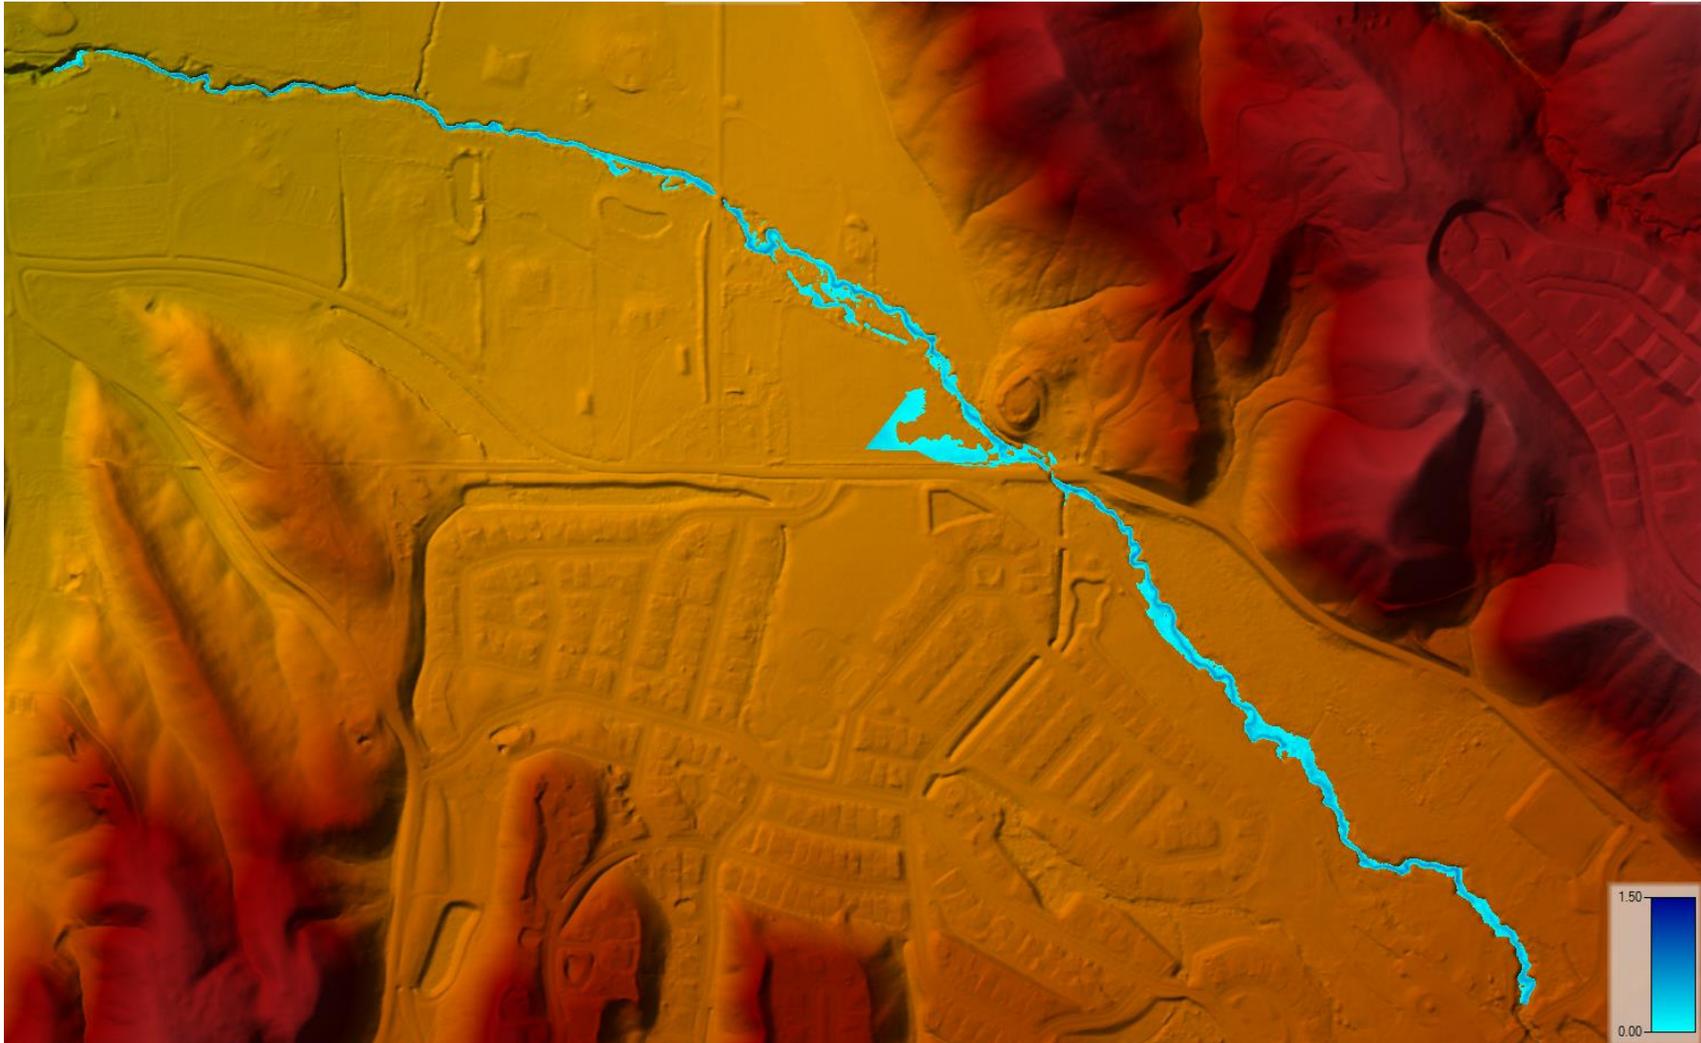
Figure G7 Model results of Reach 4 water depth with a discharge of $1.42\text{m}^3/\text{s}$ and a Manning n 0.065.

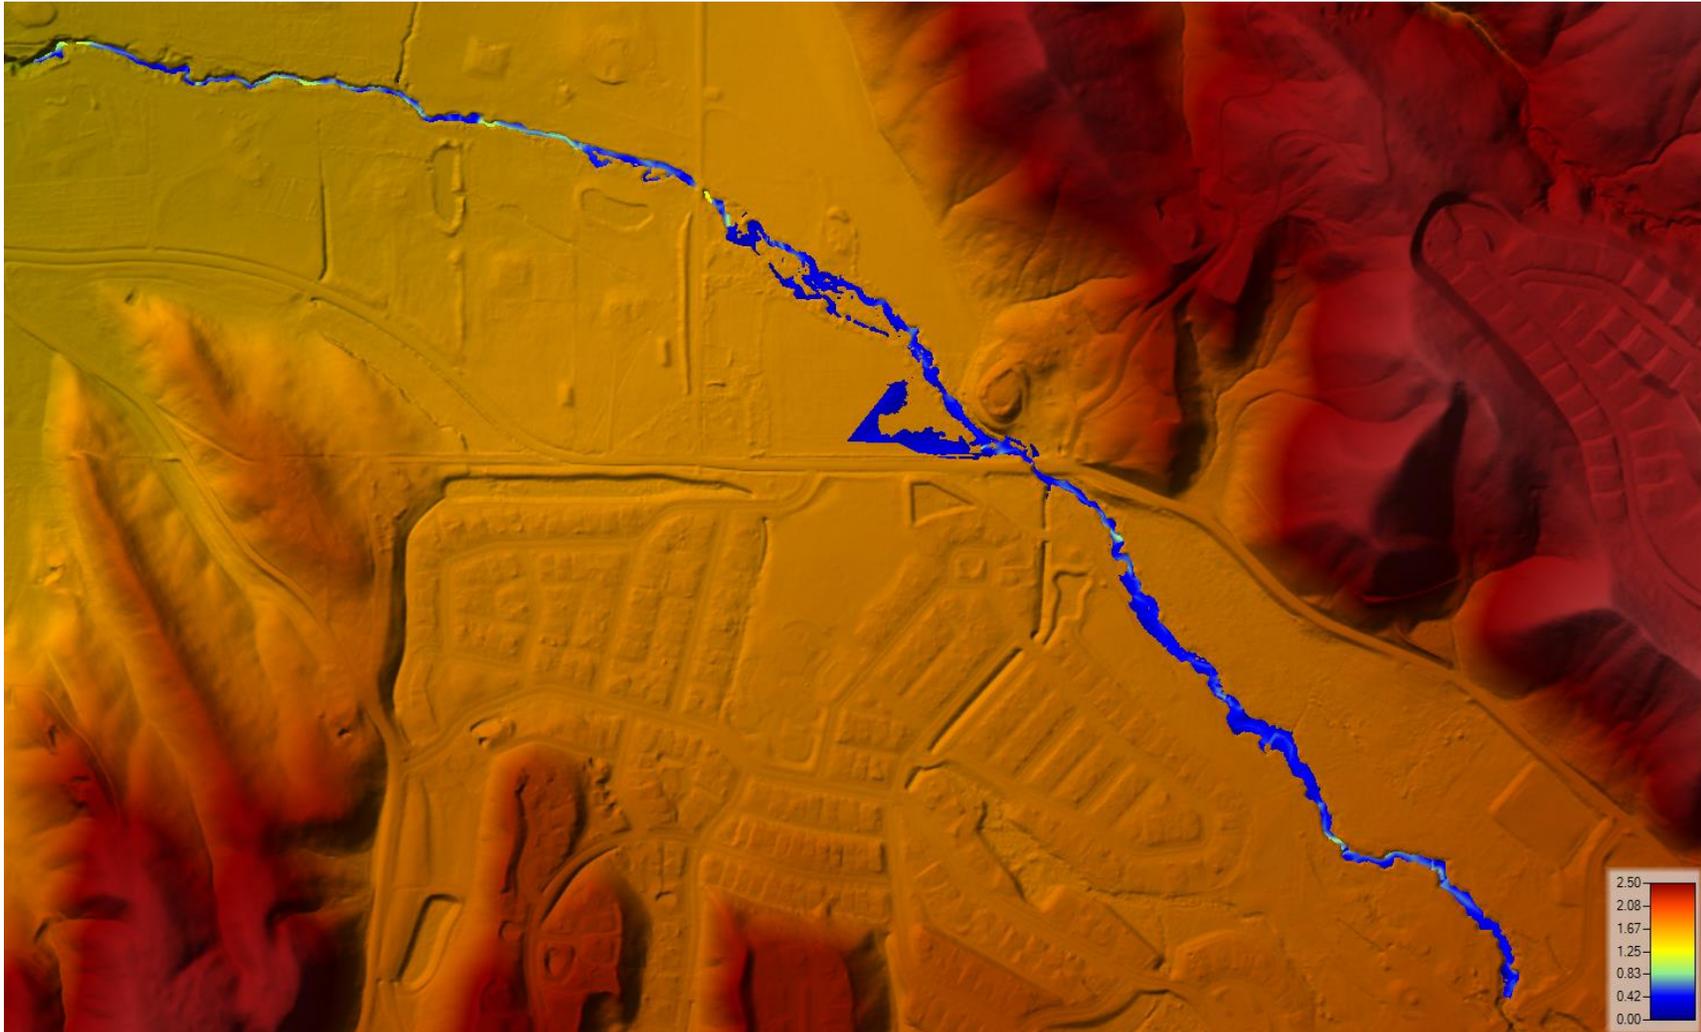
Figure G8 Model results of Reach 4 water velocity with a discharge of $1.42\text{m}^3/\text{s}$ and a Manning n 0.065.

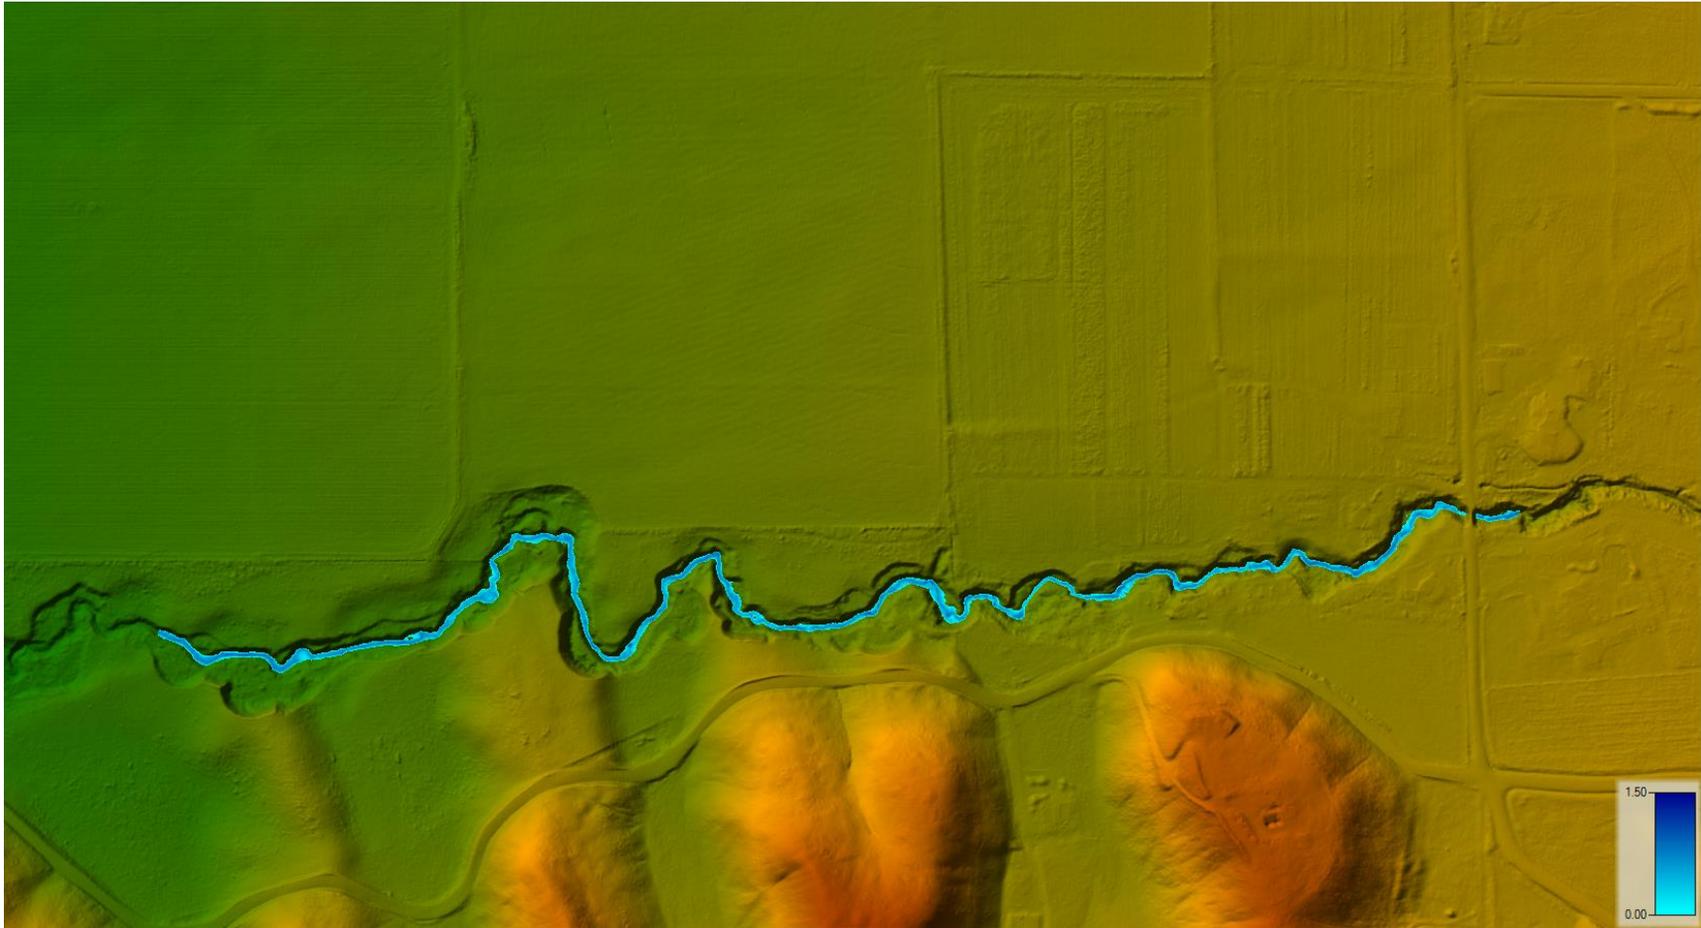
Figure G9 Model results of Reach 5 water depth with a discharge of $1.42\text{m}^3/\text{s}$ and a Manning n 0.065.

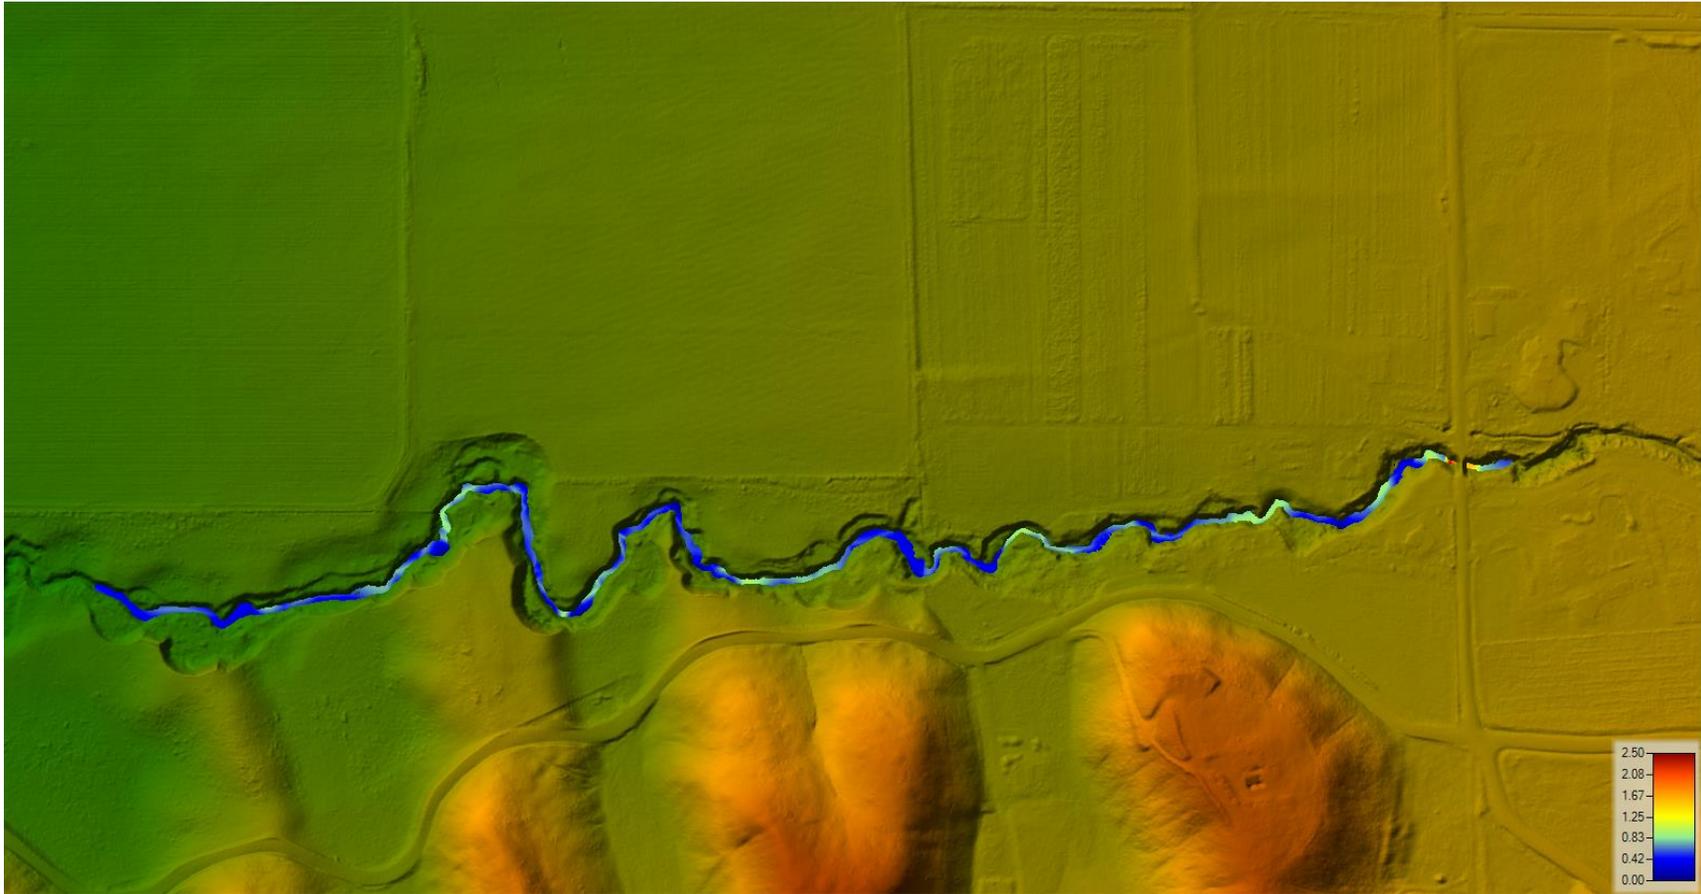
Figure G10 Model results of Reach 5 water velocity with a discharge of $1.42\text{m}^3/\text{s}$ and a Manning n 0.065.

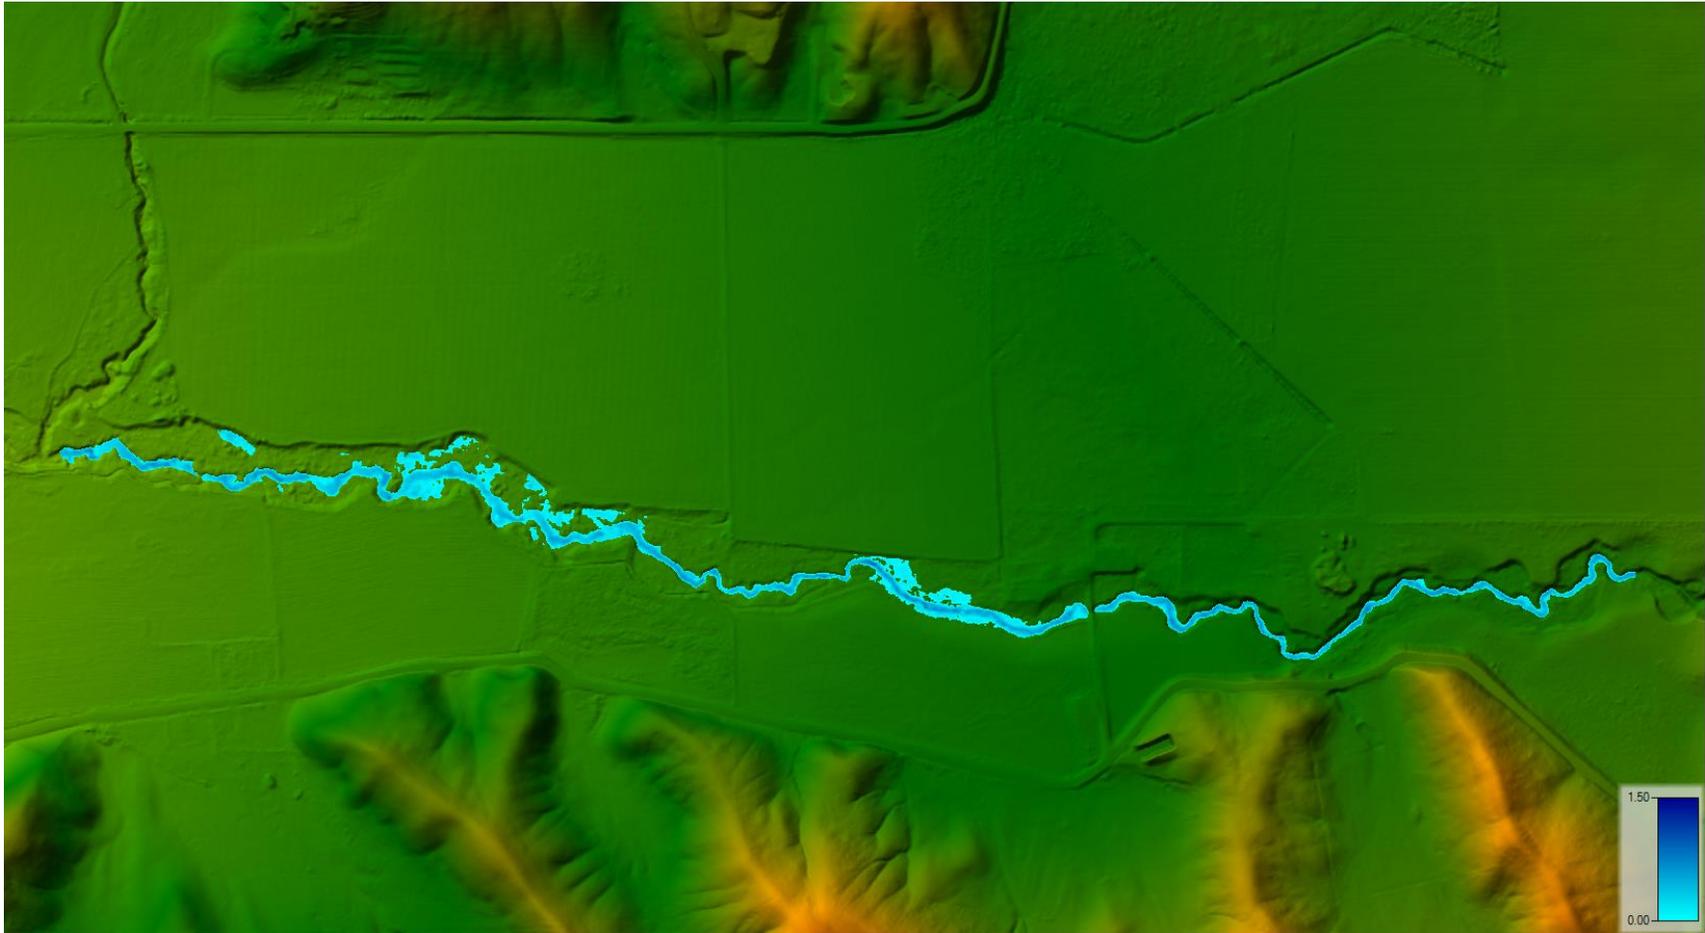
Figure G11 Model results of Reach 6 water depth with a discharge of $1.42\text{m}^3/\text{s}$ and a Manning n 0.065.

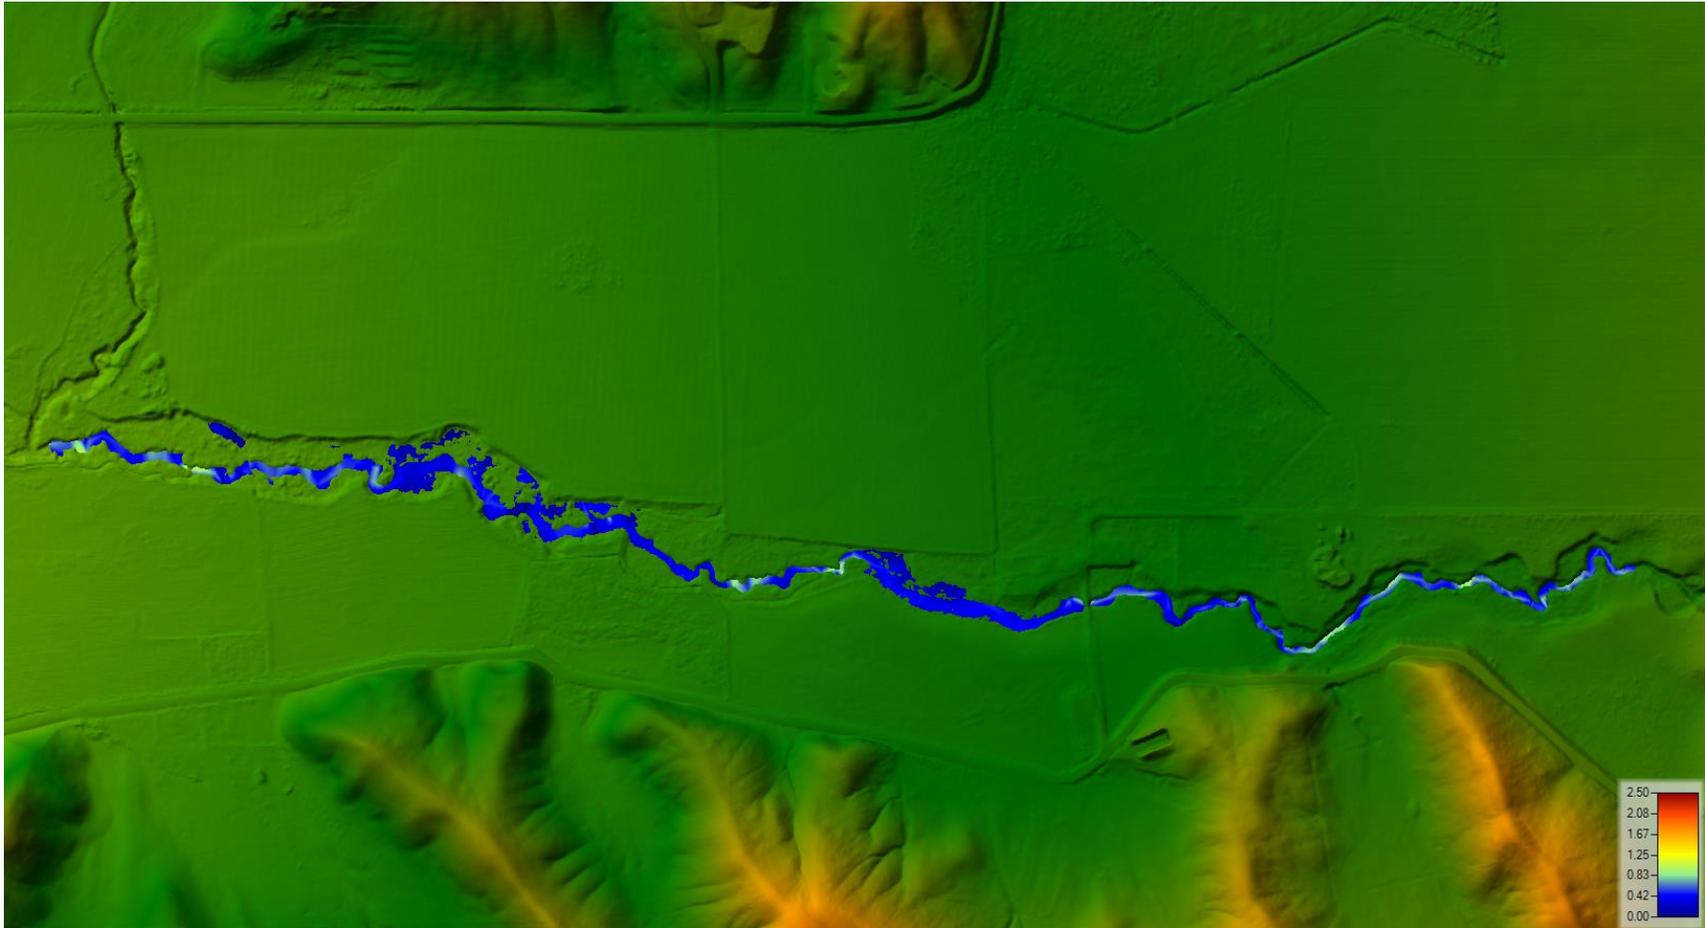
Figure G12 Model results of Reach 6 water velocity with a discharge of $1.42\text{m}^3/\text{s}$ and a Manning n 0.065.
