INVESTIGATING THE CAUSES OF A LANDSLIDE IN TERRA NATIVA  
SUBDIVISION AND DESIGNING SLOPE STABILIZATION USING RECYCLED  
PLASTIC PINS

submitted in partial fulfillment  
of the requirements for the degree of  
Master of Science in Civil Engineering  
Boise State University

August 2023

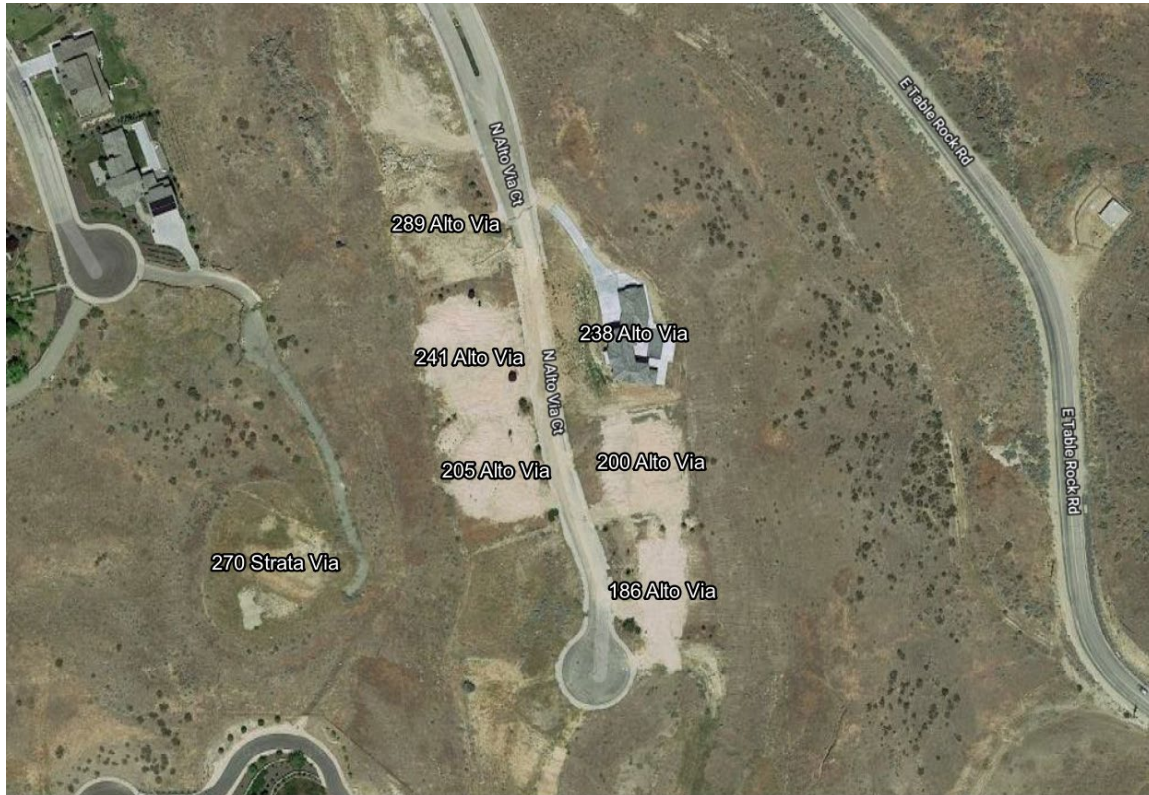
**Picture 2. Lots at Alto Via Court (Courtesy QGIS)**

Damage started with the Sericati residence at 289 Alto Via Court—see Picture 2—in January of 2016 with minor internal cracking. In the months that followed, the

damage worsened and spread to all other homes on the street, except for the home at 238 Alto Via Court, which was narrowly missed by the slide (Woodworth et al., 2016). By the beginning of May, the Ada County Highway District (ACHD) Commission had closed the entire street for safety reasons (Shelton, 2016). In 2018, five of the six original homes were demolished (KTVB, 2018).

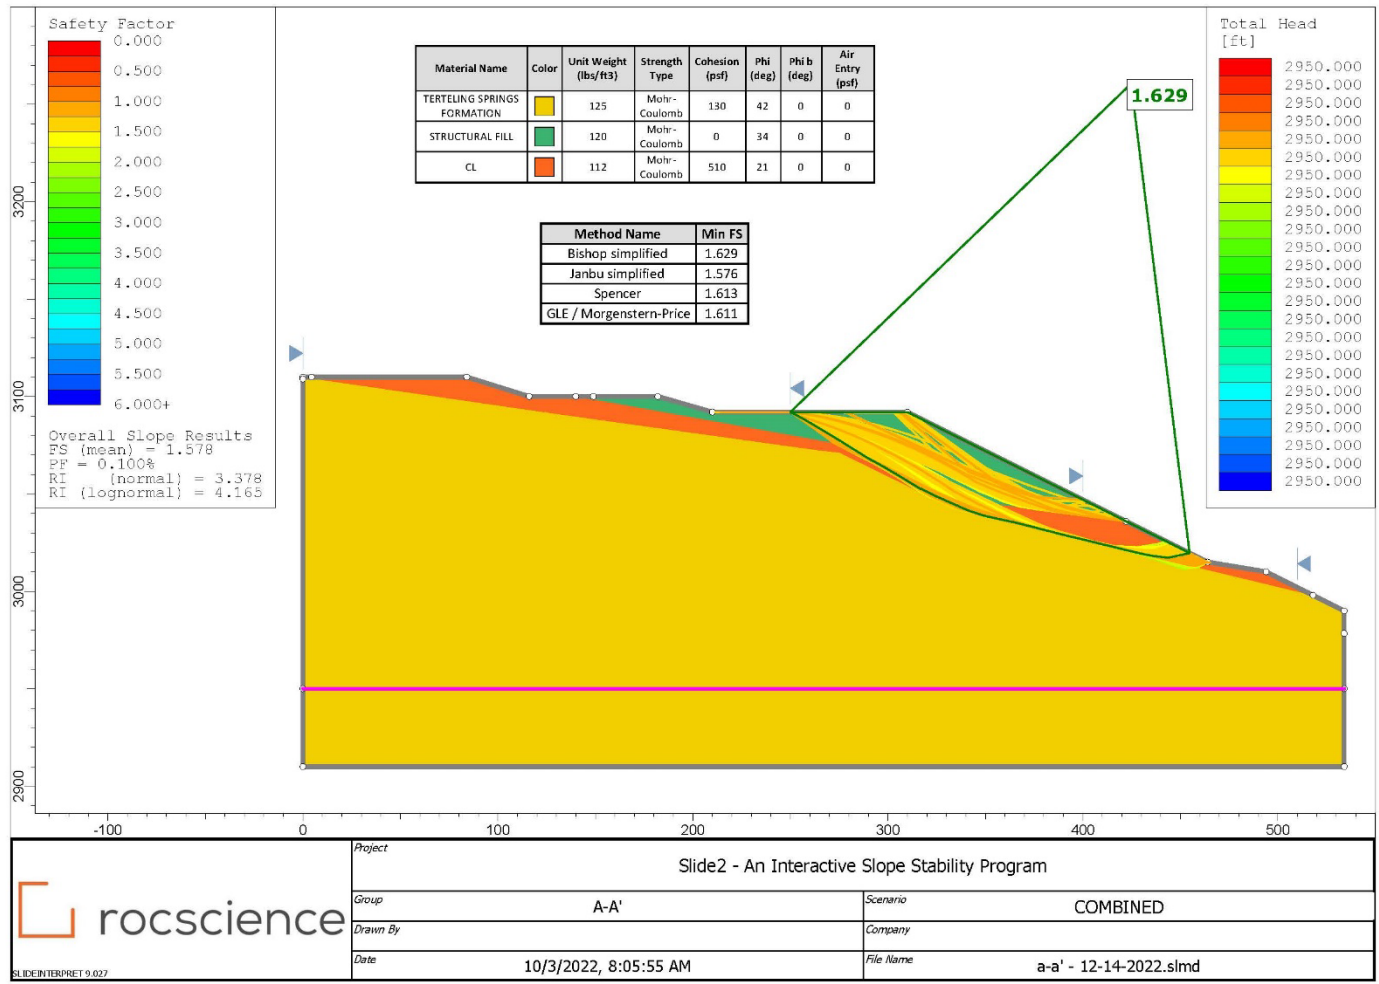
Figure A.1 Cross Section A-A' Before Failure

The following pages present the five cross sections with their accompanying factors of safety for the pre-failure analysis.

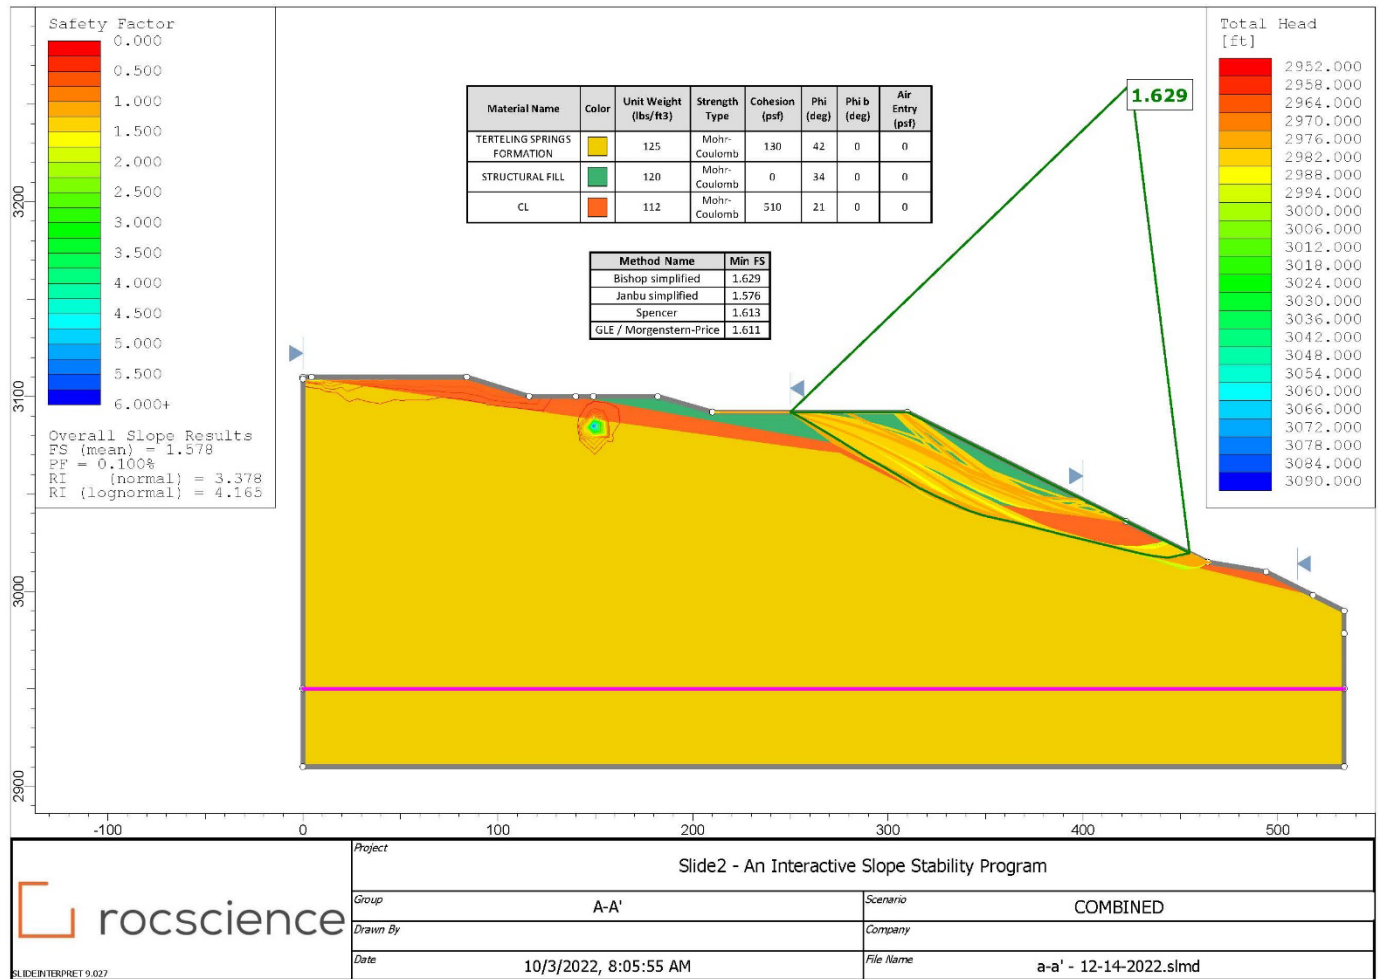
Figure B.1 Cross Section A-A' After Failure

The following pages present the five cross sections with their accompanying factors of safety for the combined post-failure analysis.
